**Specialist Professional and Technical  
Services (SPATS) Framework  
Lot 1 & Lot 2**

**Task 1127  
Smart Motorway Incident and Infrastructure  
Investigation – M1 Junction 10 to 13**

July 2021

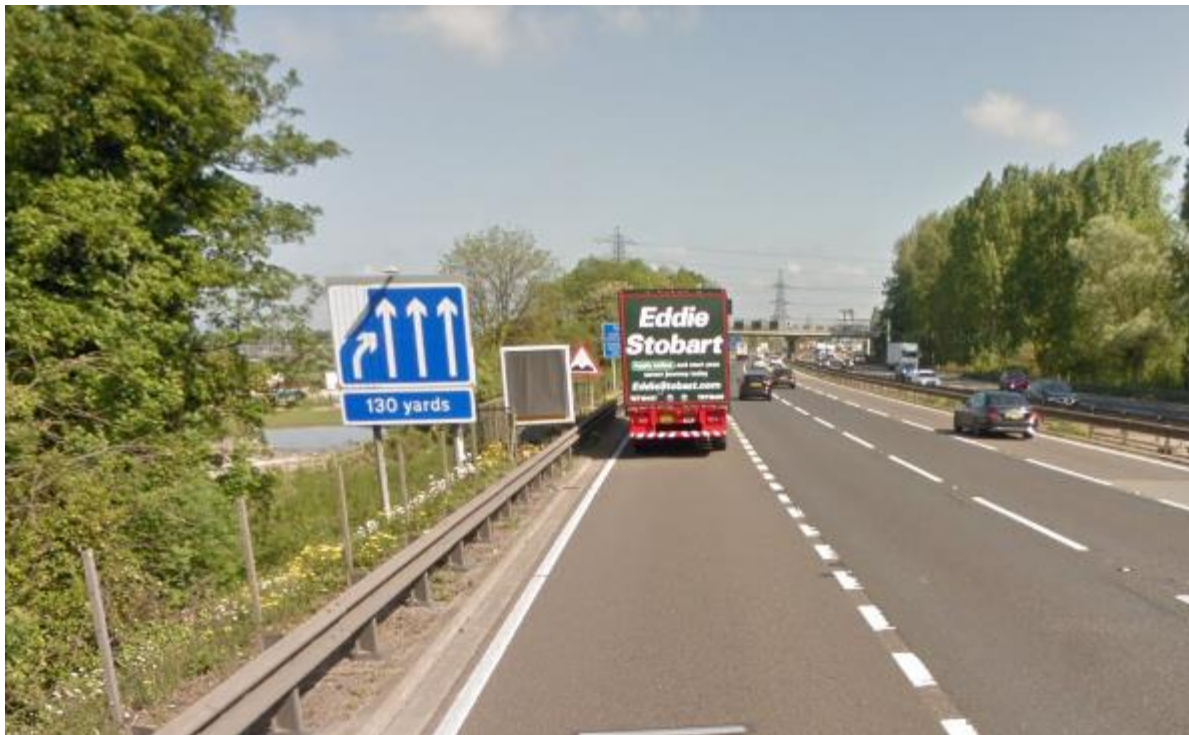
**Figure 5.1** View of advance signing associated with the transition from through junction running to dynamic hardshoulder

In comparison, elsewhere on the network lane drop diverges are relatively common. These require through traffic to make a similar manoeuvre from LBS1 to LBS2 to continue through the junction, however this lane drop arrangement is signed typically from one half or one third of a mile (or greater) in advance, and does not occur immediately following a merge. The lane change manoeuvre at lane drops

can therefore be considered as easier to undertake than those required at merges by this scheme's operational regime.

Consider increasing the number of signs for the transition from through junction running to dynamic hard shoulder downstream of the junction merges to provide additional warning and instruction for all drivers but particularly those in LBS1 and LBS2. Currently the signing is limited to one sign, see figure 5.1 providing between 130 and of 200 yards warning. Only on the northbound approach to junction 10 are two signs provided, a ½ mile and 100 yard sign. It is noted that the transitions between through junction running and dynamic hardshoulder will not exist when this section of the M1 is converted to an all lane running scheme, programmed for completion by the end of March 2025.

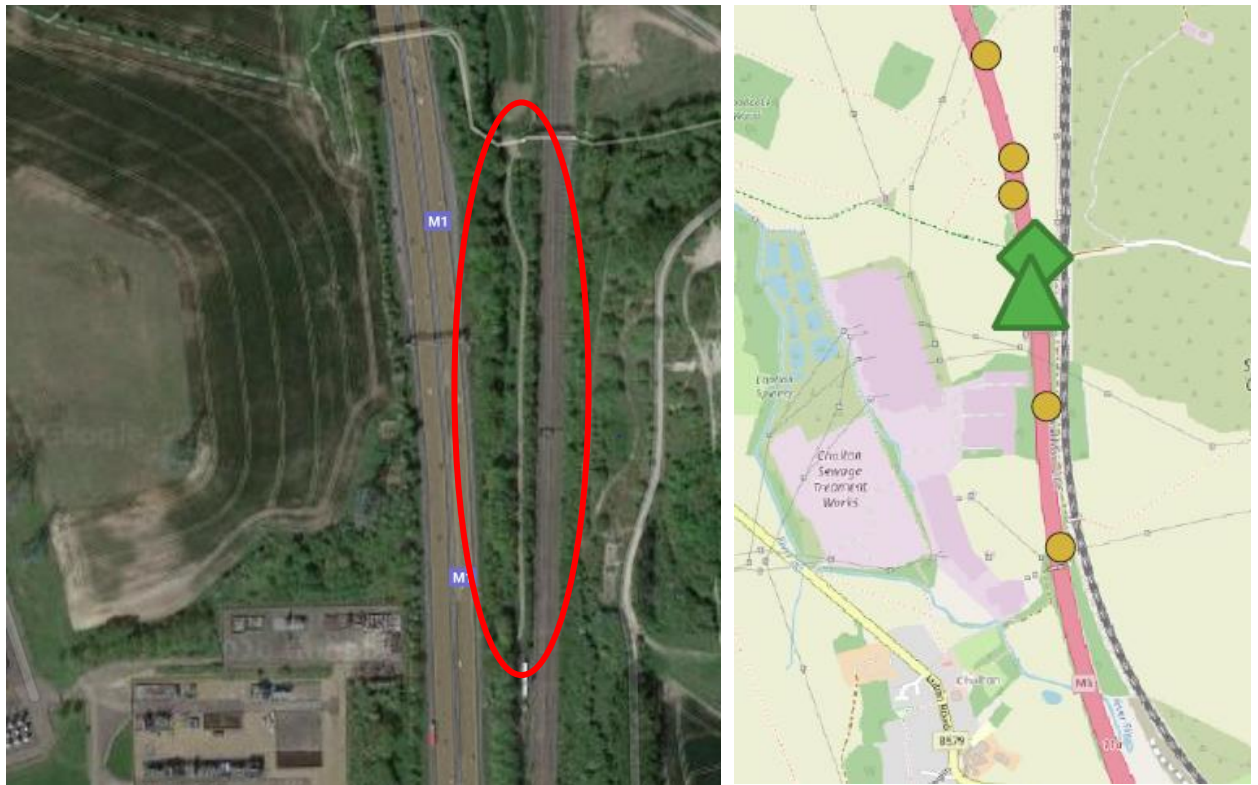
Figure 5.2 Aerial view of public right of way immediately adjacent to the M1 and corresponding incident plot showing 2019 'pedestrian on the network' data

- clusters recorded at junctions 10 and 11 which are located adjacent to the built up areas of Luton and Dunstable.
- between junctions 10 and 11a the incidents appear adjacent to local routes which cross the M1, for example High Street, or potentially offer short cuts between residential areas.
- between junctions 11a and 13 the incidents are recorded in close proximity to emergency areas; possibly associated with ex-passengers or potentially associated with where public rights of way cross the motorway either via accommodation bridges or subways. Figure 5.2 provides an example of where a public right of way runs immediately adjacent to the M1 and then uses an accommodation bridge to cross the carriageway on an indirect route.

No clearly identifiable issues have been found, however it is recommended that pedestrian provision, fencing and other deterrents are reviewed, particularly at the southern end of the scheme where the M1 passes through the built up areas of Luton and Dunstable. The large scheme process set out in GG 142 *Walking cycling and horse-riding assessment and review* is suitable for this application - to identify demand opportunities for new and improved facilities and their integration with the local and national network(s). This was not a mandatory requirement when this scheme was designed although it now is for all Highways England promoted schemes. Additionally, consider applying Highways England's suicide prevention tool kit.

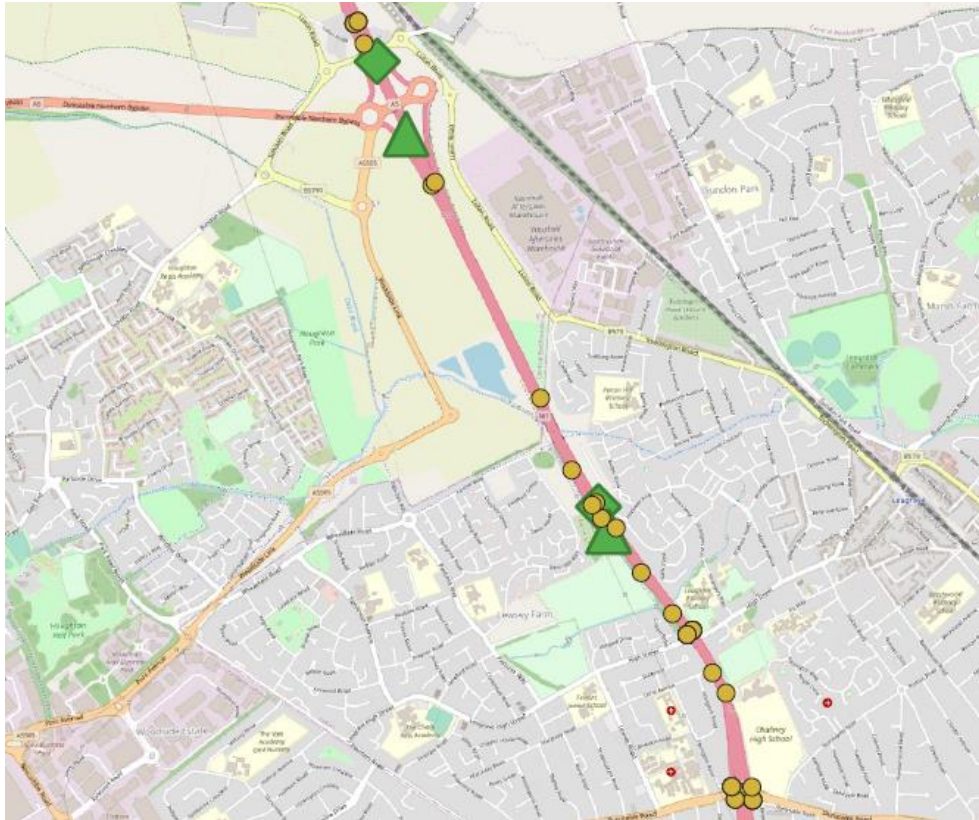
Figure 5.3 ‘Pedestrian on network’ incidents in 2019 between junctions 11 and 11A

Figure 5.3 shows an extract from the 'pedestrian on network' incident plot for 2019 between junctions 11 and 11a and highlights the potential severance effect of the M1 between Dunstable to the west and Luton to the east. At the southern end of this link there are a number of reported incidents shown, some could be associated with the emergency areas.

Over the three year period 2017 to 2019, 145 incidents involving pedestrians on the network were reported between junctions 11 and 11a, an average of 48 per year, almost one per week. This coincides with where the fatal collision was recorded involving a pedestrian on the southbound exit slip road. Figure 5.4 shows a StreetView image of the southbound exit slip road.

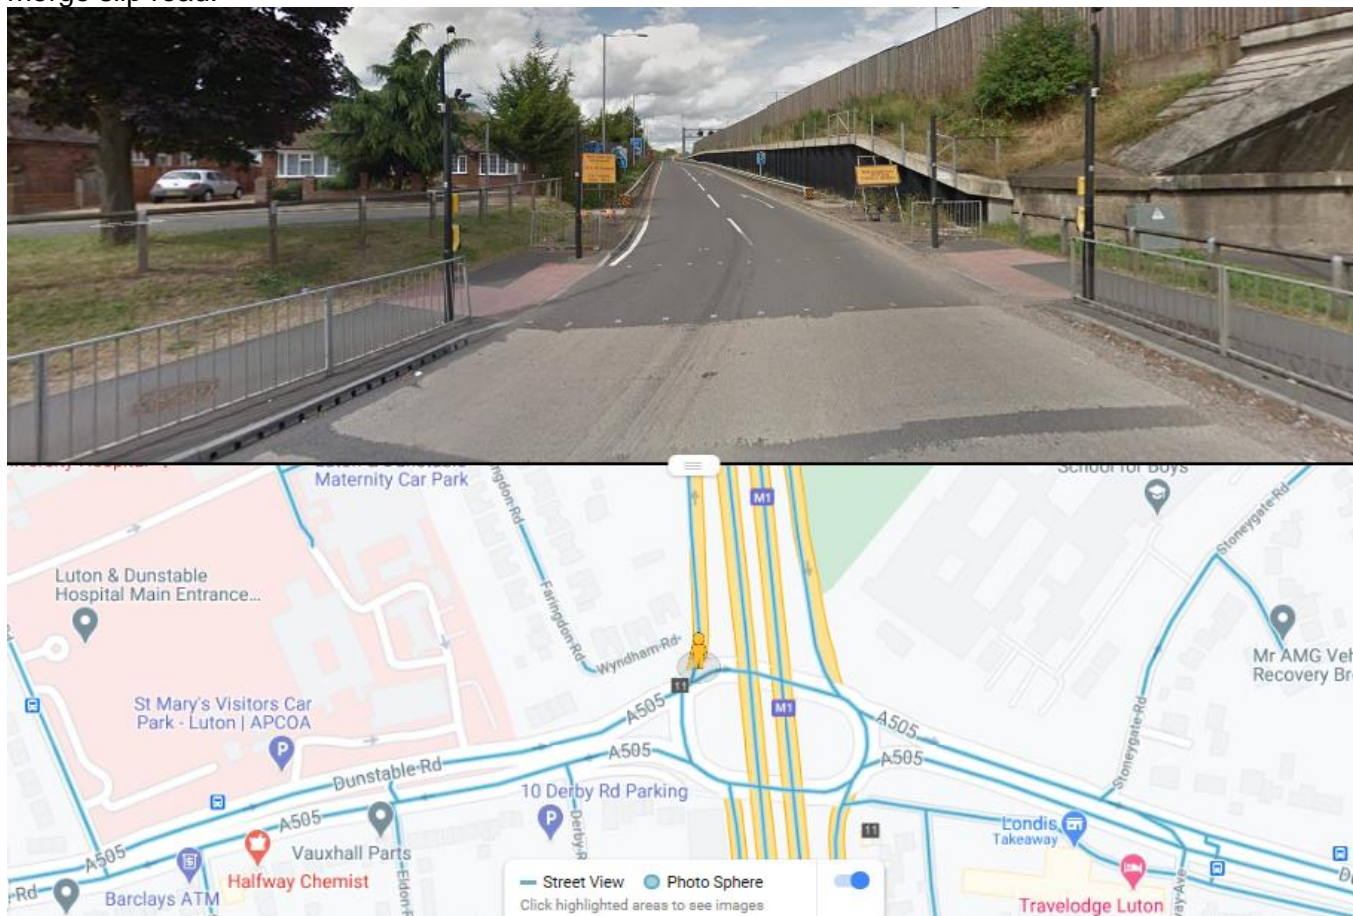
**Figure 5.5 Google Mapping and StreetView showing hospital proximity to junction 11 and pedestrian facilities at the northbound merge slip**

Luton and Dunstable University Hospital is situated immediately west of junction 11 and the Highways England Operations team considered that this may be either an attractor or source of some pedestrians.

Figure 5.5 shows the proximity of the hospital to junction 11 and pedestrian facilities at the northbound merge slip road.

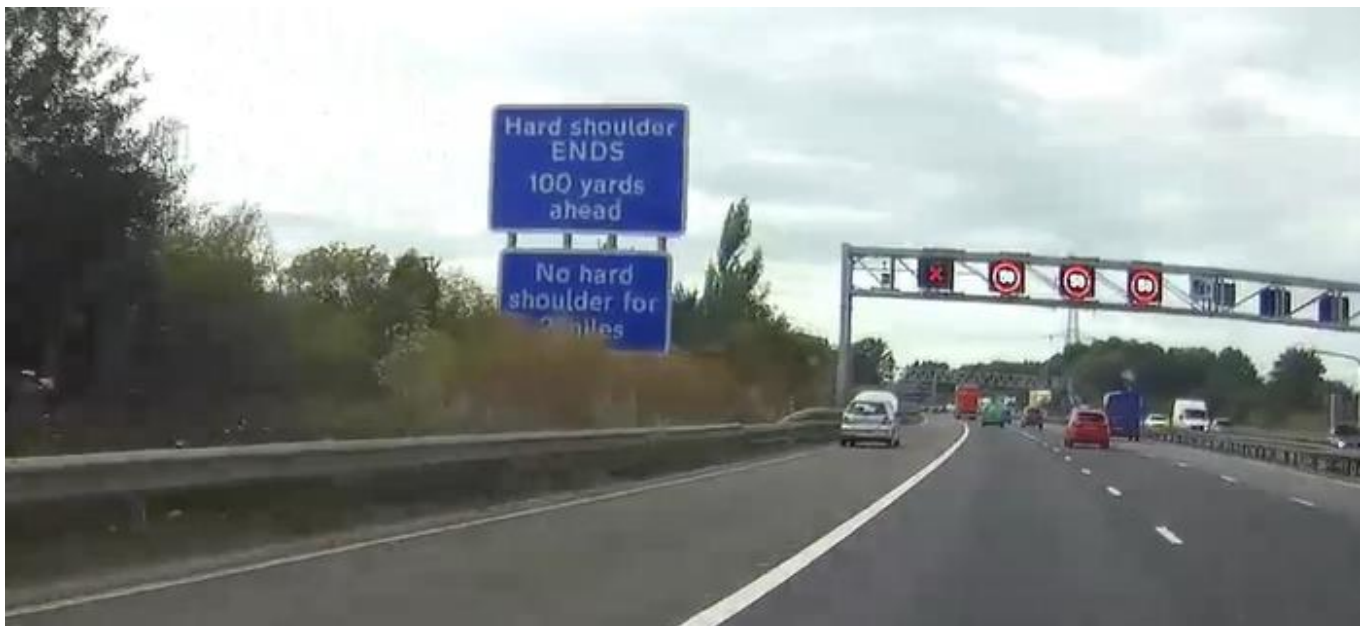
**Figure 5.6 View northbound prior to MSA diverge (Dashcam footage 22/07/2020)**

In the 12 month post opening, stage 4 road safety audit concerns raised by the motorway service area manager were cited around confusing signing prior to the service area potentially resulting in unnecessary weaving. This relates to the northbound approach to the motorway service area where signs indicating the end of the hard shoulder are provided just before the 300 yard sign for the diverge, see Figure 5.6. Drivers using LBS 1 when permitted, may react to this sign and change lane only to change back again as the through junction running starts or if they wish to leave the motorway at the services. Three lane change collisions were recorded on the northbound approach to the motorway service area, one slight and one serious in year 3 and one slight in year 6.

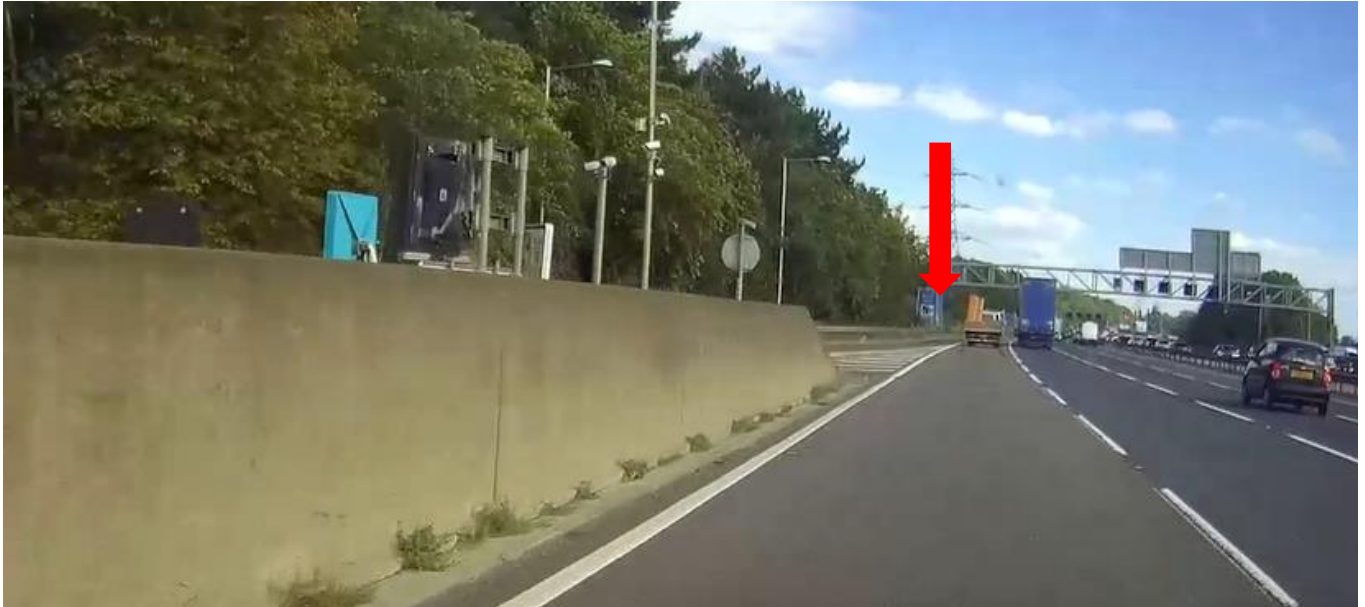
**Figure 5.7 View southbound prior to motorway service area merge (Dashcam footage 22/07/2020)**

The 12 month post opening stage 4 road safety audit also identified that the nearside concrete barrier prior to the motorway service area southbound merge partially obscured the view of vehicles. This may be resulting in drivers changing lanes rapidly on seeing a vehicle in the merge from the motorway service area.

The collision descriptions indicate that six of the thirteen lane change collisions at this location involved a vehicle moving from LBS 1 to LBS 2, which suggests that they are anticipating or accommodating a vehicle merge. The frequency of these collisions has fluctuated with four recorded in years 1 and 2, one in year 4, three in year 6 and one in year 7.

Figures 5.7 and 5.8 show the view to and from the motorway service area merge and illustrate why drivers might choose to change lane on the approach to the merge in anticipation of a vehicle joining the southbound carriageway.

Both factors could be contributing to the frequency of lane change collisions at this location.

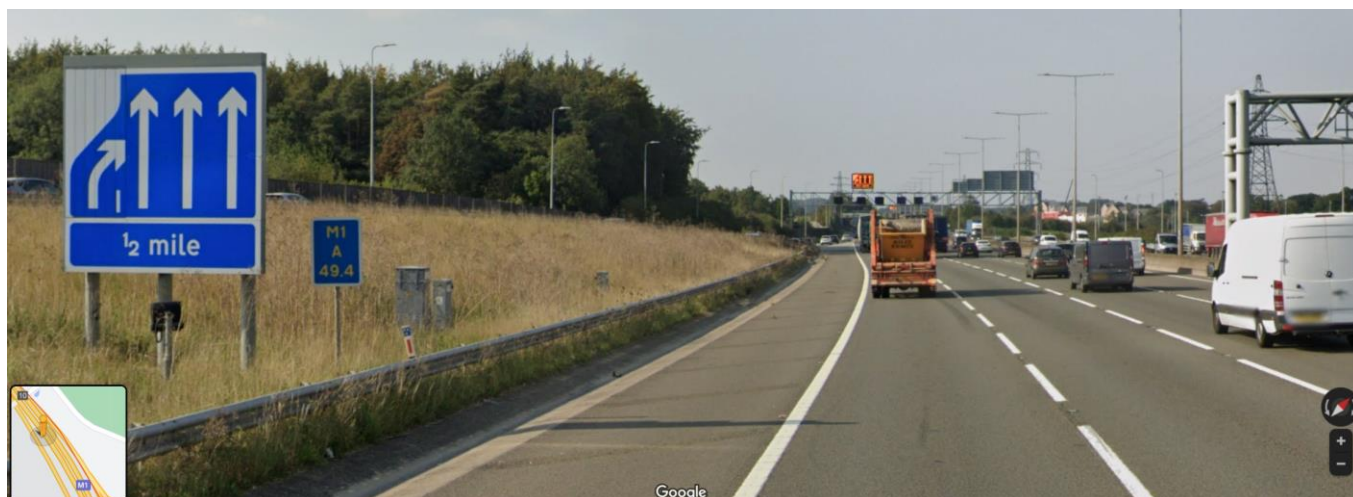
Figure 5.9 View northbound prior to junction 10 merge and rotating fixed message sign (Google Streetview image, Sep 2020)

On the mainline approach to the northbound merge, half mile and 100 yard rotating fixed message signs are provided to indicate if the hard shoulder is operating as a running lane, see Figure 5.9. Feedback from Highways England Traffic Officers on this section of the M1 highlighted that there have been issues with these signs becoming stuck and so it is possible that the signs do not necessarily depict the same message as the gantry signing resulting in unnecessary lane changing movements or misuse of the hard shoulder.

From the collision data descriptions it is not always clear if the dynamic hard shoulder is in operation however of the 13 slight collisions prior to the merge, six occurred during the weekday peak; four on a Friday, when it would be expected that four lanes were available north of junction 10. Six of the thirteen collisions have occurred during darkness, which is a greater than average for Highways England motorways of 30% (2018) – and particularly notable as this is a lit link.

Given the anecdotal evidence that the rotating fixed message signs can become stuck and the commitment that this section of the M1 between junctions 10 to 13 is being converted from a dynamic hard shoulder operation to all lane running at which point these signs can be removed, it is recommended that:

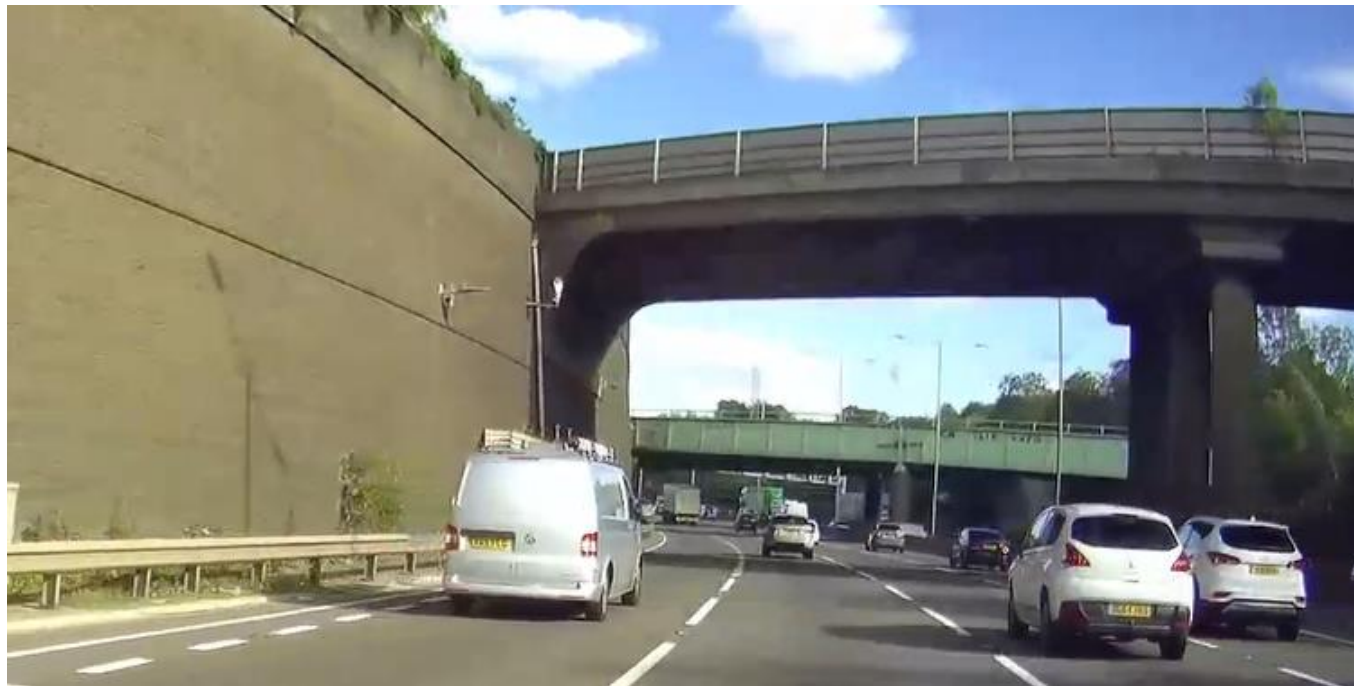
**Figure 5.10 View southbound at junction 11 merge tip (Dashcam footage July 2020)**

On the southbound carriageway at junction 11 the overhead structures combine with the high nearside retaining wall to create a tunnel-like effect. The horizontal alignment may also increase the effect of the 'blind spot' particularly when moving from LBS1 to LBS2. Of the fourteen collisions recorded in the vicinity of the southbound merge there have been seven lane change collisions; four of which involved a left hand drive vehicle, and four shunts. Figure 5.10 shows the view southbound at the merge tip.

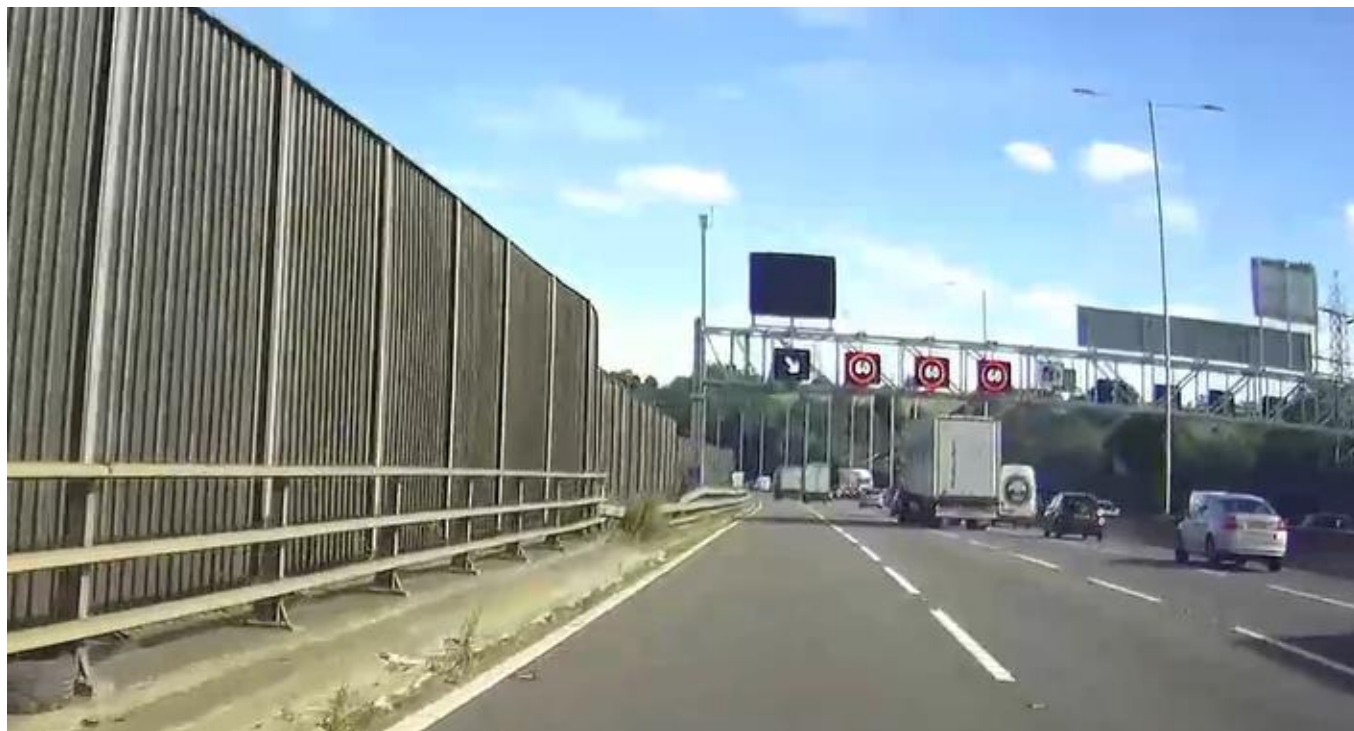
Figure 5.11 View southbound of overhead signs prior to junction 11 merge (Dashcam footage July 2020)

Advance signing of the transition from through junction running to hard shoulder running on the southbound carriageway is limited to one sign without a distance plate. Visibility to the sign is also reduced, particularly from LBS1 due to the preceding overbridge. Both the dashcam footage and Google StreetView images from June 2019 indicate that the overhead signals are set to try and reinforce the layout using the 'move across' arrow and red x on successive signals, see Figure 5.11.
