**Specialist Professional and Technical
Services (SPATS) Framework
Lot 1 & Lot 2**

**Task 1127
Smart Motorway Incident and Infrastructure
Investigation – M1 Junction 30 to 35**

July 2021

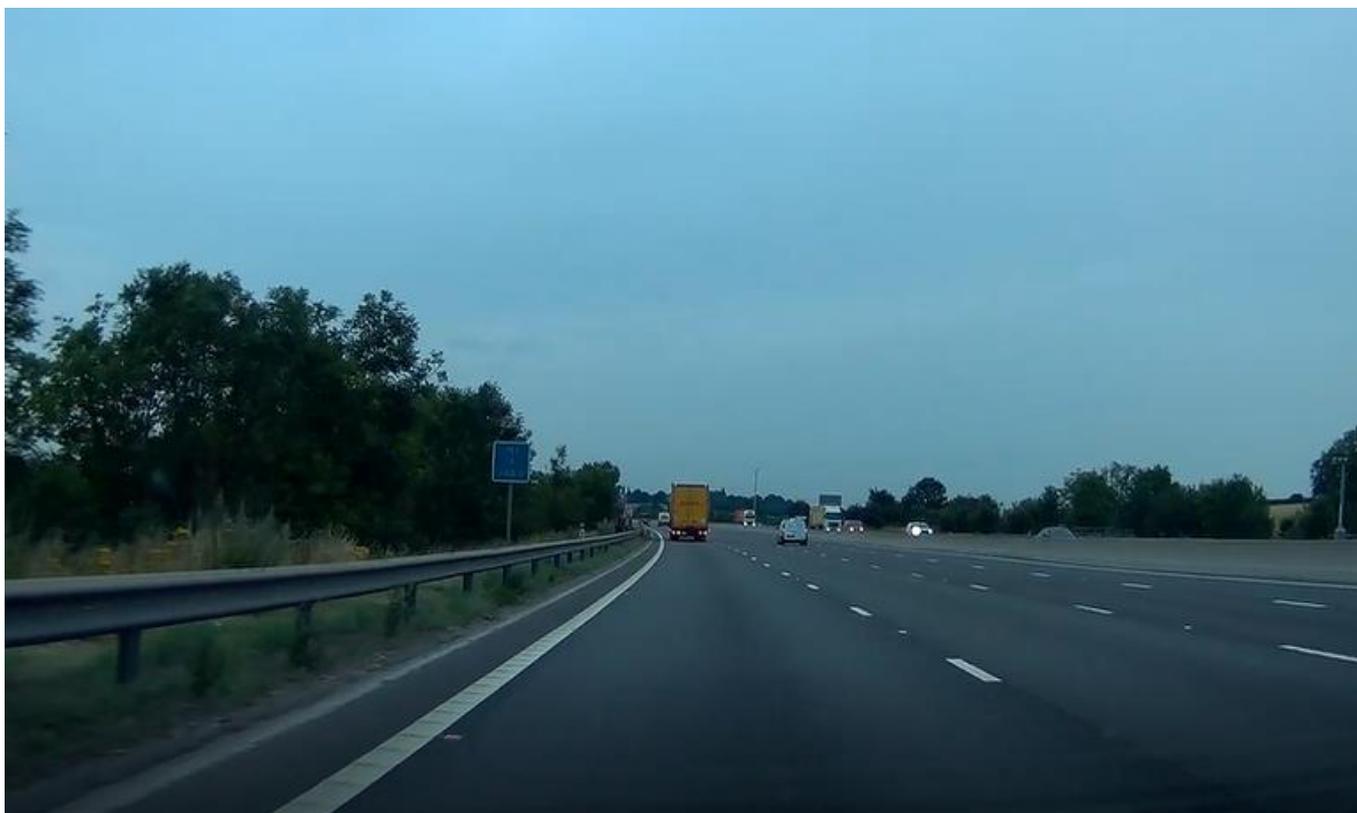
Figure 5.2 Northbound visibility North of Woodall motorway service area (dashcam video, July 2020)

It is unclear as to why live lane stoppages are resulting in a cluster of serious collisions in this location. Two of the collisions occurred on a sweeping left hand bend with the other two occurring downstream of this, forward visibility to vehicles may therefore be an issue. This was noted as an issue with the Stage 4 road safety audit.

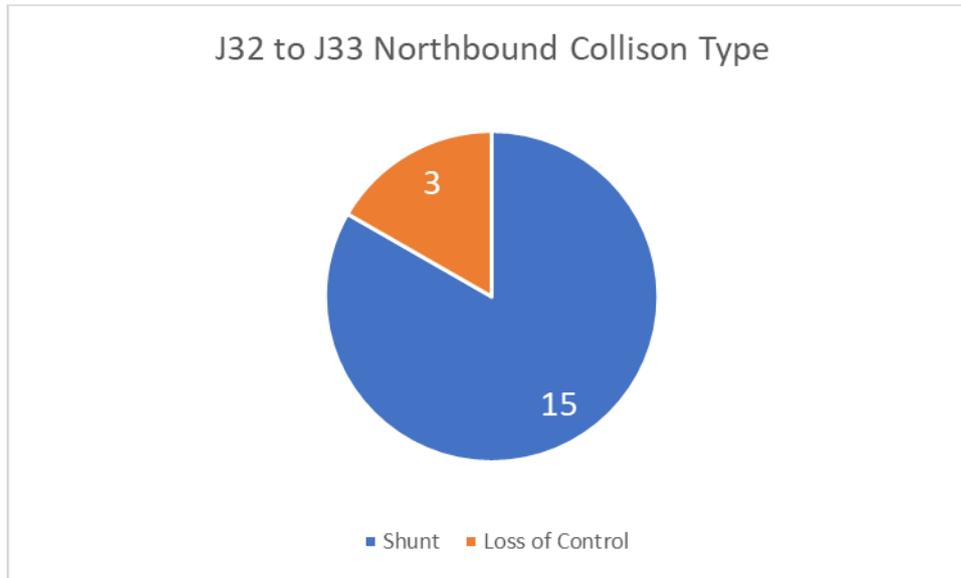
Figure 5.3 Junction 32 to 33 northbound collision type

On the approach to Junction 33 there were a further five shunt collisions on a dry road surface with a further four on the approach to the 2/3-mile advanced direction sign. A total of 18 collisions occurred on this northbound link; Figure 5.3 shows the collision types.

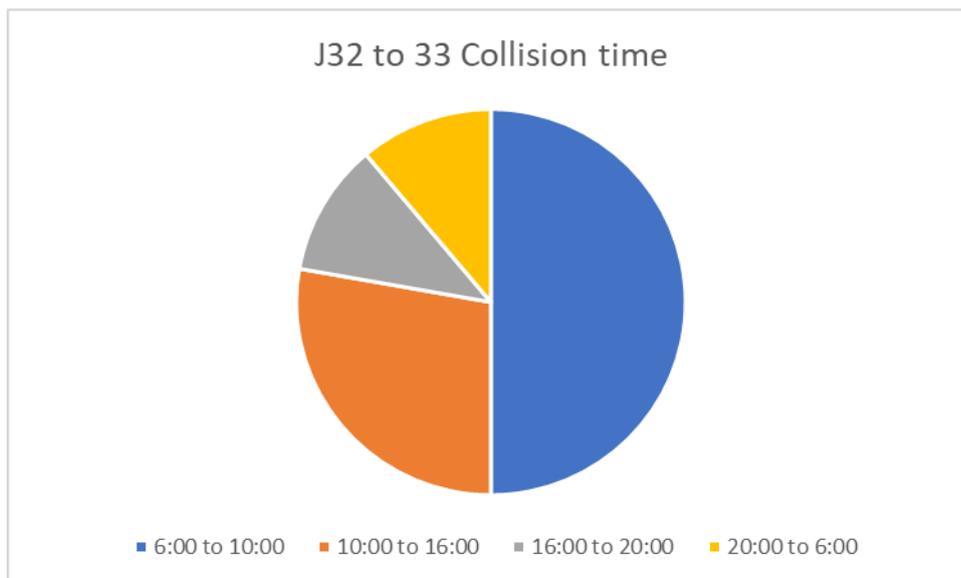
Figure 5.4 Junction 32 to 33 wet surface conditions northbound collision times

Figure 5.4 shows the collisions times for the link, with half the collisions on the link occurring between 6:00 and 10:00. This would suggest congestion during this period.

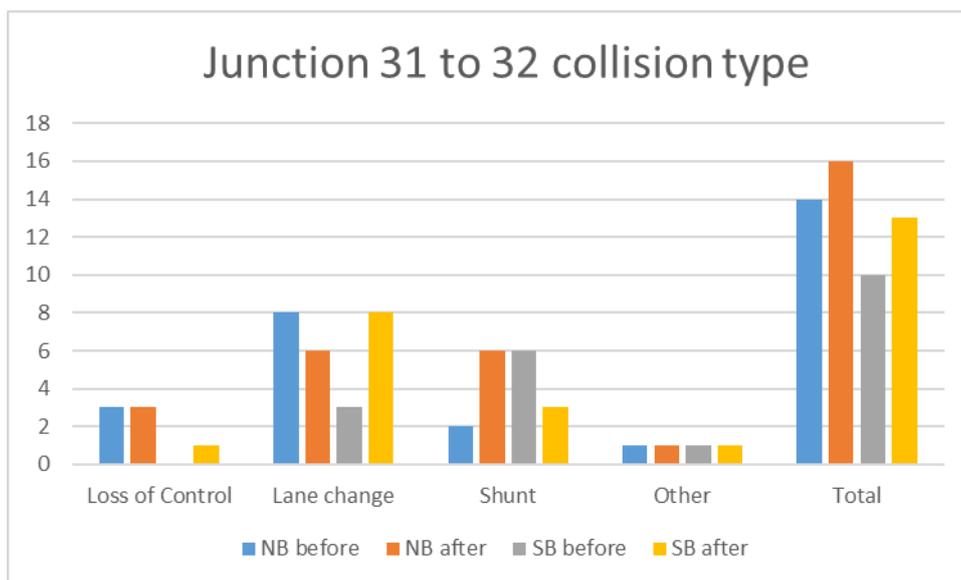
Figure 5.5 Junction 31 to 32 collision types

The increase in shunt collisions on the northbound carriageway would suggest an increase in congestion, but given the increased capacity and signalling this is unlikely to be the case. Four of these collisions occurred in 2016 with only two occurring in the subsequent years. In 2016 the Junction 32 to 35a smart motorway was in construction and the traffic management may have been increasing congestion on the approach through this link; the completion of those works and the resultant increased capacity downstream may have addressed the number of shunts.

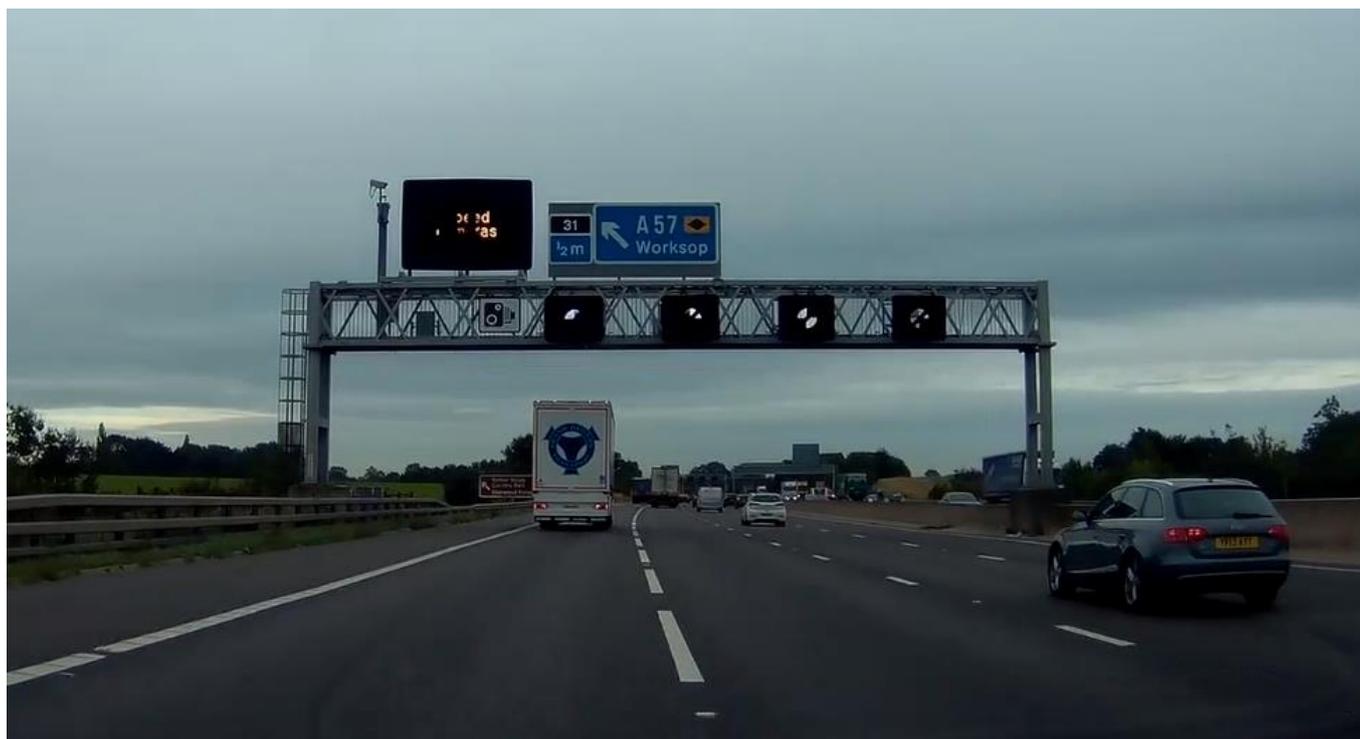
Figure 5.6 ½ mile advanced direction sign for Junction 31 over lane 1 / 2; hazard lines between lane 1 / 2 (dashcam video, July 2020)

A review of the drive through video as shown in figure 5.6, has identified that the exit signs on the southbound carriageway are positioned above lane 1 and partially above lane 2 rather than being offset to the left and the hazard road markings are provided up to the secondary advance direction sign, both of these may lead road users to misunderstand the layout for a lane drop ahead and result in unnecessary lane changes.

B) J32 to 31 lane change collisions	<ul style="list-style-type: none"> • Lane destination markings on road • Supplementary ADS on approach to J31 southbound • Provision of hazard road markings

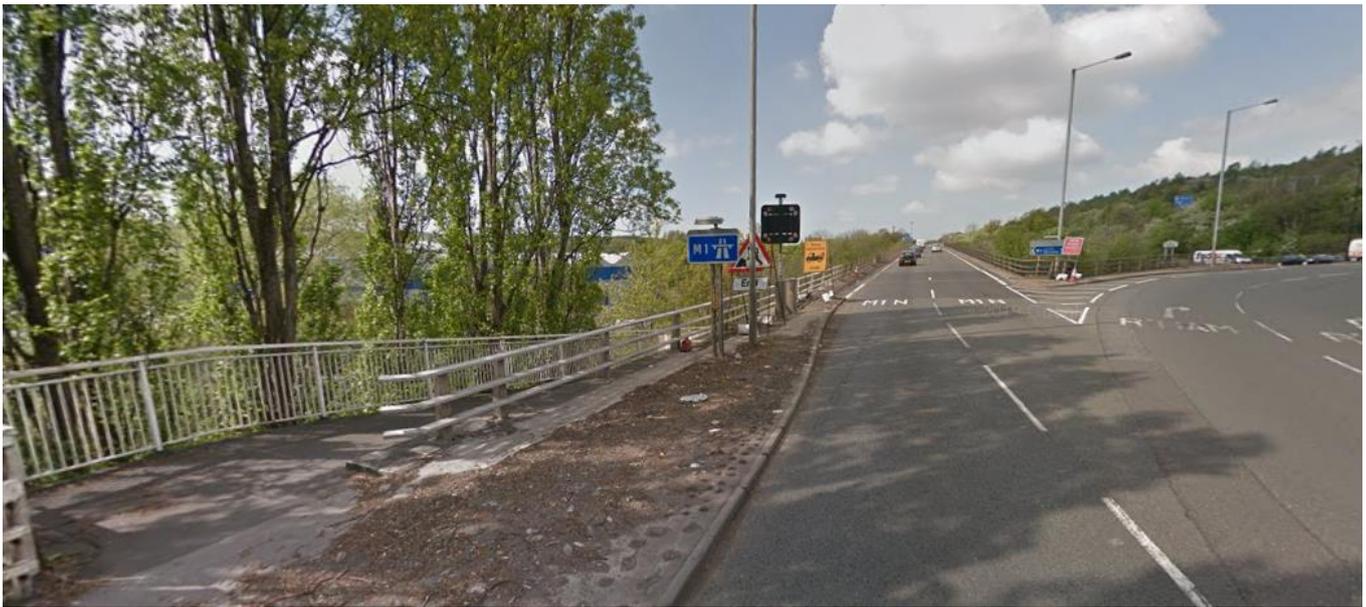
Figure 5.10 Streetview image of junction 34 northbound entry slip

- The aforementioned fatality from a potentially socially vulnerable pedestrian who had gained access to the carriageway from a slip road at Junction 34. The view of the entry slip road at Junction 34 is shown in Figure 5.10 with the ramped footway in the foreground and a maintenance path continuing towards the slip road.
- A serious collision involving a pedestrian on the northbound entry to Junction 31 being struck by a vehicle. The view of the northbound entry slip road at Junction 31 is shown in Figure 5.11 with the footway and uncontrolled crossing in the foreground.

Collisions and incidents involving pedestrians have been reviewed and the range of crossing and potential access points (i.e. via slip roads close to urban areas) is a risk factor. Measures to prevent pedestrian incursion at slip roads are recommended.

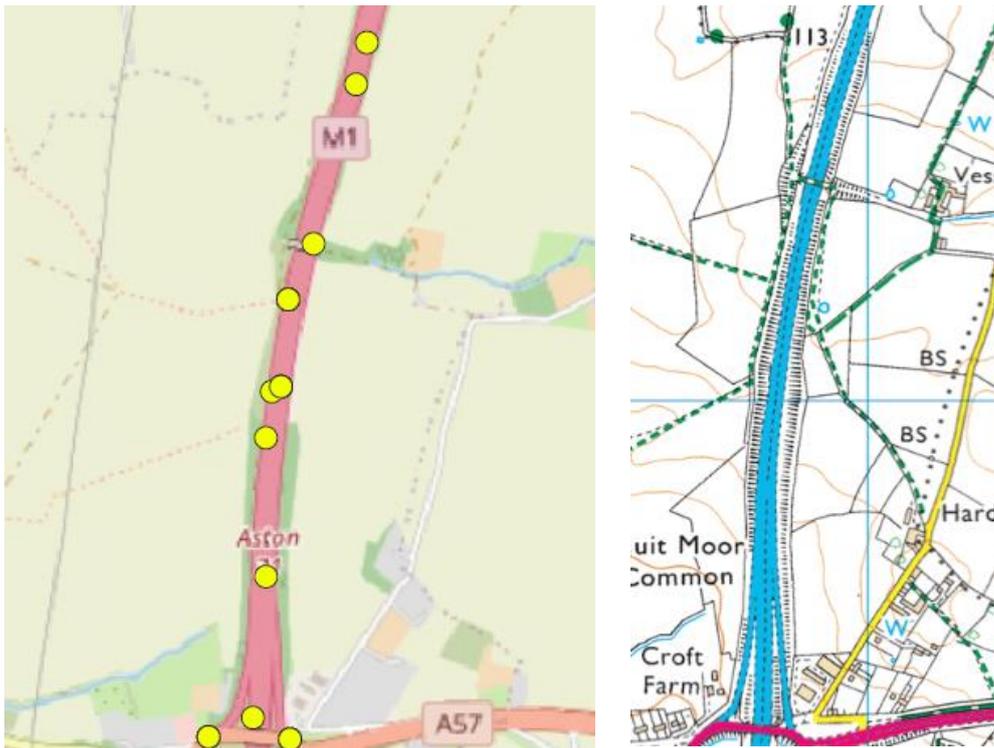
Figure 5.12 Pedestrian on network plot north of Junction 31 and corresponding public rights of way network

- between Junctions 31 and 32 a cluster of incidents appear to be associated with where a number of public rights of way run immediately adjacent to the motorway and converge at an accommodation bridge in order to cross the motorway. Figure 5.12 illustrates the incidents and their locality with respect to public rights of way. The detour is approximately 750m and may result in pedestrians attempting to cross the carriageway rather than follow the footpath. This situation with accommodation bridges occurs at other locations along this section of the motorway but potential pedestrian clusters are not apparent elsewhere.
