**Specialist Professional and Technical
Services (SPATS) Framework
Lot 1 & Lot 2**

**Task 1127
Smart Motorway Incident and Infrastructure
Investigation – M6 Junction 5 to 6**

July 2021

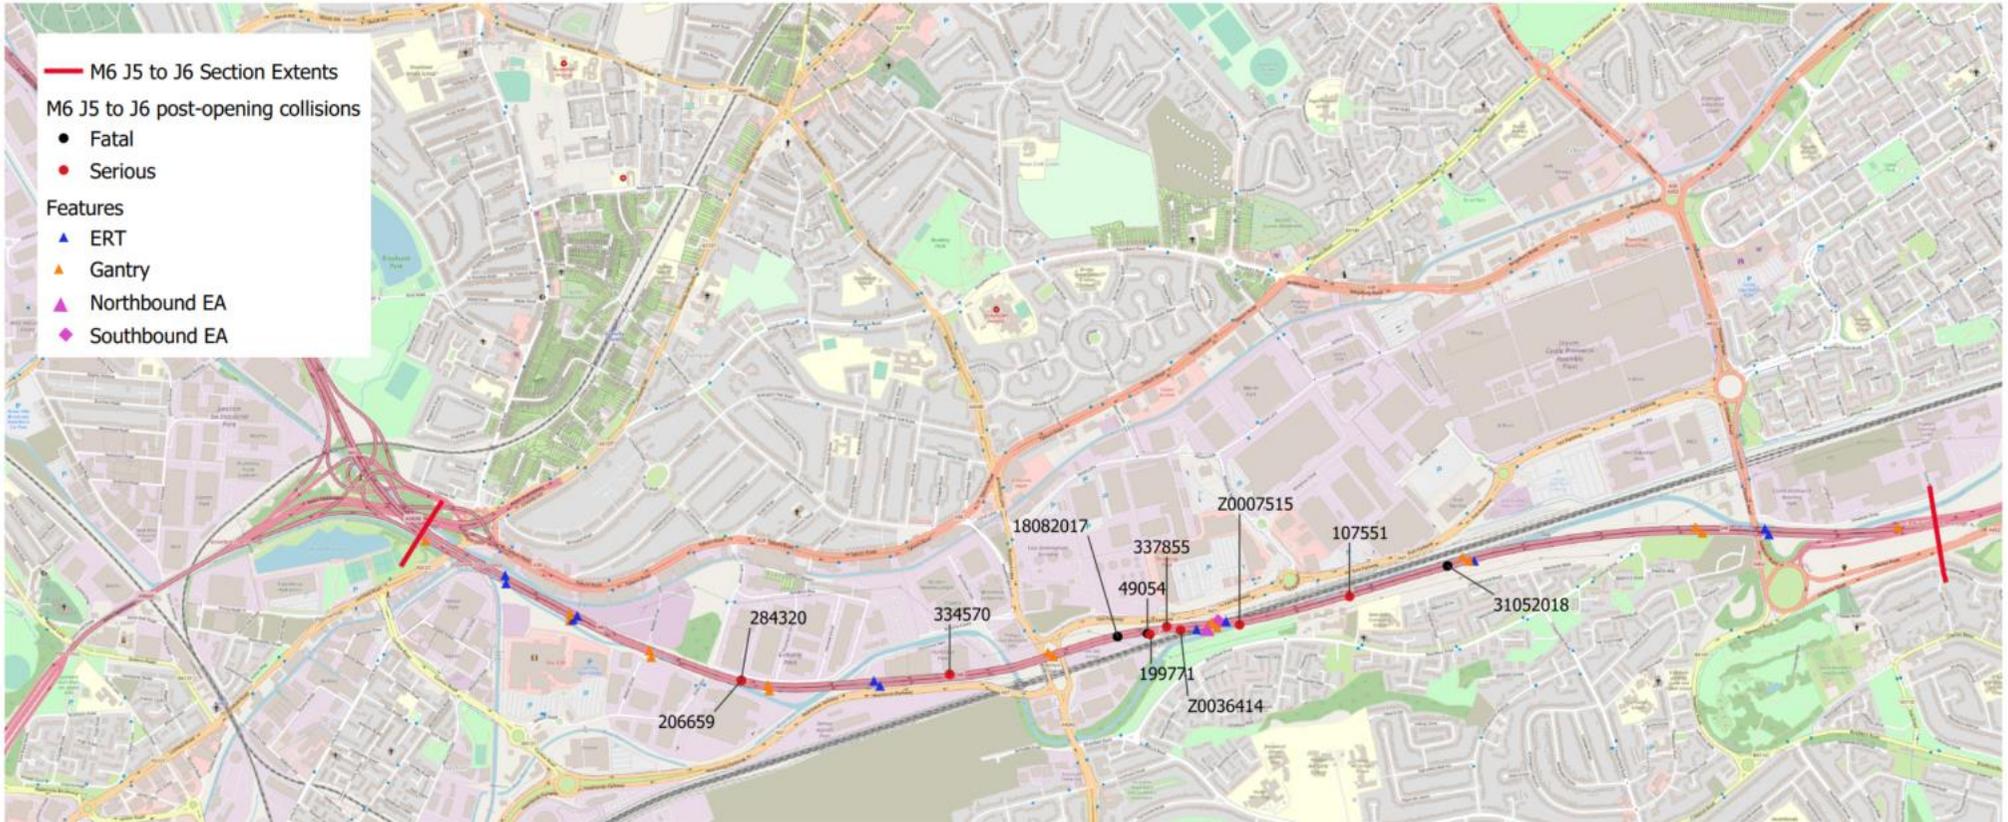
Figure 5.1 Location of fatal and serious collisions (including emergency telephones and signal gantry locations)

Collision Ref.	Carriageway	Date & Time	Conditions	Detail	Casualties	Comment
Z4905416	Northbound	04/02/2016 at 01:50. (Thursday)	Wet and in the dark on a lit section of carriageway	Two vehicles involved; Vehicle 1 was a car and vehicle 2 was a large goods vehicle (larger than 7.5 tones). The contributory factor was noted as exceeding the speed limit.	Two males both fatally injured aged 26 and 42.	Limited detail is available to inform the investigation.
Unknown – (referenced as 18082017 on Fig 5.1)	Southbound	18/08/2017 at 09:11. (Friday)	Dry in daylight	Two vehicles involved; vehicle 2 (a recovery truck) makes a live lane stop in LBS1 which is open to traffic. The Regulation 28 report to Prevent Future Deaths written by the coroner states that, “ <i>Mr Ahmed activated his hazard lights, exited his lorry, opened the bonnet and stood looking into the engine.</i> ” The vehicle is present for 2 minutes and 15 seconds when vehicle 1, a goods vehicle, collides with the rear of vehicle 2. A 60mph speed restriction was in place. The driver of the stopped vehicle was under the influence of drugs.	One male of 36 was fatally injured and one male of 34 was slightly injured.	The next place of relative safety was an emergency refuge area 300m downstream from the collision location.

Unknown – (referenced as 31052018 on Fig 5.1)	Southbound	31/05/2018 at 19:29. (Thursday)	Dry/light	A car stops for unknown reason in LBS1 whilst it is open. An approaching goods vehicle collides with the rear of the car. A 60mph speed restriction was in place. The Regulation 28 report to Prevent Future Deaths written by the coroner states that, <i>“It is not known why the Toyota Yaris stopped but there is no evidence of a fault with the vehicle causing it to stop, illness of the driver or a hazard in the road.”</i>	An 8-year-old boy was fatally injured but the injuries to the 3 others involved are unknown.	The collision occurred approx. 3 miles along the link (M6 B MP179). The closest place of relative safety was 1 mile upstream with a further facility 1.5 miles downstream. Collision was 650m downstream of a signal gantry.
---	------------	---------------------------------	-----------	--	--	--

Collision Ref.	Carriageway	Date & Time	Conditions	Detail	Casualties Sex Age	Comment
Z0036414	Northbound	18/10/2014 18:54	Dark(lit)/dry	Limited detail. Collision involved a goods vehicle and a car. Contributory factors were fatigue, illness or disability.	M35 M60	Limited details to fully understand the type of collision
Z0007515	Northbound	15/03/2015 07:45	Light/wet	Lane changing. Contributory factors were impaired by alcohol, aggressive driving, careless/reckless.	F23 F38 F21 M27	
107551	Northbound	28/08/2016 04:25	Light/dry	Rear shunt. Contributory factor was travelling too fast.	M58 M20 M21 M22 M21	Although recorded as light, it is likely that this collision was actually in the hours of darkness given the time of occurrence.

Collision Ref.	Carriageway	Date & Time	Conditions	Detail	Casualties Sex Age	Comment
284320	Southbound just after junction 6	06/04/2018 01:13	Dark/dry	Live lane stop in lane 3. A goods vehicle in lane 2 has tyre blow out and stops in lane 3. Two other vehicles, a goods vehicle and a car collide with the stopped vehicle.	M54	Live lane stop shortly after junction 6 when LBS1 was not open . It also involved a tyre blowout. The operating regime was not a significant factor. It should be noted that this section is lit by street lighting; this may have been missed from the collision report.
206659	Northbound	02/07/2017 17:10	Light/dry	Rear shunt in lane 3 in stationary traffic. Contributory factors were failure to look, judge.	M34 M27 M38	
334570	Southbound	21/09/2018 18:37	Light/dry	Lane change from 3 to 4 resulting in 4 vehicle rear shunt.	F45 M53 M25	
199771	Southbound	05/07/2017 09:07	Light/dry	A car changed from lane 2 to 3 and was struck by a goods vehicle. Contributory factors were aggressive driving, careless.	M48	A 40mph limit was displayed on the gantries suggesting queue protection had been triggered and congestion was present.

337855	Northbound	21/09/2018 00:36	Dark(lit)/wet	A vehicle lost control on standing water in lane 3. Contributory factors were too fast, braking.	M35 M51 M22 M34 M39

Of the five serious injury collisions recorded on the northbound carriageway two involved a rear shunt, one changing lane, one loss of control and one unknown. Three of the collisions occurred in a weekday peak. The shunt type collisions would indicate congested driving conditions, and this is reflected in some of the collision descriptions, i.e. stationary traffic. Two of the collisions were recorded in the dark and two on a wet road surface. The number of recorded serious collisions has remained reasonably consistent since 2015, averaging one per year.

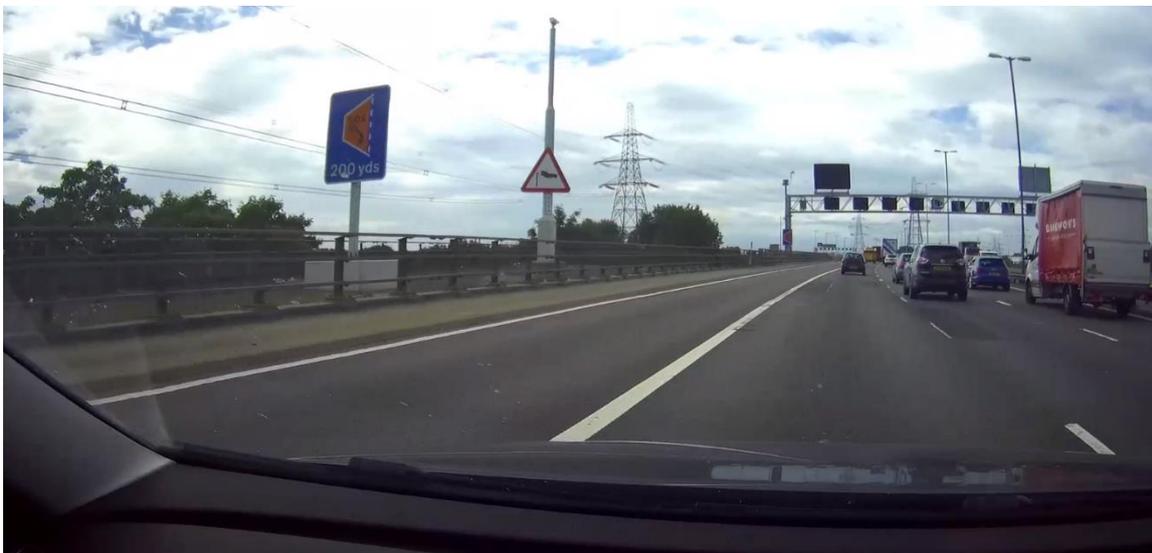
Figure 5.2 View of northbound emergency area at 200 yards sign.

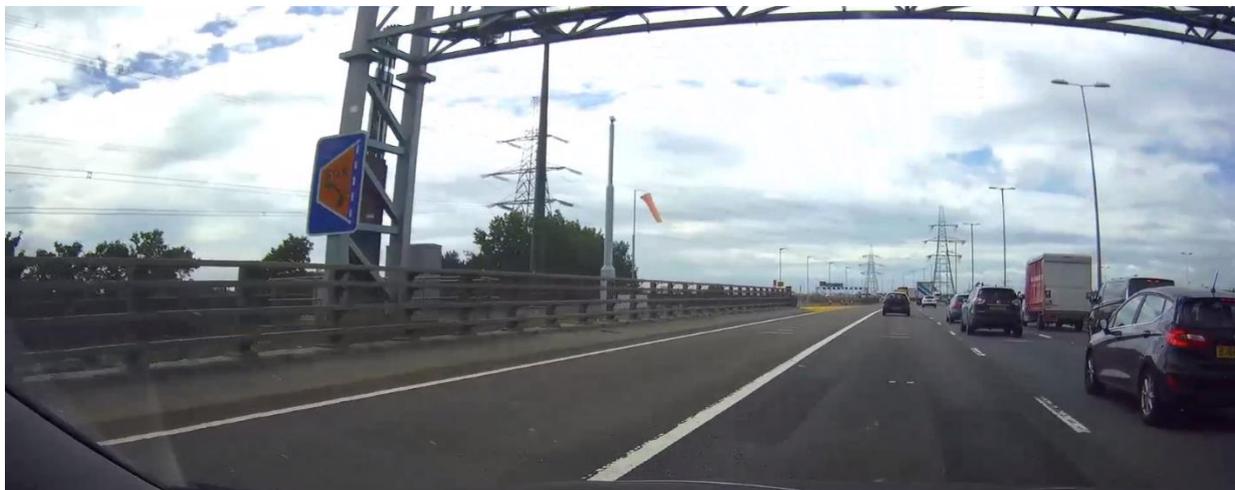
Figure 5.3 View of northbound emergency area at confirmation sign.

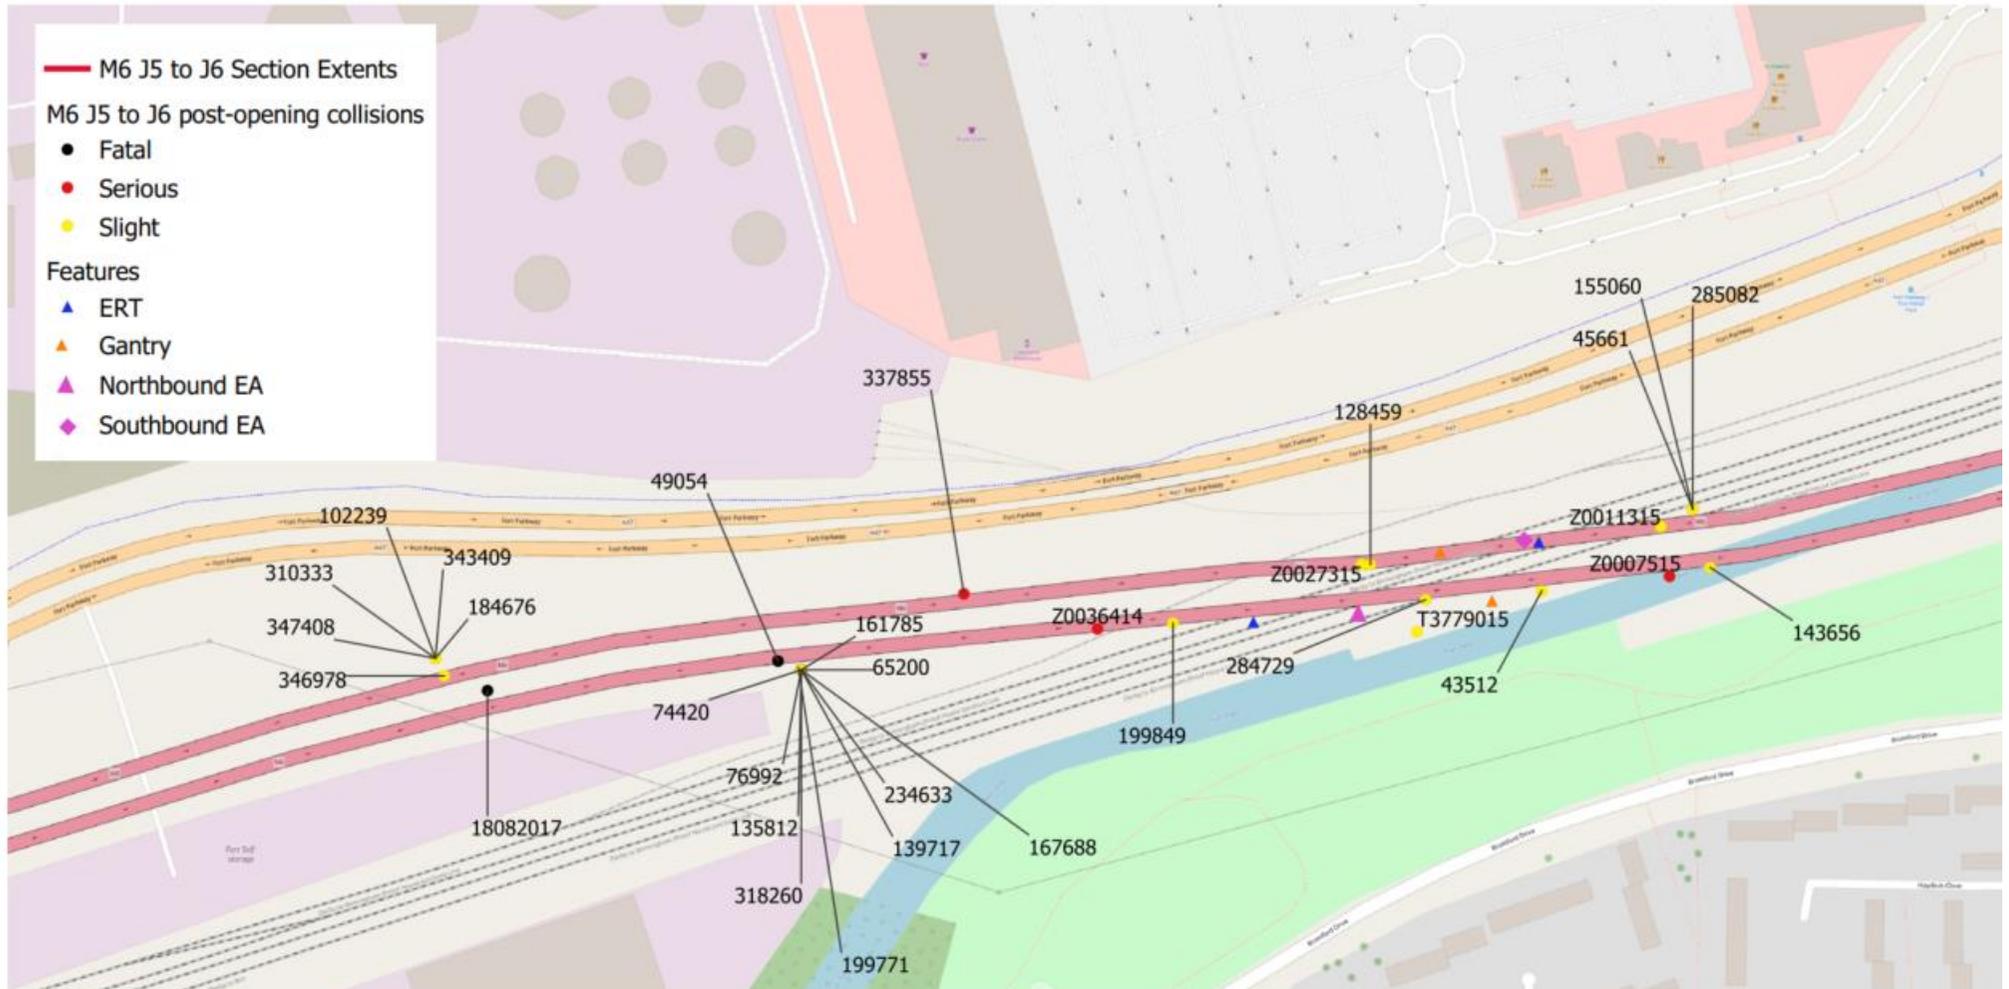
There were slightly more collisions recorded on the northbound carriageway (18 No.) compared to the southbound carriageway (15 No.). Interrogation of the descriptions and circumstances suggest none of these collisions involve vehicles entering or leaving the emergency area facilities. Collisions on the northbound appear to be related to congestion, queuing and sudden changes in the general vehicle speed resulting in shunt and swerving collisions. Nine of the eighteen collisions make direct reference to the congestion being present. Based on the time of day and descriptions 78% would have taken place when LBS1 was likely to have been open due to high traffic flows.

On the southbound there is a no clear link to congestion and LBS1 would likely have been operational in 53% of the events. One collision, reference 155060, relates to a vehicle attempting to reach LBS1 when their nearside tyre comes off the vehicle.

Figure 5.4 – Location of collisions in after period close to the emergency areas.

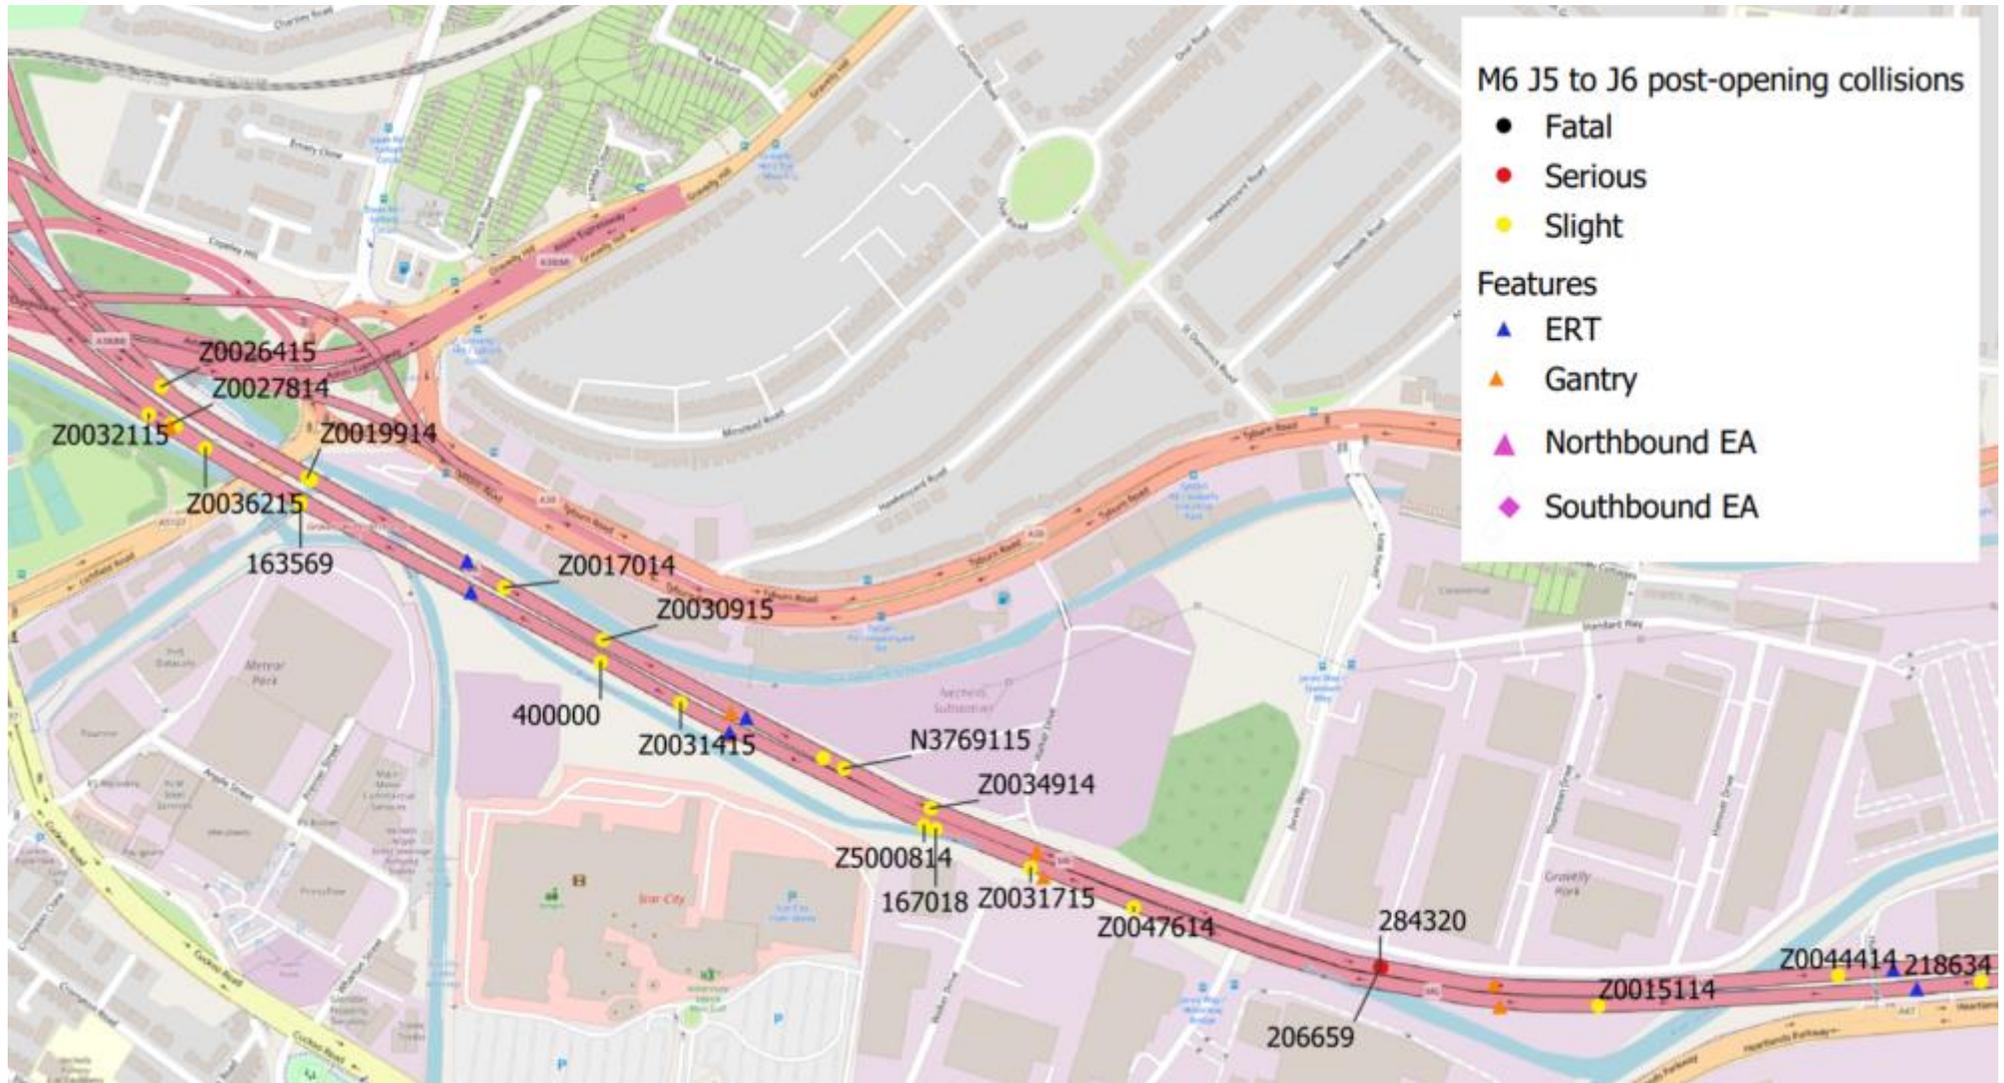
Figure 5.5 – Location of collisions in after period at junction 6.
