# Smart motorways

Incident and infrastructure investigation

M1 Junction 30 to 35

Highways England response

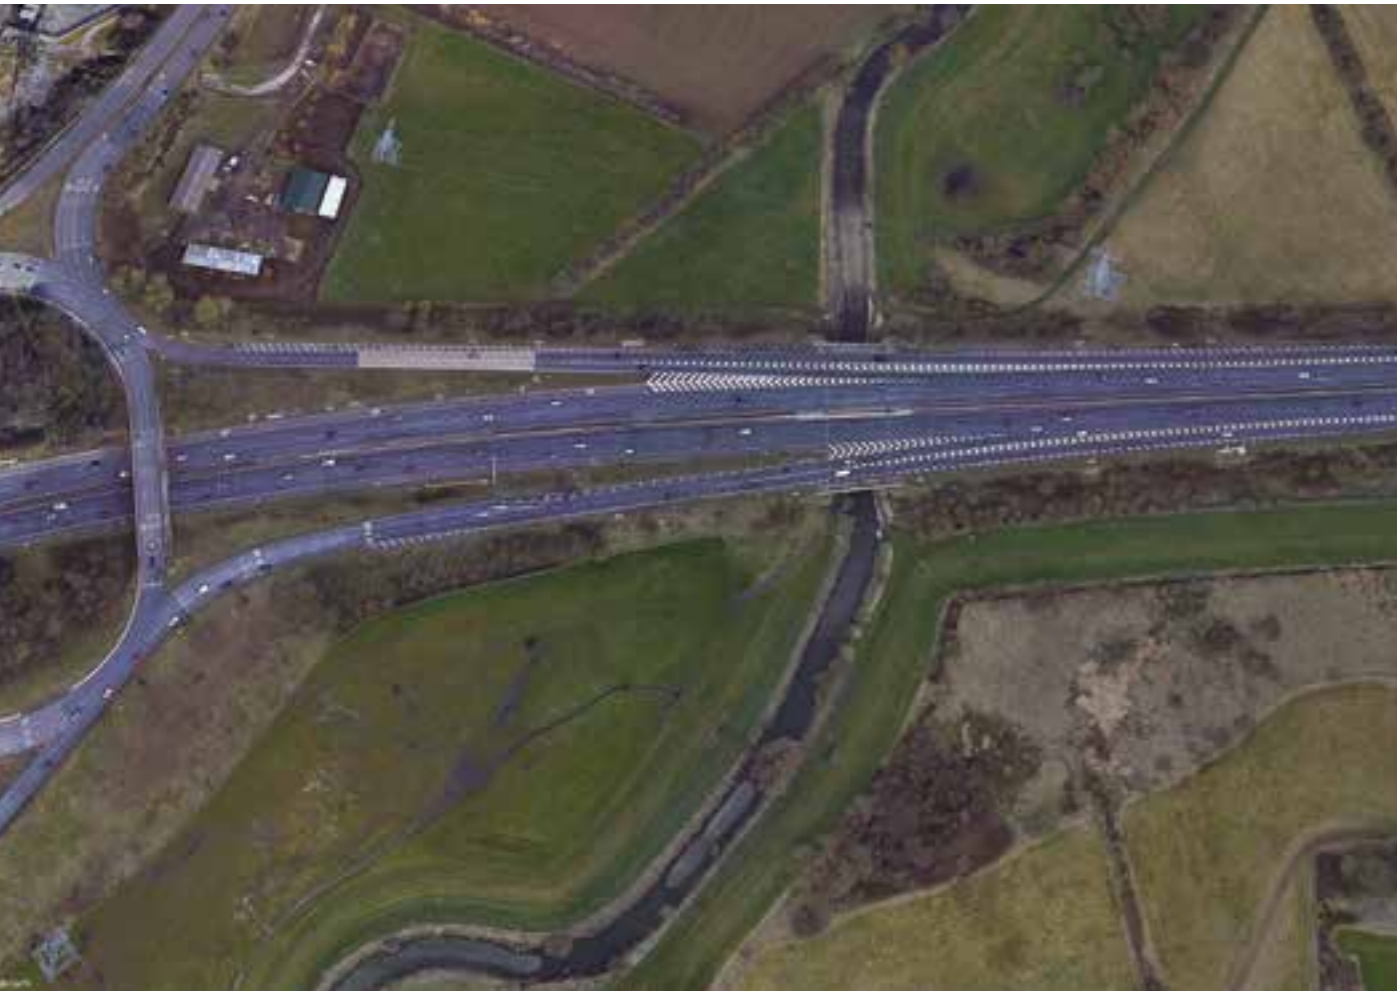
Of the sixty-three collisions between junction 32 to 35, eighteen occurred between junction 32 and 33 northbound.

The majority of collisions occurred on the approach to junction 33, with a total of fifteen shunt collisions being recorded.

Figure 1 M1 J33 northbound exit slip road (shown on lower portion of image) © Google

In addition, eight of the eighteen collisions on this link occurred on a wet road surface. These were concentrated on the approach to junction 33.

- The high proportion of shunt collisions between junction 32 and 33 northbound (83%), and the associated collision descriptions, highlight a potential issue with congestion and queuing on the exit to junction 33, with queues backing up onto the mainline, particularly during the morning peak.
- The significant proportion of incidents occurring on a wet road surface (44%), suggests there could be an issue with the wet skid resistance of the road surface or poor drainage.

Alternative intervention 1, Rotherham Metropolitan Council's scheme to improve M1 Junction 33 provides suitable solutions to the issues identified. The scheme will provide improvements to signal timings, road layout and queuing capacity. It is recommended no action is taken until the scheme has been completed and a period of monitoring has taken place.

A skid resistance survey, carried out on the 20 and 21 August 2020, included the following links: 1.25 miles in advance of the M1 northbound Junction 33 and the full length of the northbound exit slip road. This confirmed the skid resistance of the road surface in lane 1 as being well above the required level. This covers the appropriate sections of carriageway and therefore no further action is required.

We also carried out a review of flooding hot spots (FHS) to look at any issues relating to drainage capacity and the maintenance cycle of drains being cleared. This review included the northbound exit slip road. Flooding reported was identified as being generally caused by blinded gullies, where the gully cover has been blocked by material, preventing water from entering so it runs further down the carriageway. The FHS has been maintained in accordance with the maintenance plan and, as a consequence, no flooding has been recorded for several years. As a result, no further action is required.

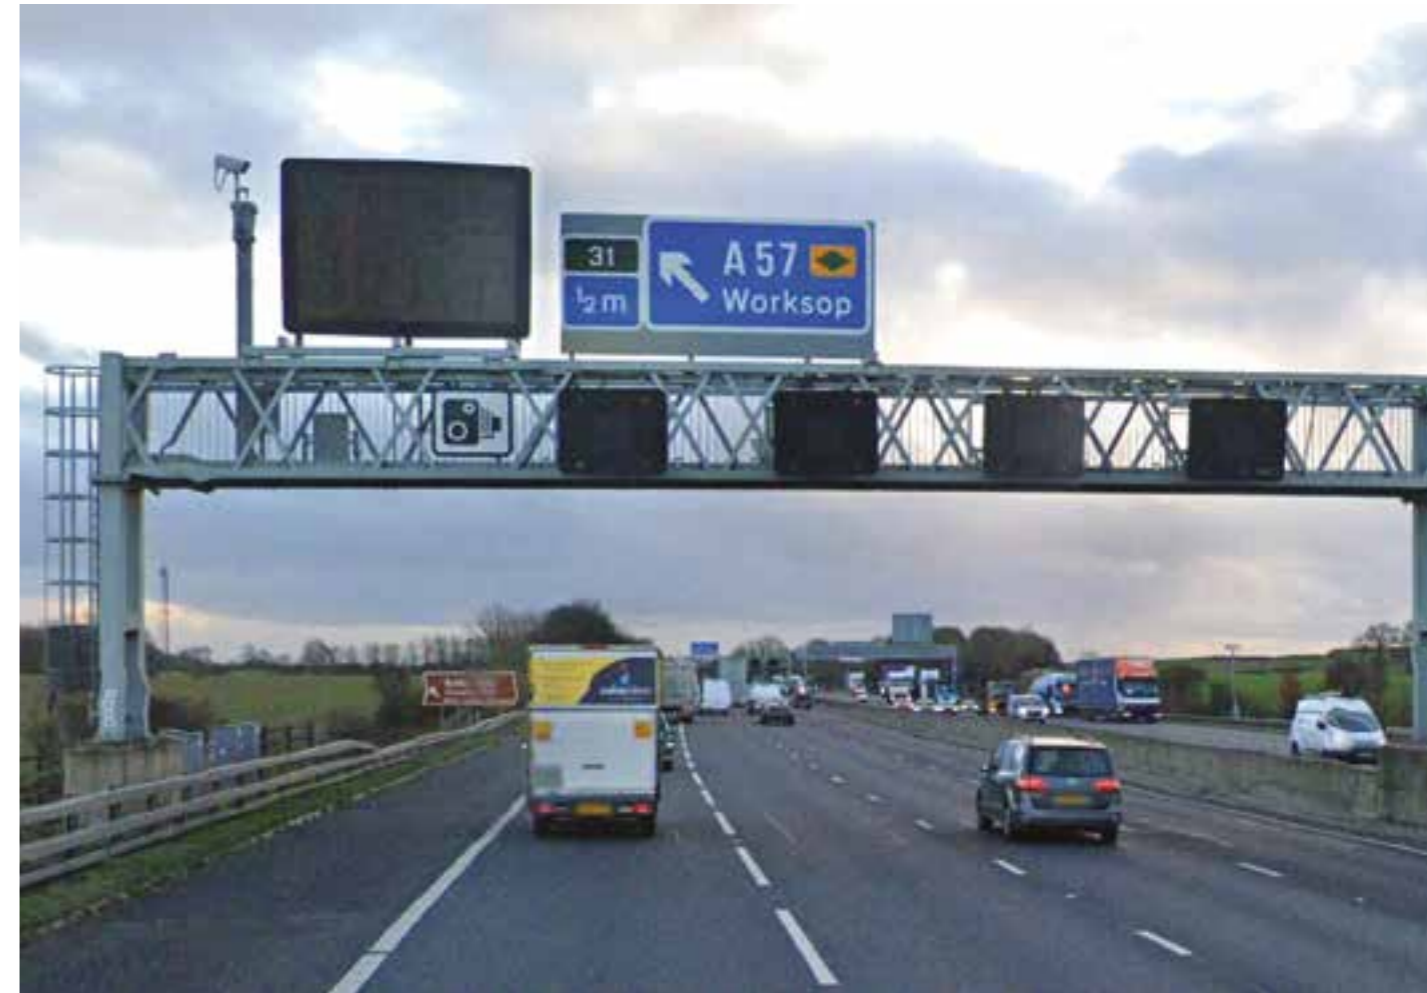
The exit sign on the southbound carriageway, located on an overhead gantry, ½ mile in advance of the junction, is positioned above lane 1 and partially above lane 2 rather than being offset to the left.

Hazard road markings are provided between the ½ mile and ¼ mile (secondary advance direction sign) only.

Figure 2 M1 J31 southbound ½ mile advance direction sign and hazard road markings between lane 1 and 2 © Google

All these factors have the potential to cause confusion for road users and may lead to unnecessary lane changes. The link has a relatively short weaving length of just 0.86 miles.

We do not recommend intervention 1 as the introduction of destination road markings in lane 1 would discourage use by other traffic not required to take the exit, and potentially lead to more lane changes on the approach to the junction.

We are progressing interventions 2 and 3, subject to signing approval.

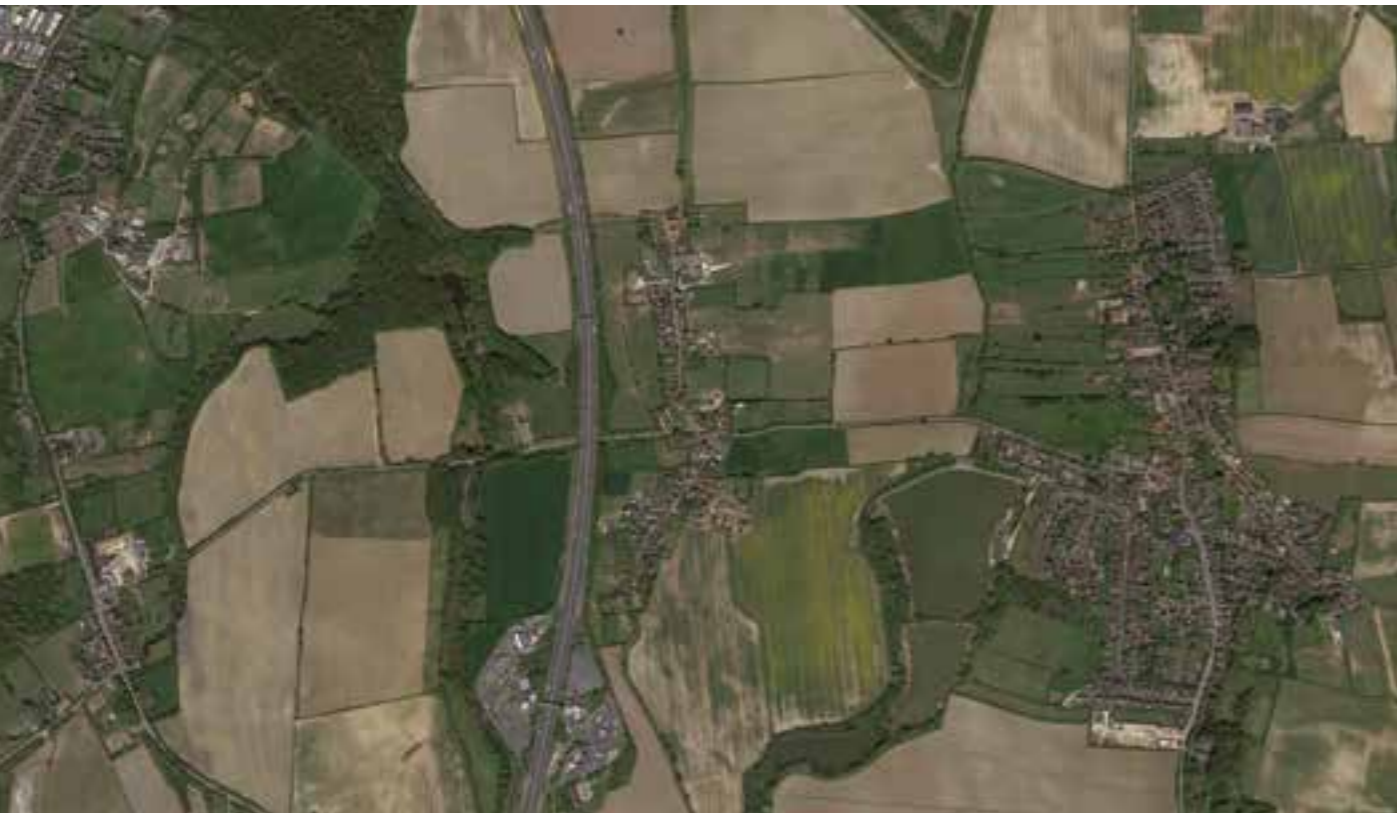
A cluster of six collisions on the northbound ALR section to the north of Woodall motorway service area (MSA) has been identified. These collisions involved five serious collisions and one fatal collision, including four live lane stops.

Figure 3 M1 Woodall MSA (at the bottom of the image) and emergency areas to the north (orange trapezoids at the top of image) © Google

The section is on a sweeping left-hand bend so nearside vegetation has the potential to restrict the ability of approaching drivers to see a stopped vehicle.

There is a long left-hand curve, just north of Woodhall MSA which may affect forward visibility.

Apart from the location and live lane stop involvement, no other clear link between the collision factors can be identified, which makes it difficult to suggest or recommend further focussed or specific measures. We will take forward interventions 1 and 2.

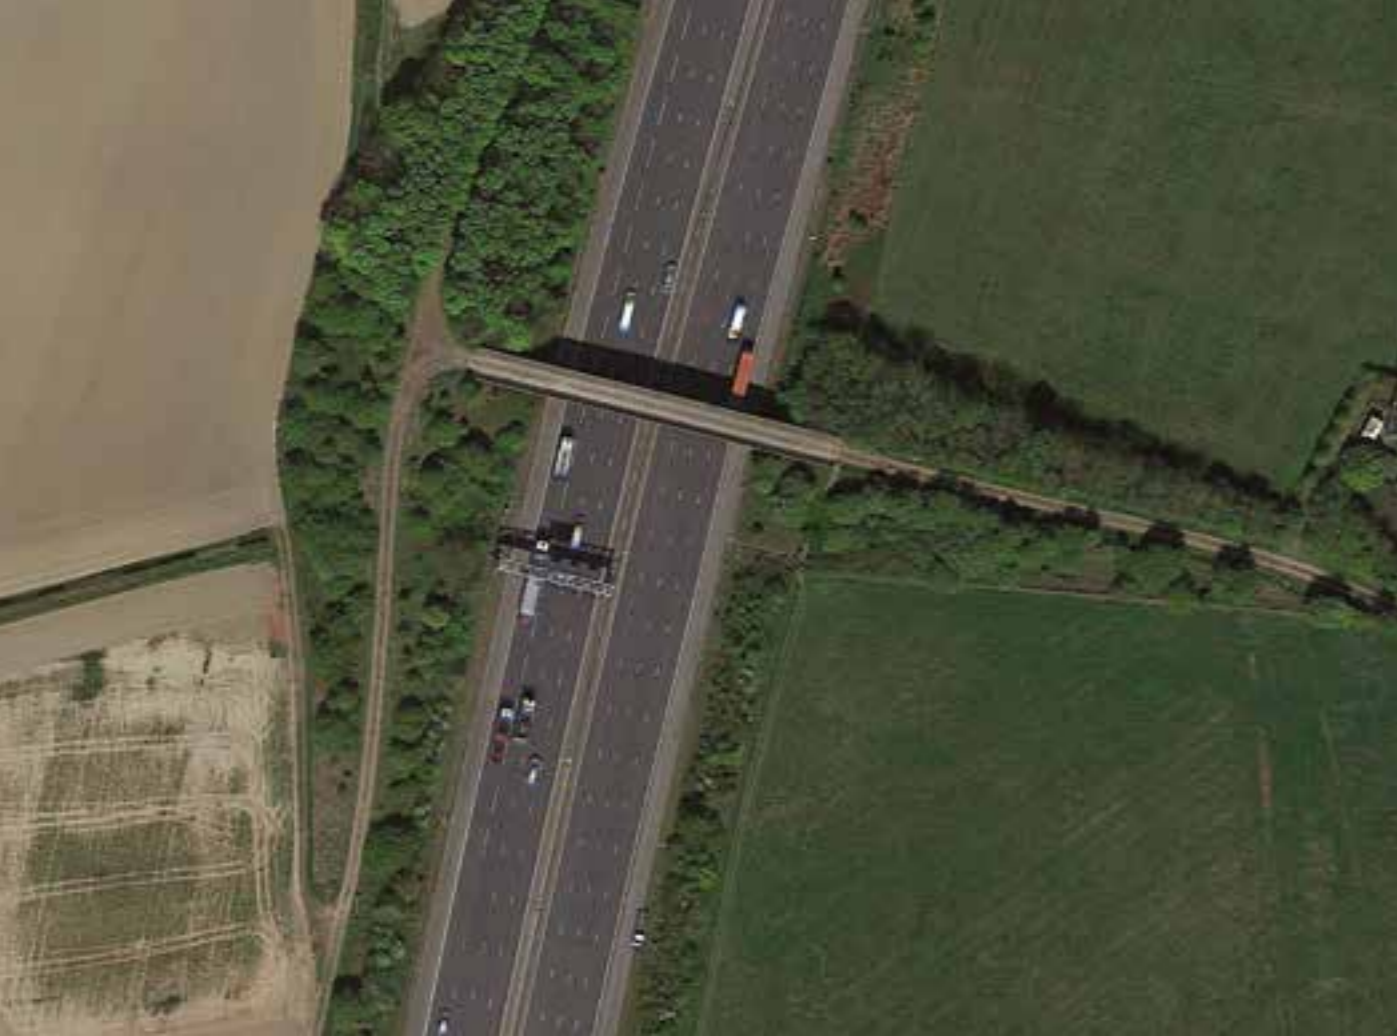
The independent review identified that there have been a number of incidents involving pedestrians on the motorway, with a particular cluster between junctions 31 and 32. In addition, some bridges have also been identified as a cause for concern, with suicide incidents recorded at them.

There are public rights of way that run immediately adjacent to the motorway between junction 31 and 32 and converge at a bridge in order to cross the motorway.

Figure 4 Hardwick Lane bridge and adjacent public rights of way between M1 J31 and J32 © Google

The installation of anti-access fencing at the location identified will mitigate access to the motorway for pedestrians. This work fits with the recommendations in the suicide prevention toolkit.

We have identified the points of access to the network in line with proposed intervention 1 and we will progress the proposal to provide anti access fencing at the most appropriate locations to remove access to pedestrians. We will progress feasibility work to identify suitable interventions on 5 of the structures on this stretch. We have carried out initial site assessments and have identified some potential improvements at the structures where incidents have been recorded.

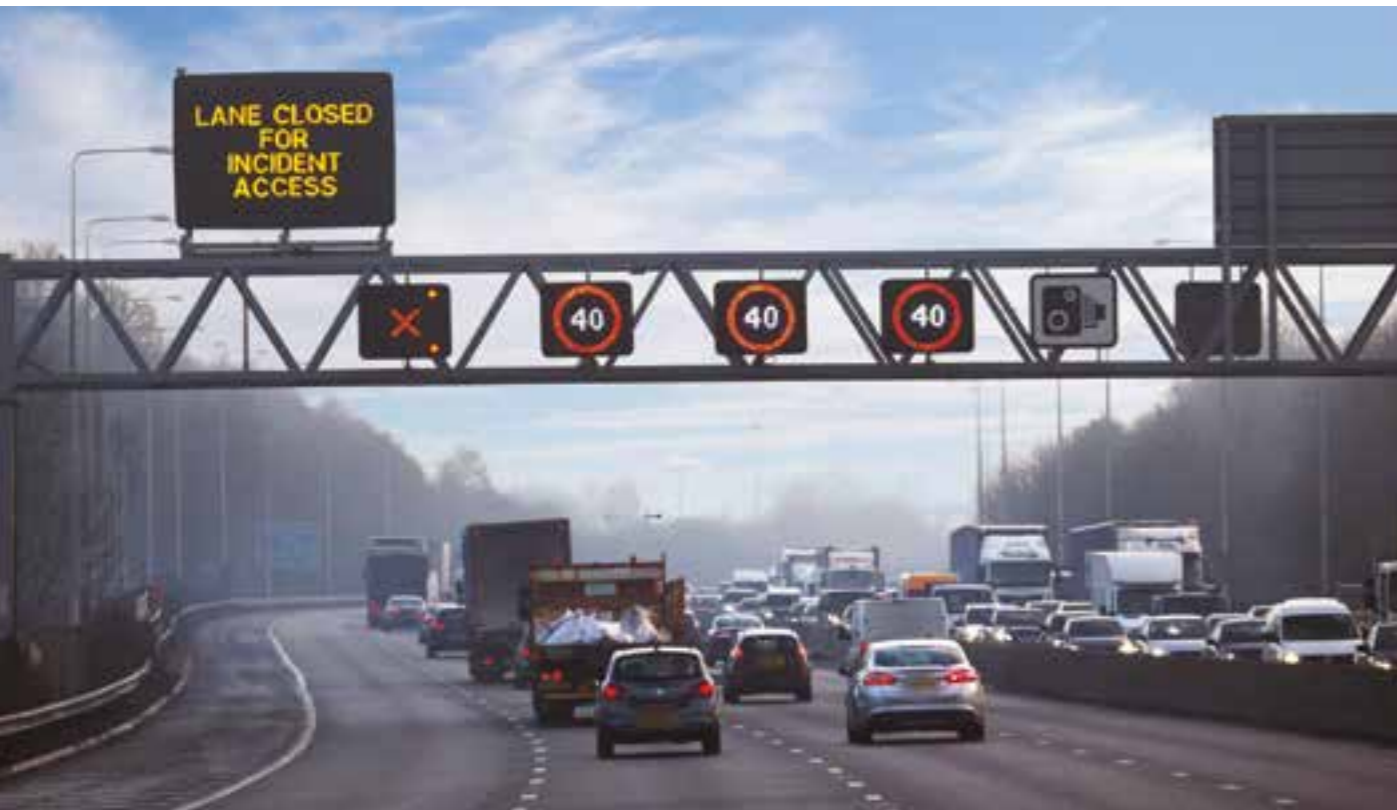
The independent review identified a need to investigate issues around signs and signal availability, and the reliability of technology on this stretch of the M1.

Figure 5 Signs and signals used on a section of smart motorway

A national issue existed around the availability of power supply units (PSUs) for variable message signs. There has been a period where faults, particularly on the M1 J32 to 35a section, were unable to be resolved due to spares availability. We have prioritised signs in ALR sections, and 21 power supply replacements on the ALR sections on the M1 J28 to 35a have been carried out since August 2020.

We will continue to prioritise resolution of these faults commencing with the highest priority locations.
