**Specialist Professional and Technical  
Services (SPATS) Framework  
Lot 1 & Lot 2**

**Task 1127  
Smart Motorway Incident and Infrastructure  
Investigation – M1 Junction 39 to 42**

July 2021

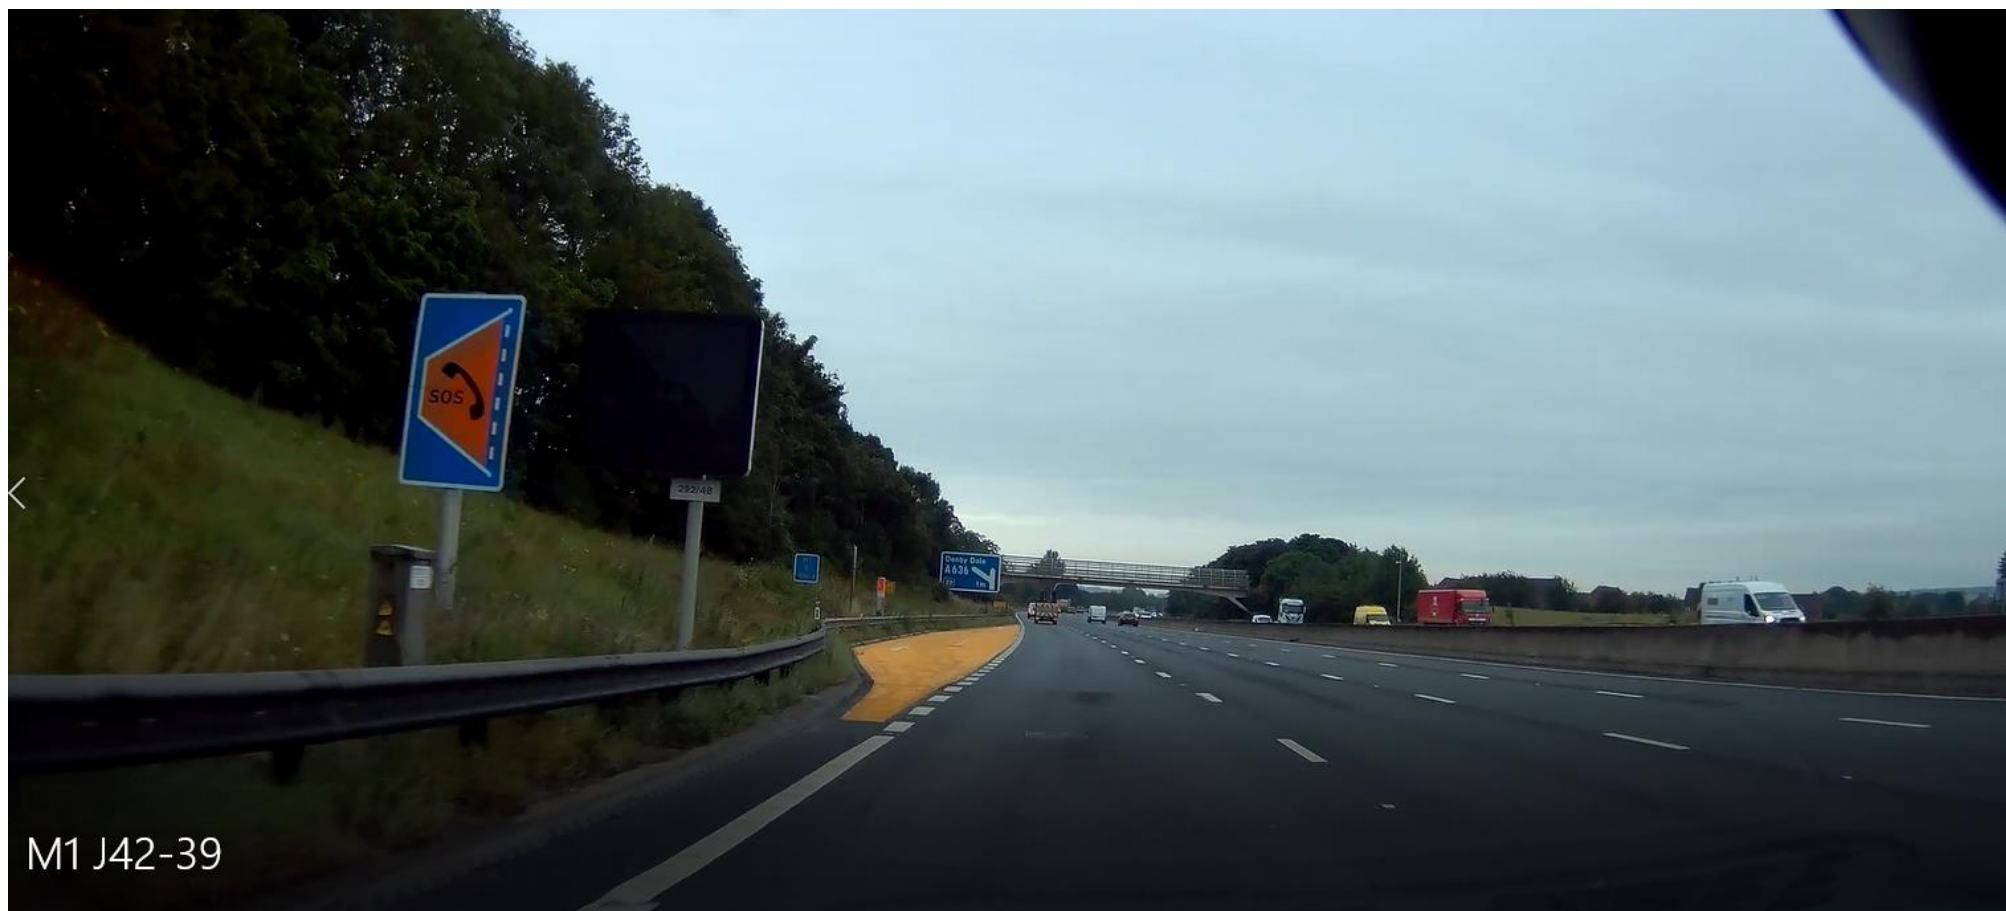
Figure 5.2 - Example of scheme emergency area - Southbound J40 to J39 (image from dashcam drive through footage July 2020)

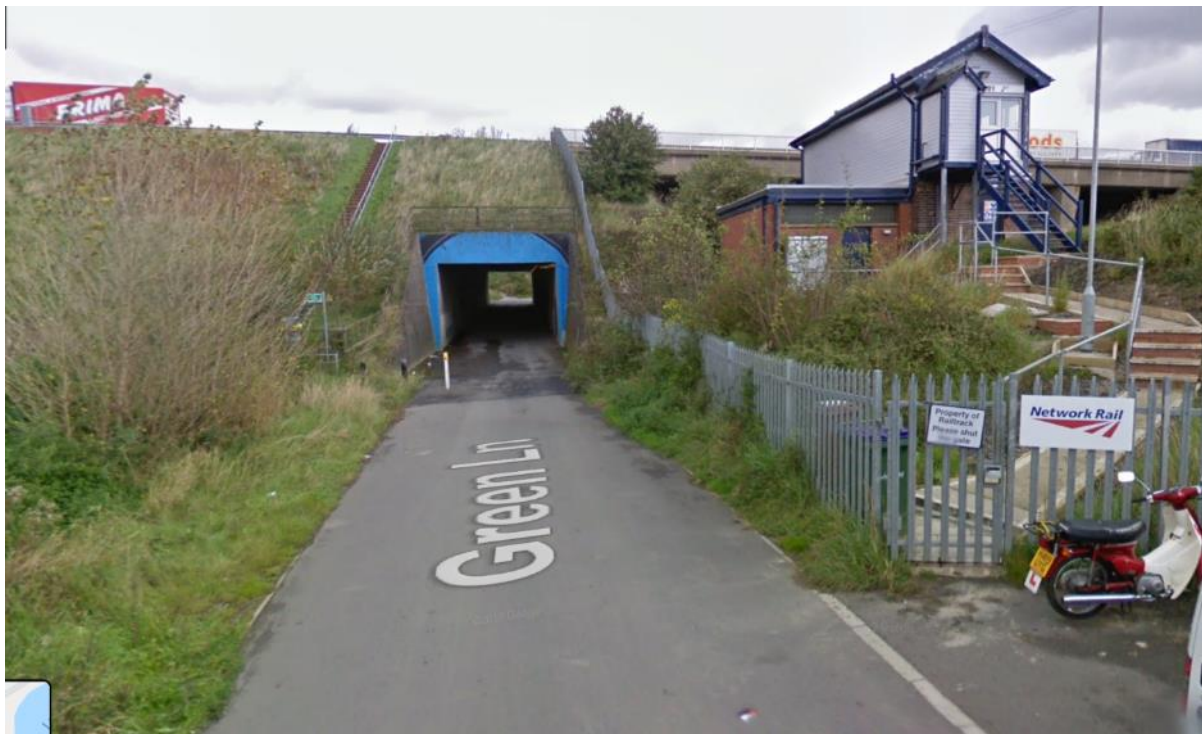
Figure 5.6 shows metal palisade fencing of the railway estate to the right of the image, and timber post and rail fencing provided at the motorway boundary.

Figure 5.6 Horbury Underpass / Green Lane viewed from the west (source: Google Streetview, August 2020)

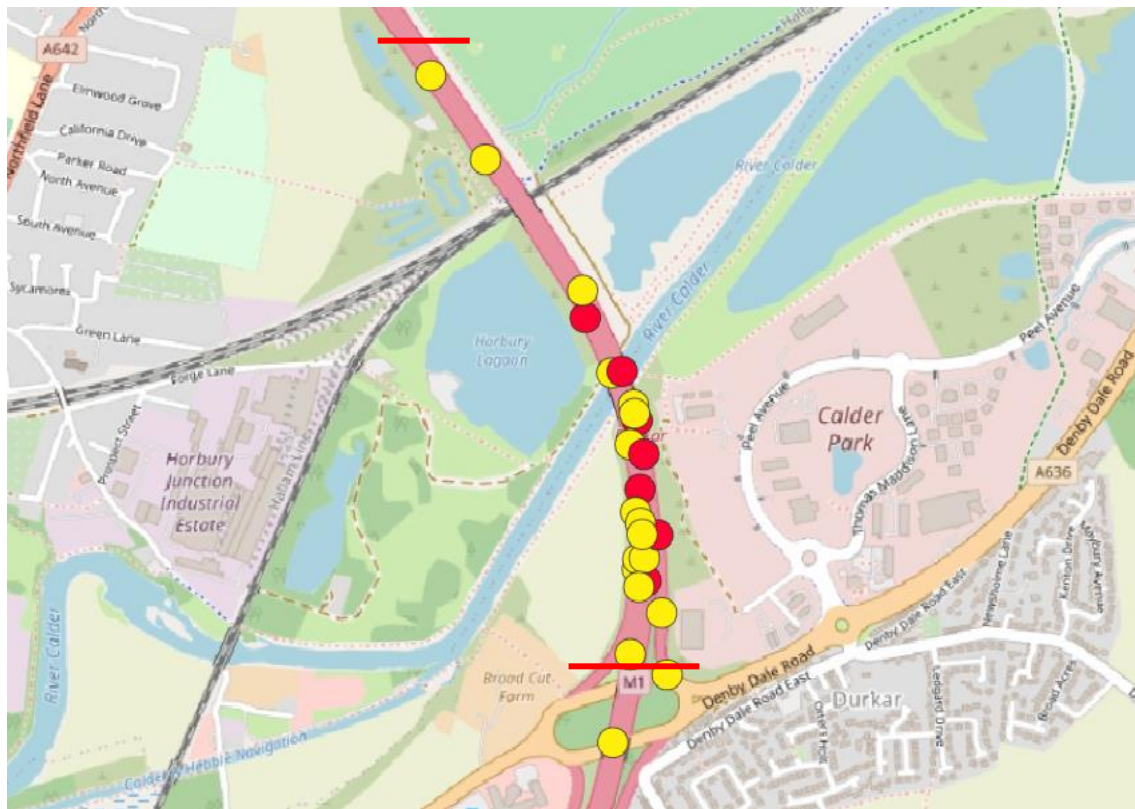
**Figure 5.14 M1 junction 39 area of focus, showing post-opening collisions** (yellow = slight, red = serious severity; no fatalities recorded in this section)

Twenty three injury collisions have been identified in this locality over four years (averaging 5.75 per year); seven serious severity (1.75 per year) and sixteen slight (four per year). No fatal collisions have been recorded. Twelve collisions occurred during darkness hours, 11 during daylight. It is unusual to see more darkness than daylight collisions in general on a motorway, although it should be noted that this is a specific location with small overall numbers of collisions under consideration.

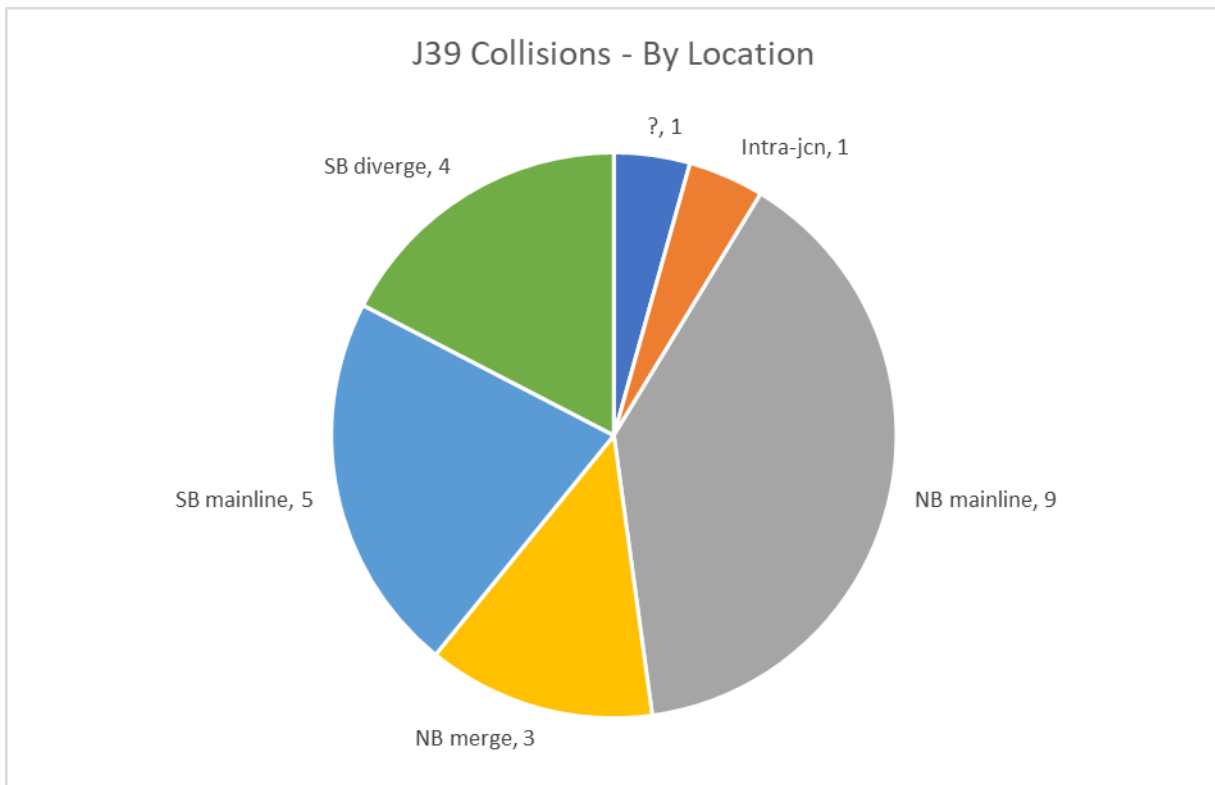
Figure 5.15 M1 Junction 39 collisions by location

- Unusually for a motorway, loss of control collisions occur more frequently than shunts<sup>3</sup>;
- Shunts are associated with the merge or diverge slips more than the mainlines, the northbound mainline shunt is unconventional in occurring at night in low flow conditions where a taxi struck the rear of another car;

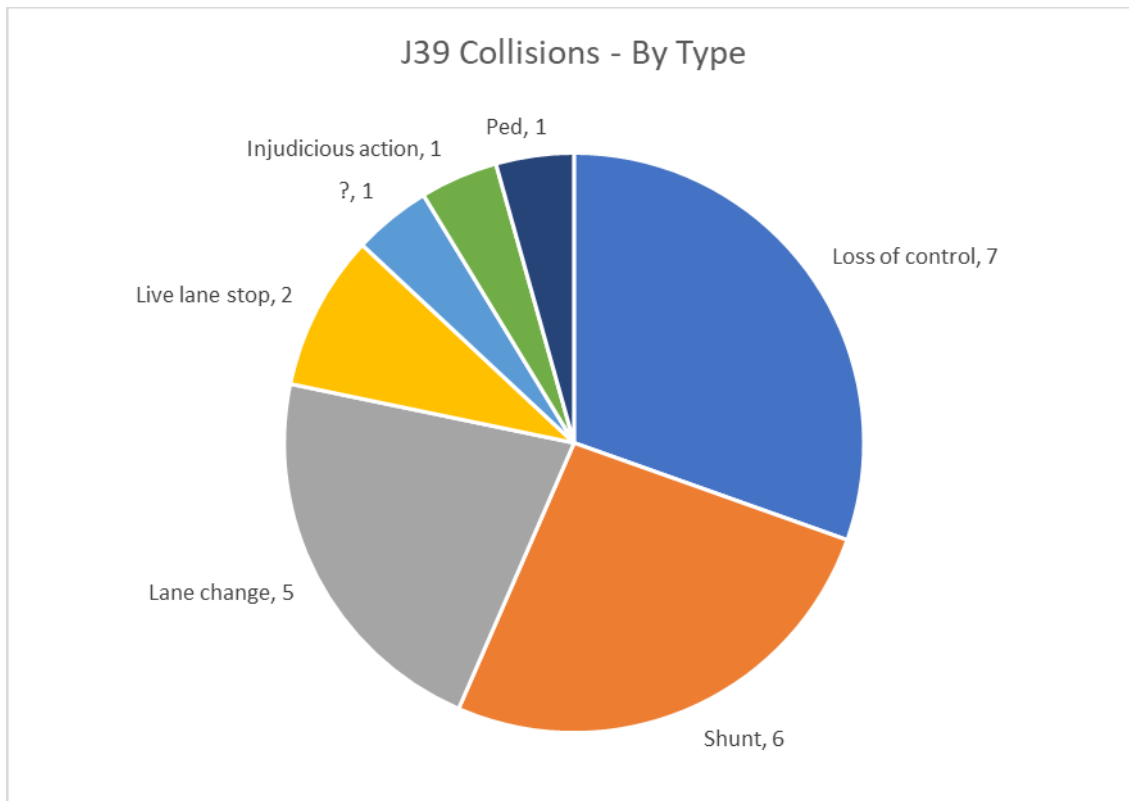
**Figure 5.16 M1 Junction 39 collisions by type**

- Only two loss of control collisions have occurred in rain conditions, although two of four occur during high winds which may be associated with the 'open' river bridge setting in the locality. One, involving an SUV, directly cites a gust of wind as leading to loss of control.

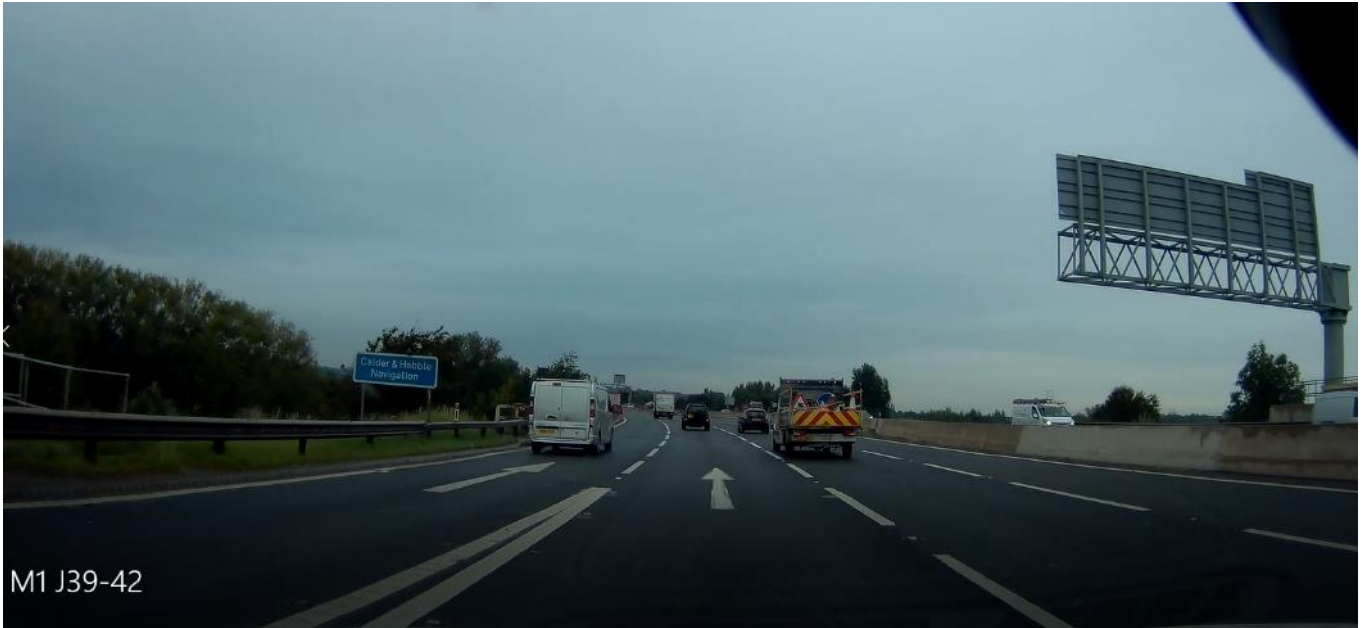
Figure 5.18 - M1 Northbound north of Junction 39 merge - image from July 2020 dashcam footage. Lefthand curve and bridge visible.

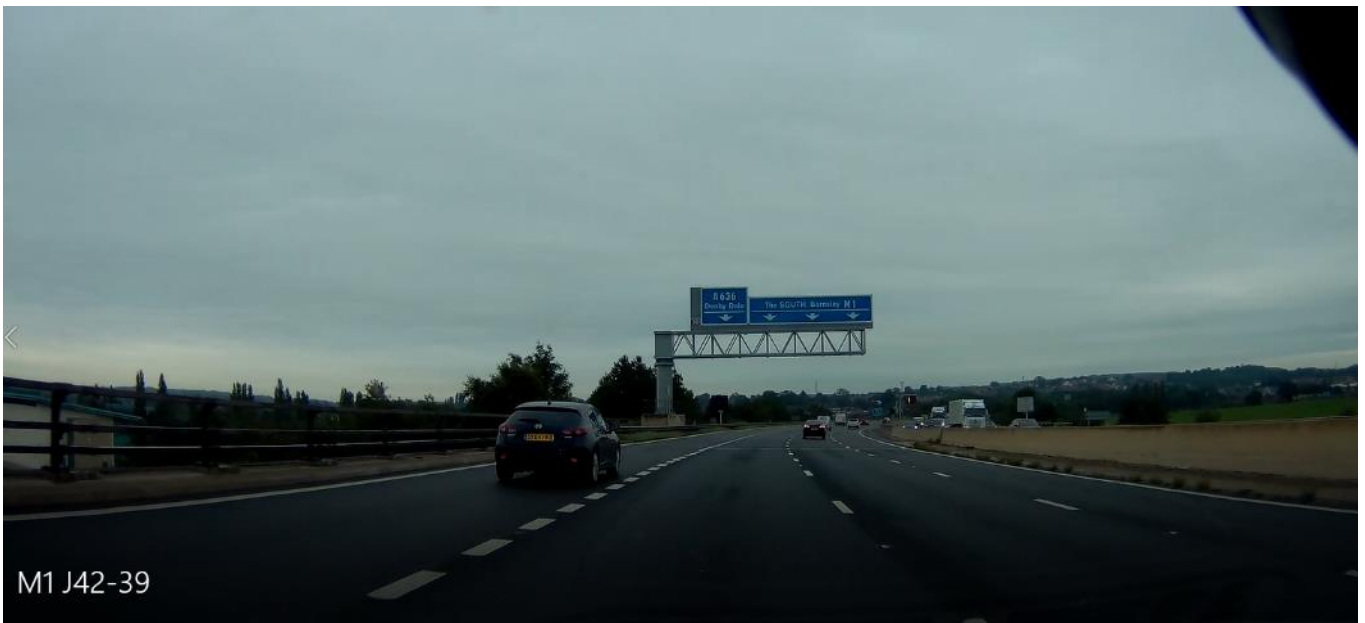
Figure 5.19 - M1 Southbound north of Junction 39 diverge - image from July 2020 dashcam footage. Righthand curve and bridge parapet visible.

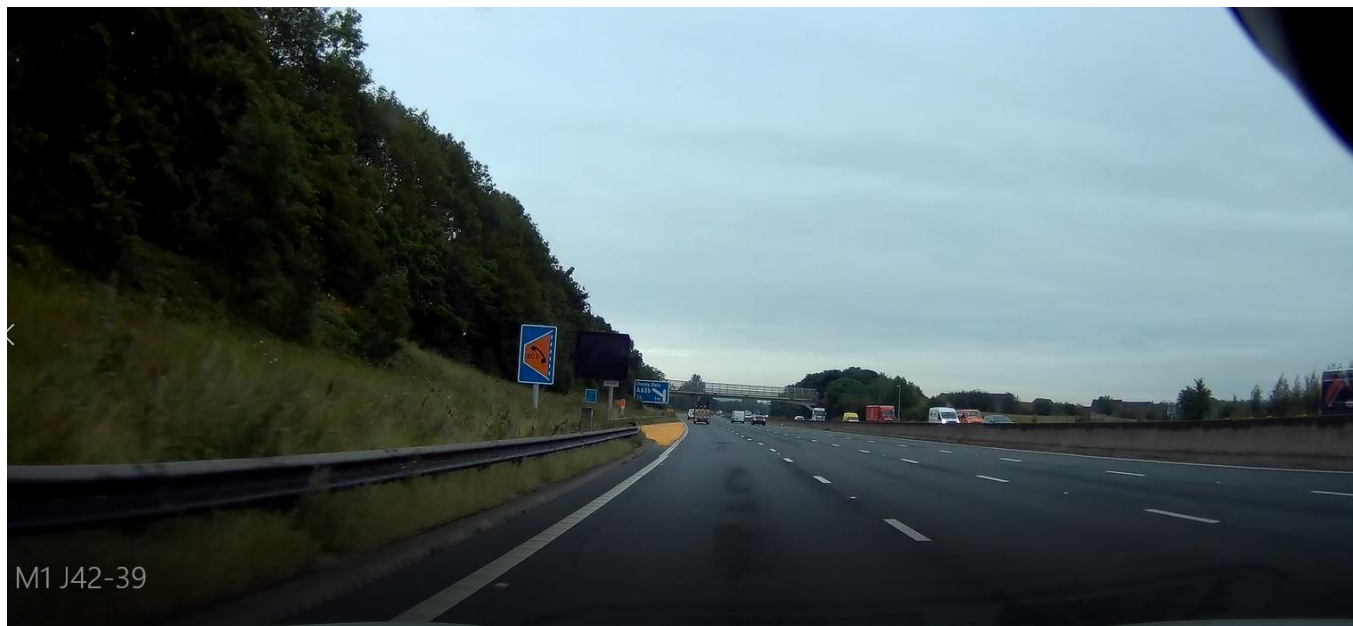
As a lane drop terminal junction this location is also prompting lane change movements southbound, however the primary 1 mile direction sign is verge mounted map-style (not indicating a lane drop) and it is situated immediately after other signing and an emergency area, which may draw attention away. Refer to Figure 5.20.

**Figure 5.20 - M1 Junction 39 Southbound: primary 1 mile direction sign, located immediately downstream of emergency area and other signing. Image from July 2020 dashcam footage.**

C) Cluster of collisions north of J39	<p>Road user <b>perception of road layout:</b></p> <ul style="list-style-type: none"> <li>• Bend ahead warning signs</li> <li>• Overhead primary direction sign to reflect southbound lane drop</li> <li>• Explore provision of street lighting</li> <li>• Lane destination markings and hazard lines for southbound lane drop</li> <li>• Alternative diverge layout</li> <li>• Display variable speed limits earlier, prior to peak periods</li> <li>• Display national speed limit off-peak</li> </ul>

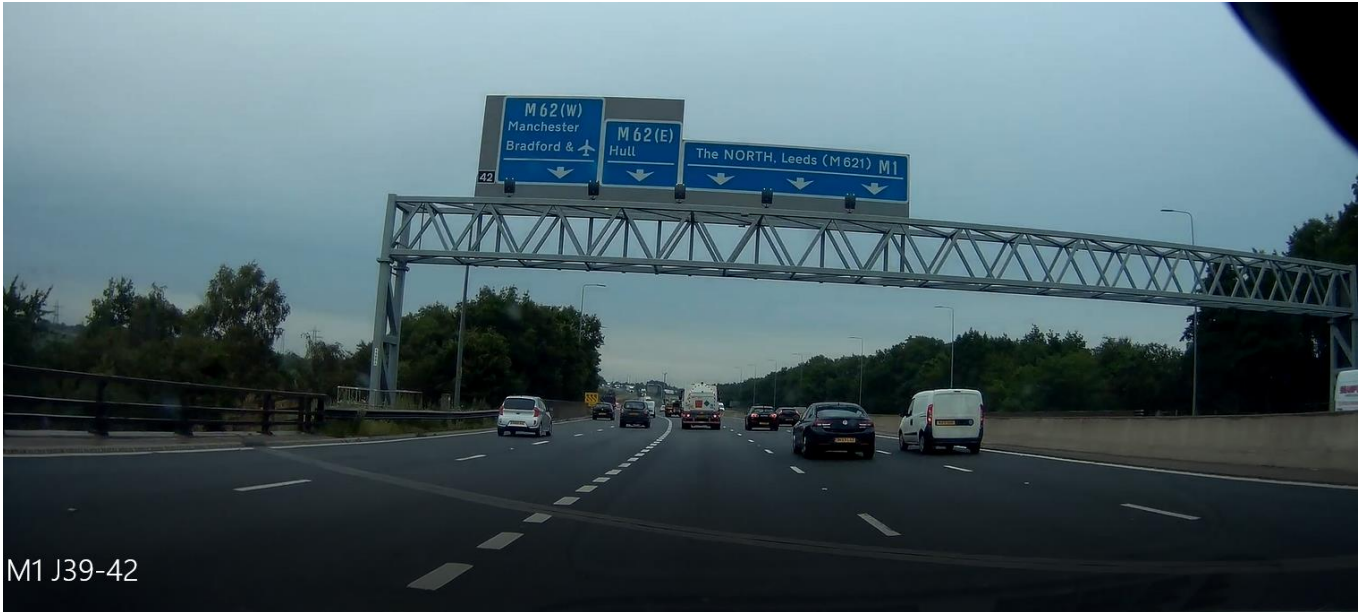
**Figure 5.21 – Junction 42 northbound diverge - five lanes and bridge parapet constrains setback, dashcam footage July 2020**

The northbound mainline section has five lanes with reduced widths in lanes 1 and 2 and a reduced setback at the rail bridge (refer to Figure 5.21); given this relatively unusual set of cross-section constraints it is relevant to note that no lane-change type collisions have been recorded. Congestion from weaving movements, from Lofthouse Interchange itself or from the M62 (in particular westbound) are likely to be the main causes of the shunt collisions that do occur.
