Lower Thames Crossing

6.3 Environmental Statement Appendices Appendix 10.6 – Preliminary Risk Assessment Report

Appendix 10.6 – Preliminary Risk Assessment Report

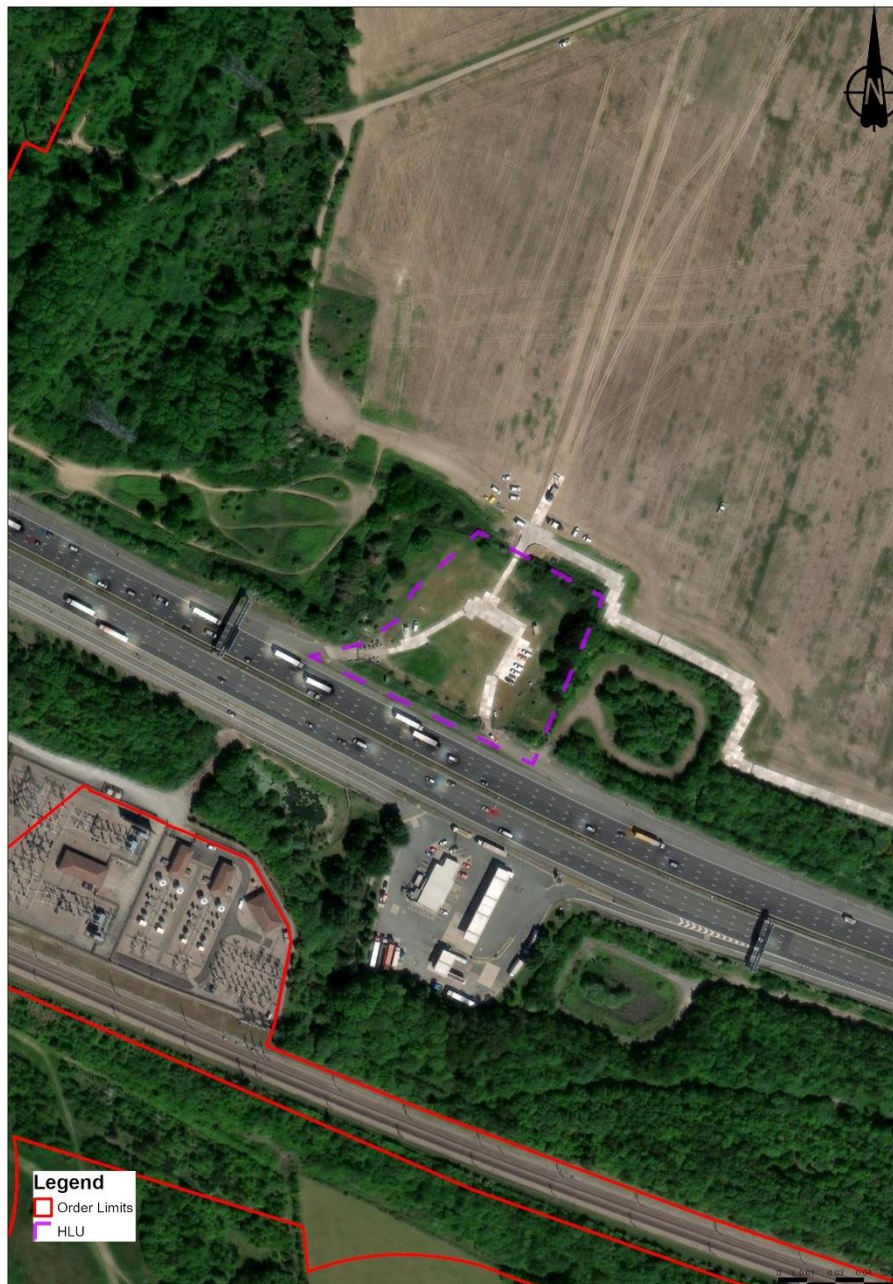
Plate 5.1 A2 Eastbound Petrol Filling Station HLU0214

- 5.2.57 A planning application (reference 19760502) was approved in 1976 for the installation of a 6,000 gallon diesel UST (Gravesham Borough Council, 2019c). The LAPPC reference, dated 1998, for this site is PP1/98/038. No pollution incidents are recorded in the area (Landmark, 2019).
- 5.2.58 A pond is visible to the east of the northern PFS, possibly a balancing pond for highway runoff.
- 5.2.59 Information received by the Applicant indicates that some contamination remediation works have been carried out following the demolition of the PFS. A WSP drawing dated August 2012 indicates the location of historical USTs and a superceptor (WSP, 2012). It is understood that remediation works were carried out following the demolition of the site between 2008 and 2011. The

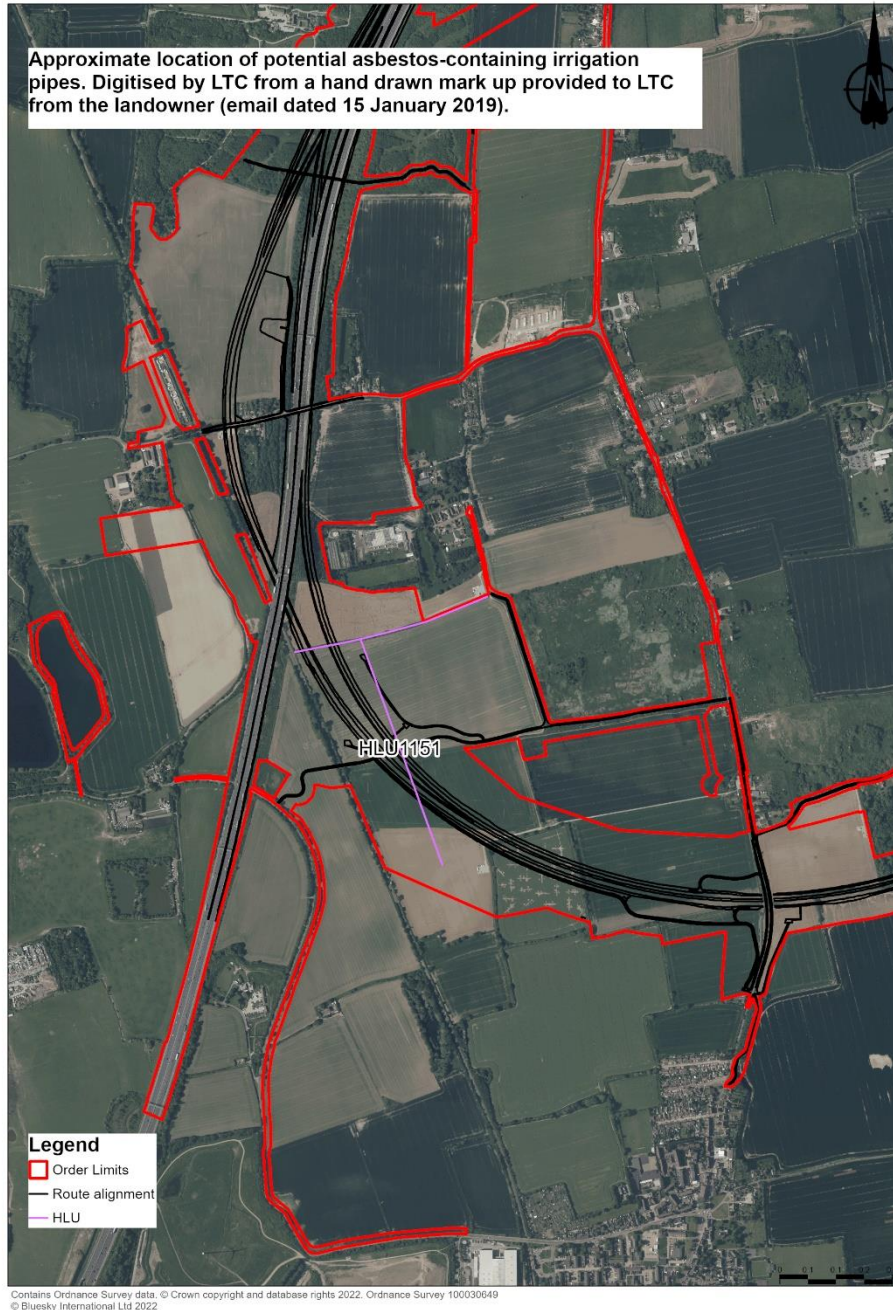
Plate 5.15 Potential asbestos-containing irrigation pipes at Hall Farm (HLU1151)

- 5.7.69 Information provided to the Project Land and Property Team (email from the landowner to the Applicant, 15 January 2019) indicates that current subsurface irrigation pipes at Hall Farm, North Ockendon, may contain asbestos (HLU1151). Two main pipes were identified: one running for 250m east–west, and a second, reported to be decommissioned, running 640m north–south (Plate 5.15). The type and percentage of asbestos has not been reported.

- 5.7.70 The potential contaminants associated with this HLU is asbestos.

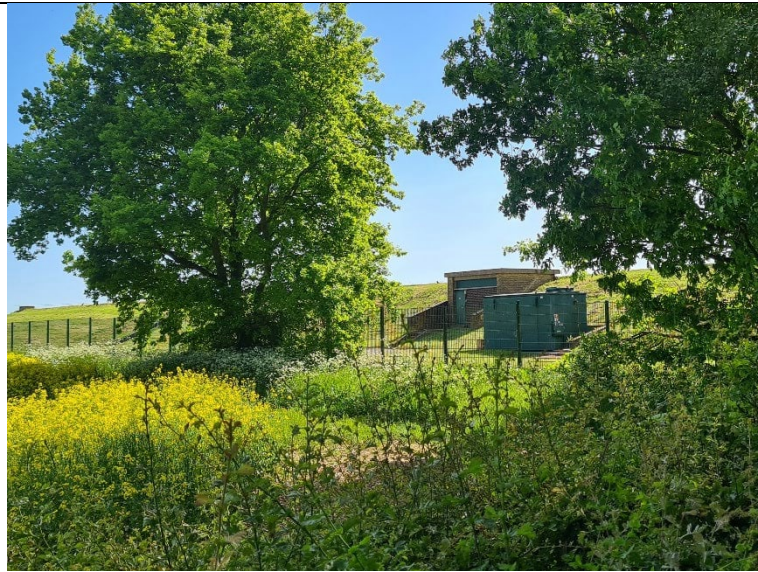
Fields in the north-eastern section and small buildings and transformer associated with Westfield Sole Reservoir – signage indicates that the site is managed by Southern Water. Electrical infrastructure and above ground storage tanks were observed.

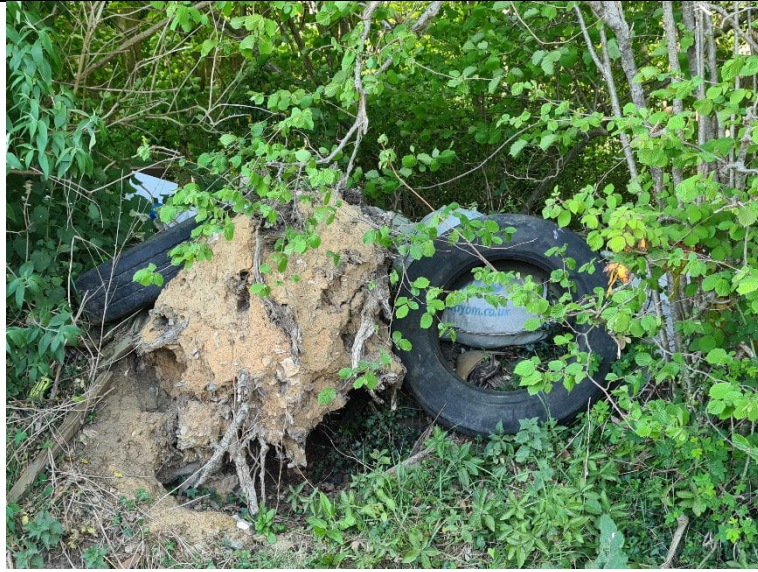
Tyres and other waste material along Bell Lane to the north of the nitrogen deposition compensation site

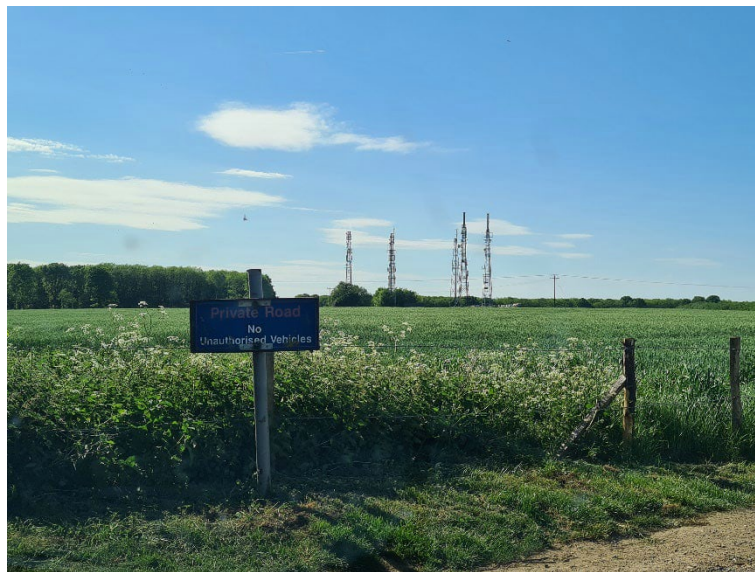
Small cluster of masts (Bluebell Hill Freeview Transmitter) visible from south-east corner of the westernmost field.

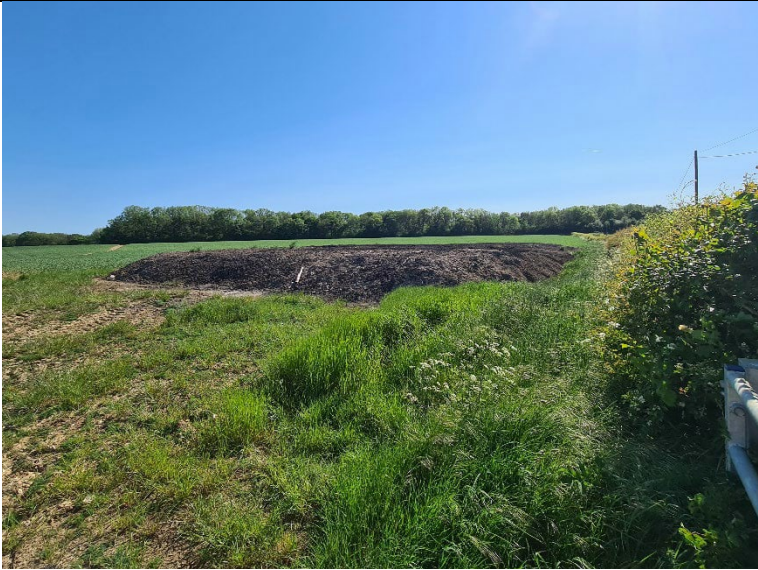
<p>Mound of stockpiled earth close to intersection of Bell Lane and driveway to farm in the north of site.</p>
<p>Geology</p>	<p>Clay-with-flints Formation (clay, silt, sand and gravel). The dominant lithology is orange-brown and red-brown sandy clay with abundant nodules and rounded pebbles of flint, underlain by the Lewes Nodular Chalk Formation.</p> <p>British Geological Survey (2022). Geology of Britain viewer. Accessed July 2022. www.bgs.ac.uk/data/mapViewers/home.html.</p> <p>British Geological Survey (2022). BGS maps portal. Accessed July 2022 https://www.bgs.ac.uk/information-hub/bgs-maps-portal/</p> <p>The Wouldham to Detling Escarpment is a 311 hectare biological and geological Site of Special Scientific Interest (SSSI) within the Kent Downs Area of Outstanding Natural Beauty. This SSSI is located adjacent to the south-western boundary of the area. Overall, the SSSI extends for 10km along the chalk scarp of the North Downs east of the River Medway.</p> <p>The geological interest of this SSSI occurs in the Upper and Lower Culand Pits, which are located approximately 1.3km to the west of the area. The sequence of Chalk in these pits contains rich and diverse collections of fossil fish that are reported as superbly preserved and as such have been the subject of much scientific research.</p> <p><i>Source: Natural England (2022) Designated Sites View. Accessed July 2022</i> https://designatedsites.naturalengland.org.uk/PDFsForWeb/Citation/1001339.pdf via https://designatedsites.naturalengland.org.uk/SiteDetail.aspx?SiteCode=S1001339&SiteName=wouldham&countyCode=&responsiblePerson=&SeaArea=&IFCArea=</p>

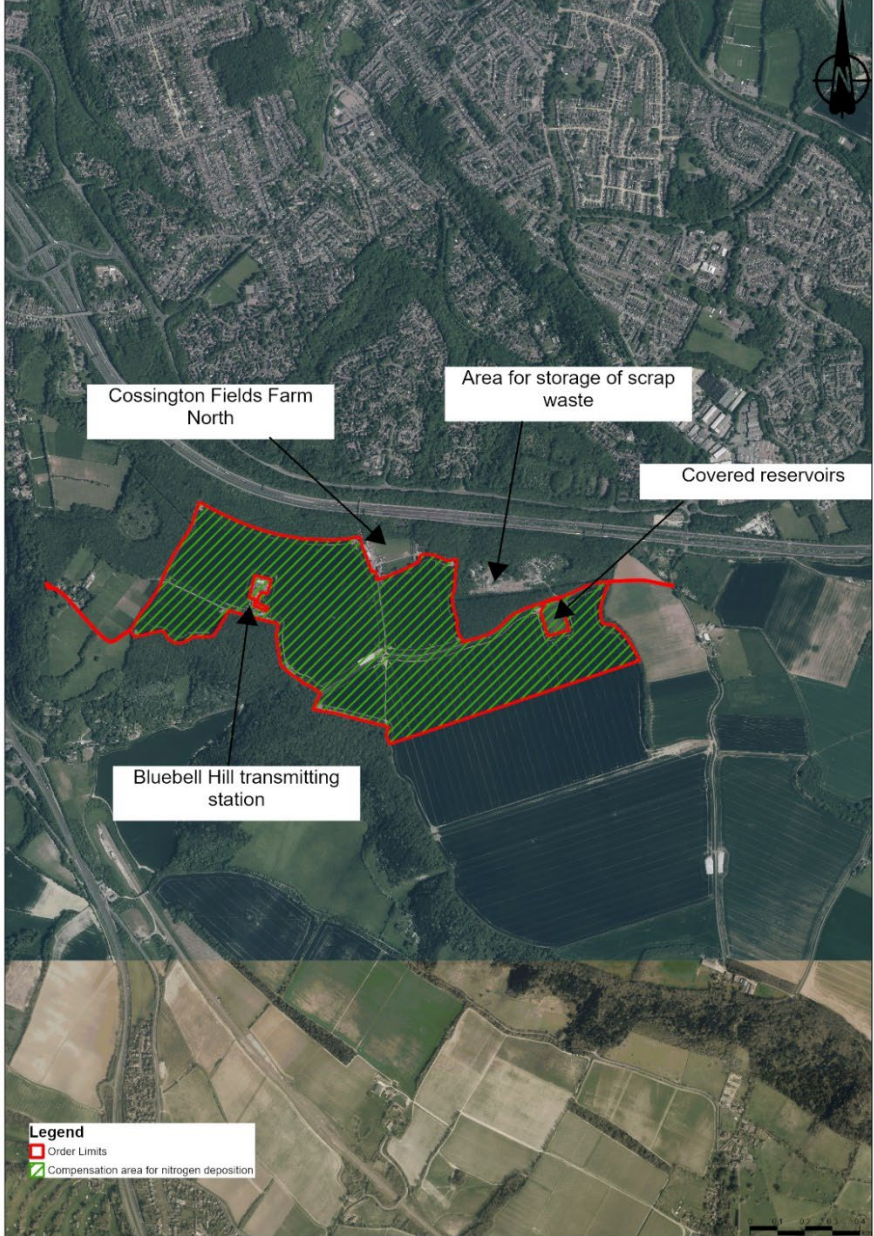
<p>Bluebell Hill Approximate postcode: ME14 3EG</p>	<p>distance this is not considered to have a credible risk of impact on the subject site.</p> <p><i>Source: Landfill https://groundsurre.io/ accessed 16 February 2022 and DEFRA historic landfill sites GIS layer</i></p>
<p>UXO</p>	<p>A UXO risk assessment was undertaken by Zetica (2022), presented as Appendix 10.10 UXO Desk Study & Risk Assessment (Application Document 6.3), with the site assessed with a Low UXO hazard rating.</p>
<p>Preliminary Risk Assessment</p>	<p>Preliminary Conceptual Site Model</p> <p>Plate D.2 Bluebell Hill Potential Sources of Contamination</p>

<p>Proposed works</p> <ul style="list-style-type: none">a. Fencing / securing site (stock fencing perimeter)b. Limited groundworks e.g. deep ploughing.c. Tree plantingd. Grassland sowinge. Utility works unknown <p>Potential sources of contamination</p> <p>Whilst considered unlikely and limited, potential localised contaminant sources are considered to include:</p> <ul style="list-style-type: none">a. Cossington Fields Farm North (petroleum hydrocarbons, PAH, metals, inorganics, pesticides, asbestos, ammoniacal nitrogen and hazardous gases).b. Area (approximately 400m wide) off Bell Lane to the north used for storage of scrap / waste (metals, petroleum hydrocarbons, PAH, inorganics, phenols, VOC, SVOC, hazardous gases and asbestos)c. Westfield Sole Covered reservoir (localised contaminant source of petroleum hydrocarbons and polychlorinated biphenyls (PCBs).d. Bluebell Hill Transmitting Station (petroleum hydrocarbons, polychlorinated biphenyls (PCBs). <p>Potential pathways</p> <p>Potentially active pathways are considered to include:</p> <ul style="list-style-type: none">a. direct and dermal contact and incidental ingestion of contaminated soilb. ingestion of soil or wind-blown dustc. inhalation of vapours, gases or wind-blown dust or fibres <p>Any utility works carried out within this nitrogen deposition compensation site would have the potential to create preferential pathways within the working area resulting in the migration and accumulation of ground gases.</p> <p>Potential receptors</p> <p>Based on the proposed works for the nitrogen deposition compensation site, potential receptors are considered to be:</p> <ul style="list-style-type: none">a. Construction workersb. Operations staffc. Ecology (proposed grassland and trees)d. Future visitors <p>In relation to any utility works, operations staff (maintenance and utilities engineers) and construction materials associated with utilities would be considered a potential receptor.</p> <p>Preliminary Risk Assessment</p> <p>The site has been an agricultural field since the earliest available historical mapping and as such on-site contamination is not expected.</p> <p>The identified off-site sources of contamination are considered unlikely to pose a risk of contamination to the site. Should unexpected contamination be encountered, implementation of standard protocols including watching briefs</p>

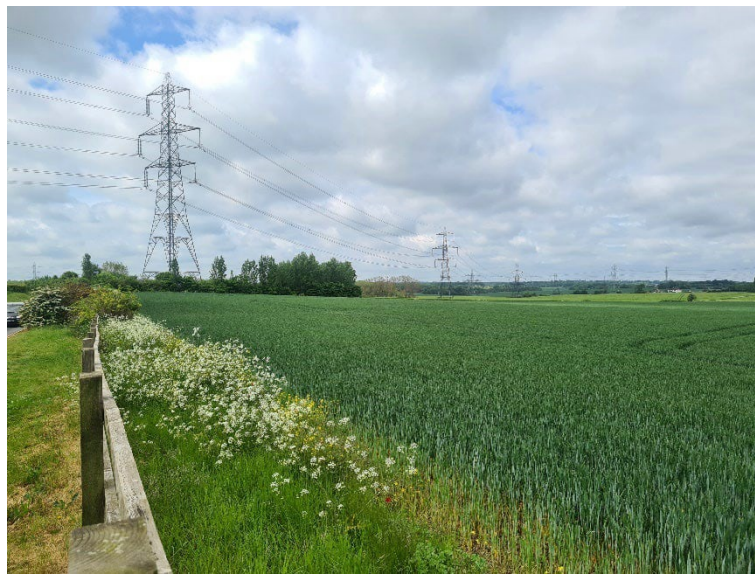
View of southwest corner of nitrogen deposition compensation site from Henhurst Road showing location of electrical pylons

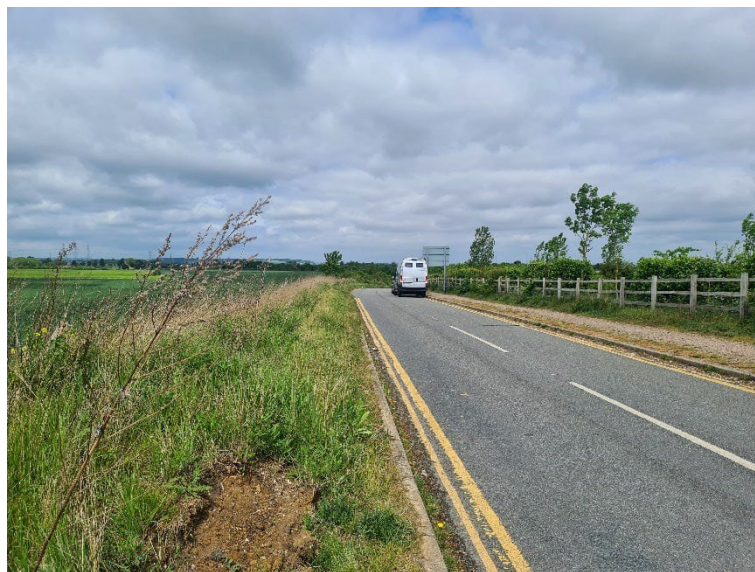
<p>Henhurst Hill Approximate postcode: DA12 3AN</p>	
	<p>Northern boundary of site from corner of Church Rd and Henhurst Road – both roads were observed to be in good condition with kerb border and no visible stains or spills</p>

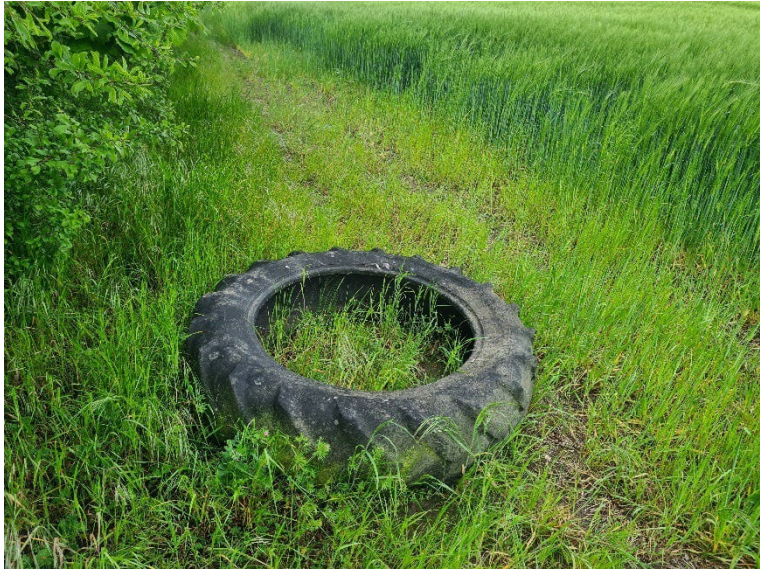
<p>Singular discarded tyre was the only significant waste observed on the site.</p>
Geology	<p>There are no mapped superficial deposits with the exception of the south west corner, which is underlain by Head (clay, silt, sand and gravel). This is further underlain by the Lewes Nodular Chalk Formation, Seaford Chalk Formation and Newhaven Chalk Formation (undifferentiated).</p> <p>The remainder and majority of the nitrogen deposition compensation site is underlain by the Thanet Formation, silty fine-grained sand, with sandy silt, silt or sandy, silty clay.</p> <p>Source: Online BGS Geology of Britain viewer https://www.bgs.ac.uk/map-viewers/geology-of-britain-viewer/ and BGS maps portal https://www.bgs.ac.uk/information-hub/bgs-maps-portal/ Accessed 21 February 2022.</p>

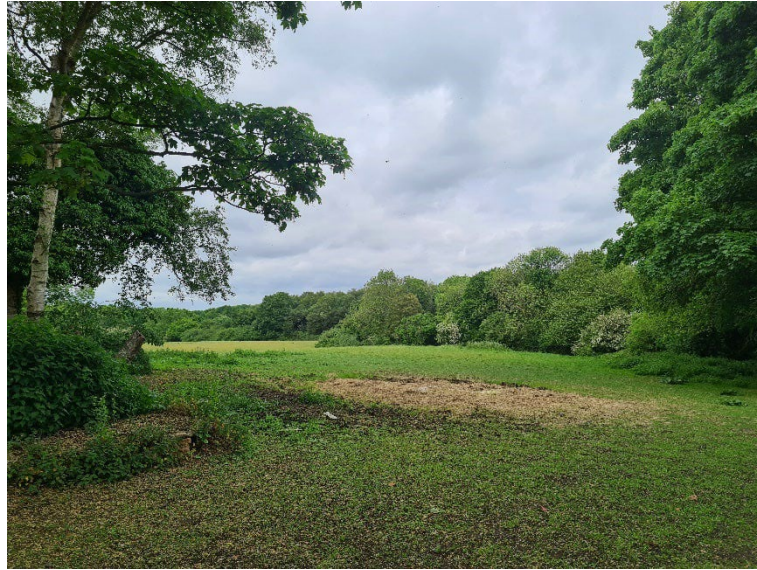
Due to access limitations only the southwest corner of site was visible during the walkovers. It is grass-covered with trees around the perimeter and appears to have been used for grazing animals.

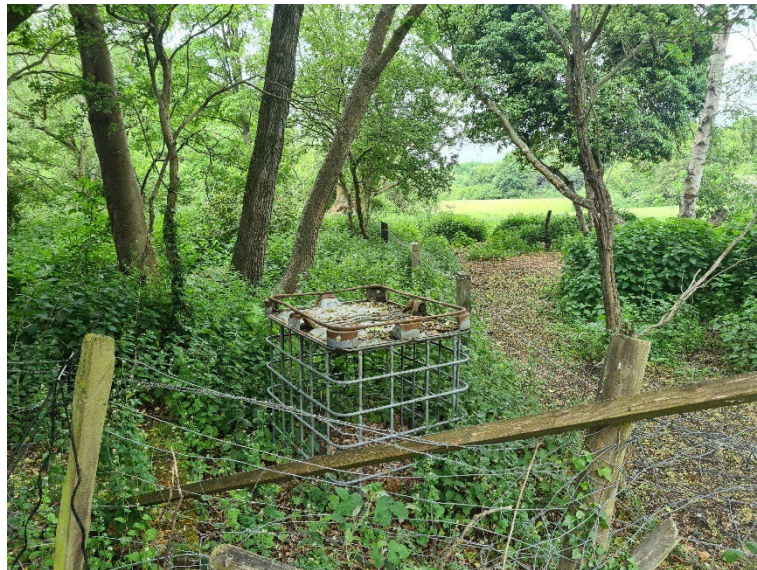
Discarded IBC cage in southeast corner of site

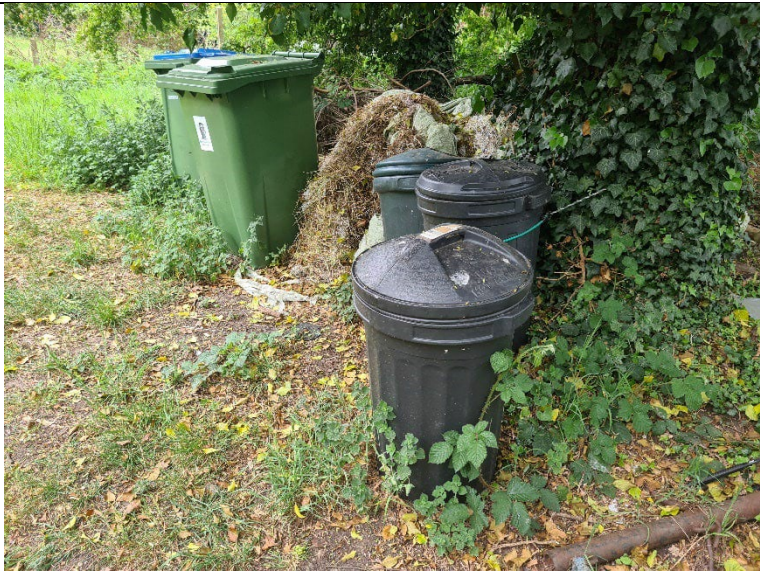
<p>Household waste bin storage in access route leading to site from Woodlands Lane</p>
Geology	<p>No superficial deposits are mapped.</p> <p>The Harwich Formation (sand and gravel) is mapped underlying the majority of the site. The Lambeth Group (sand, silt and clay) is mapped on the north and north east boundary of the nitrogen deposition compensation site.</p> <p>Source: British Geological Survey (2022). Geology of Britain viewer. Accessed July 2022. www.bgs.ac.uk/data/mapViewers/home.html.</p> <p>British Geological Survey (2022). BGS maps portal. Accessed July 2022 https://www.bgs.ac.uk/information-hub/bgs-maps-portal/</p>
Hydrogeology	<p>The site is situated on a Secondary A Aquifer.</p> <p>The majority of the site is not mapped within a source protection zone. The south-east corner is mapped to be on the edge of a Zone 3 Total Catchment.</p> <p>Source: Defra (2022) MAGIC. Accessed July 2022. https://magic.defra.gov.uk/</p>

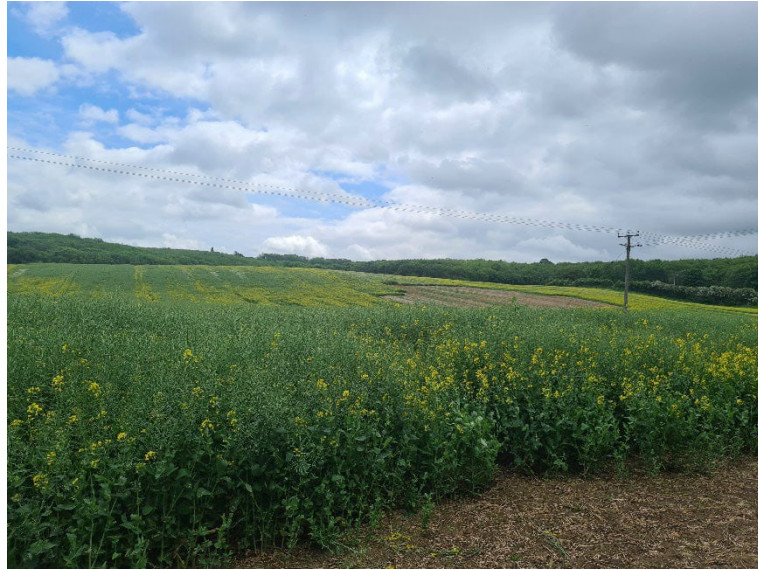
Western agricultural field crossed by telecoms lines (note area of dead crop adjacent to overhead pylon)

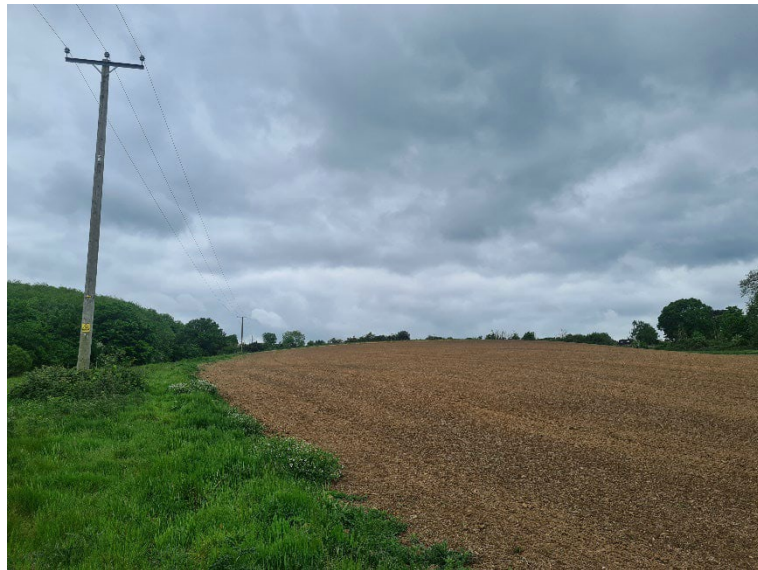
Fallow southern end of western agricultural field crossed by overhead telecommunication lines

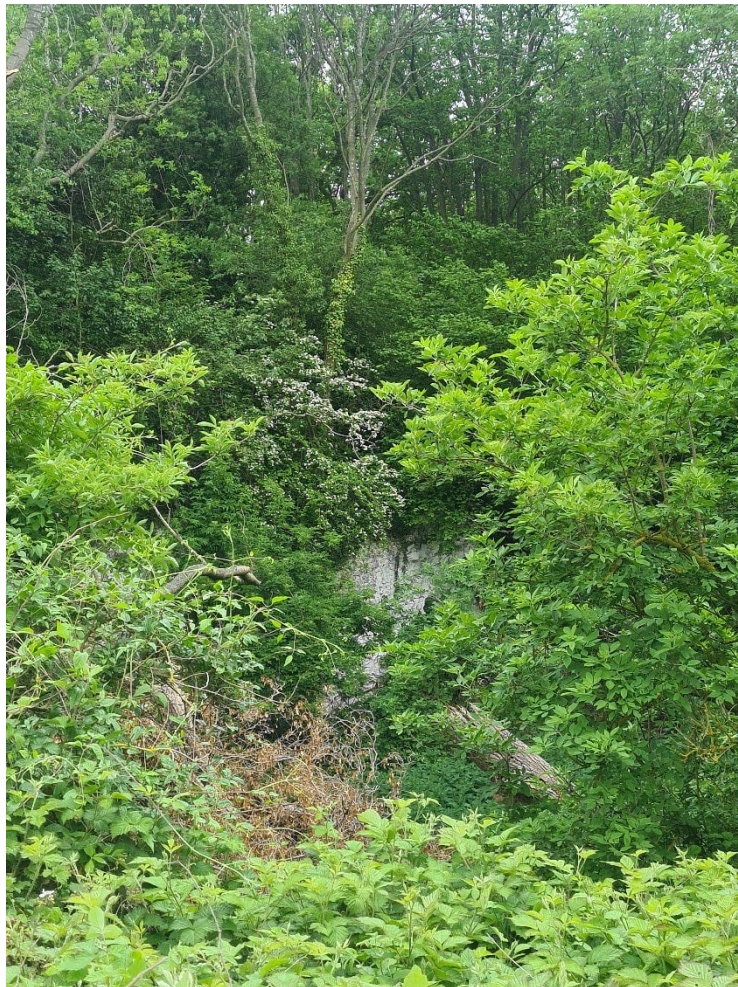
Some evidence of small-scale historic quarrying activity noted in the forested area to the north eastern corner of the site. Mapping data indicates that the area currently contains a small pond – this was not visible due to mature vegetation.

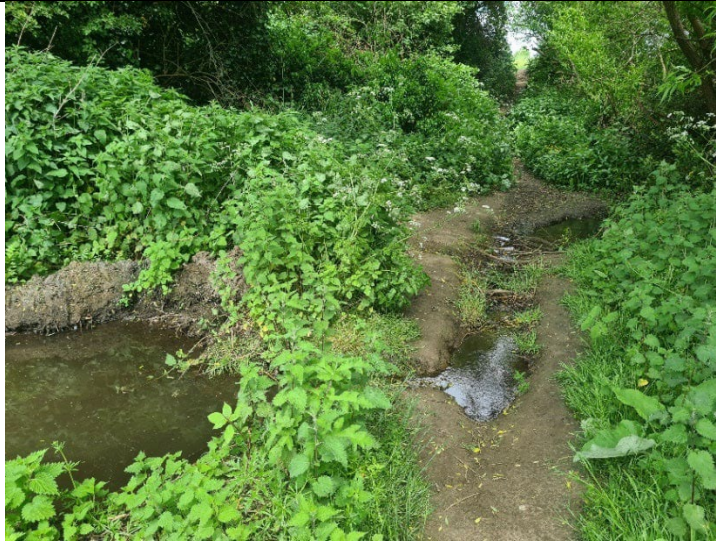
High water level was noted in the drainage ditch along the northern border of both fields (photo taken at intersection of the western and eastern field)

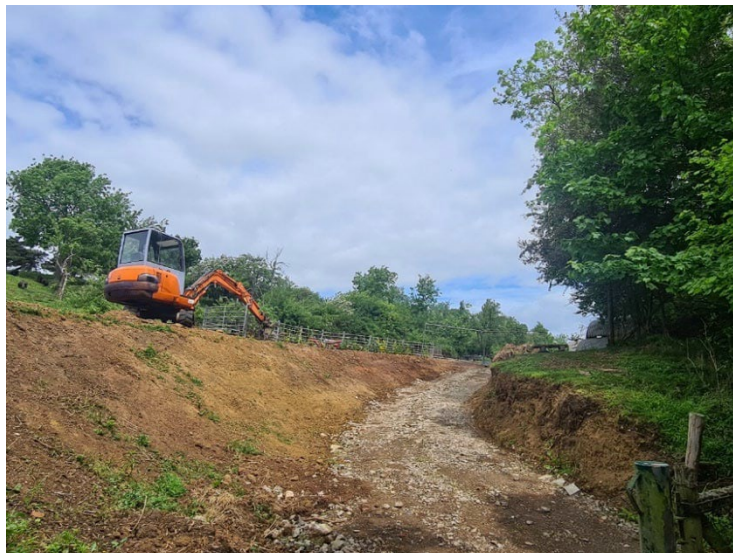
Offsite to the northern boundary parked plant and waste or stored equipment/furniture/tyres were observed but could not be investigated further due to land access constraints.

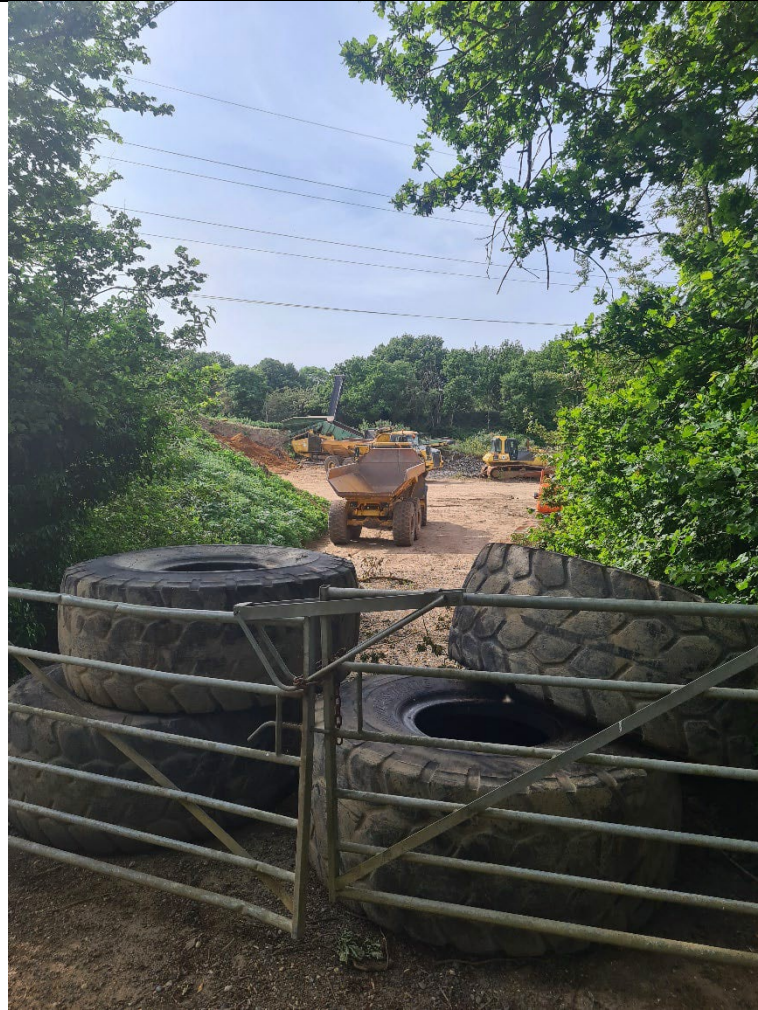
Vehicles and tyres associated with Rainbow Shaw Quarry Landfill (HLU0825) visible from Hoford Road

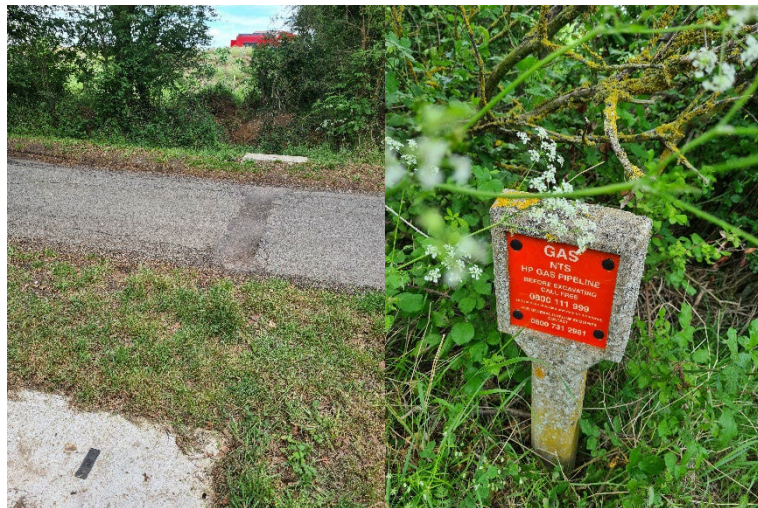
Indicative condition of roads between industrial sites to the south of the nitrogen deposition compensation site. Gas pipeline marker and indications of buried services across Codham Hall Lane to the south of site

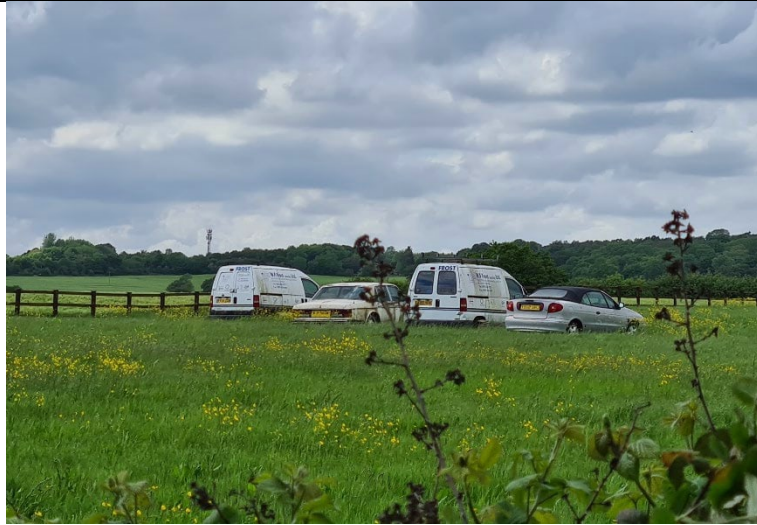
Cars parked on land just off site of the nitrogen deposition compensation site in the eastern corner - potentially unused or scrap vehicles

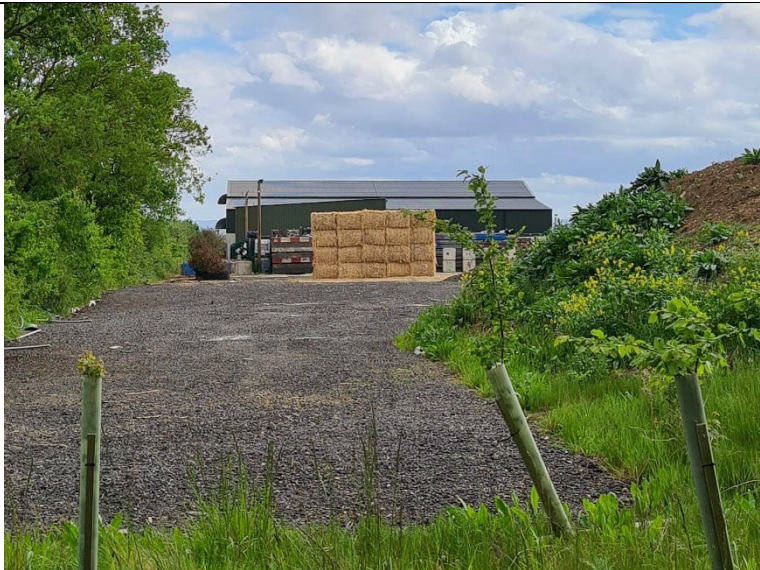
<p>Warehouse/storage unit off-site to the south looks to be organised with good site housekeeping.</p>
Geology	<p>The majority of the southern two thirds of the nitrogen deposition compensation site is underlain by Head (clay, silt, sand and gravel), there are some pockets where no superficial deposits are mapped, the majority of the northern third has no superficial deposits mapped, with the exception of one lens of Head.</p> <p>The majority of the nitrogen deposition compensation site is further underlain by the London Clay Formation, with the exception of the southernmost portion which is underlain by the Claygate Member (clay, silt and sand).</p> <p>Source: British Geological Survey (2022). Geology of Britain viewer. Accessed July 2022. www.bgs.ac.uk/data/mapViewers/home.html.</p> <p>British Geological Survey (2022). BGS maps portal. Accessed July 2022 https://www.bgs.ac.uk/information-hub/bgs-maps-portal/</p>

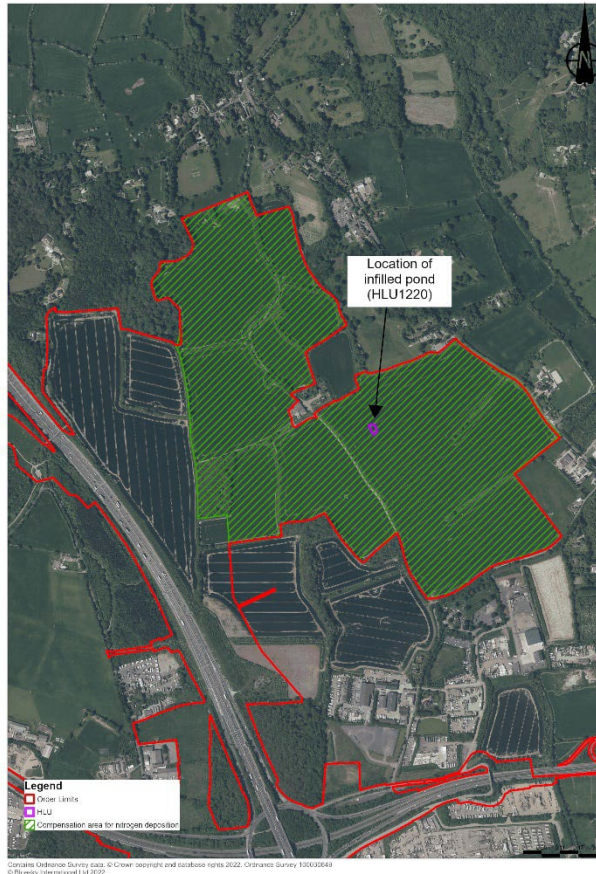
**Plate D.14 Hole Farm East nitrogen deposition compensation site
potential sources of contamination**

- a. To be carried out by Forestry England according to their planning application.
- b. Fencing / securing site (stock fencing perimeter and metal fence for compounds / building sites)
- c. Limited groundworks - digging ponds and ditches and deep ploughing
- d. Tree planting
- e. Grassland sowing
- f. Ditch and pond creation
- g. Path creation
- h. (Visitor centre and access tracks / roads also proposed but not relevant to LTC needs as this is FE proposal)
- i. Utility works unknown
