Lower Thames Crossing
6.3 Environmental Statement
Appendices
Appendix 10.10 – Unexploded
Ordnance (UXO) Desk Study &
Risk Assessment

Lower Thames Crossing - UXO Desk Study & Risk Assessment

Document Title UXO Desk Study & Risk Assessment
Document Ref. HE540039-ZET-GEN-GEN-REP-GEO-00001
Revision 5
Project Location Lower Thames Crossing
Client Arcadis/National Highways
Date 11th October 2022

UXO DESK STUDY & RISK ASSESSMENT

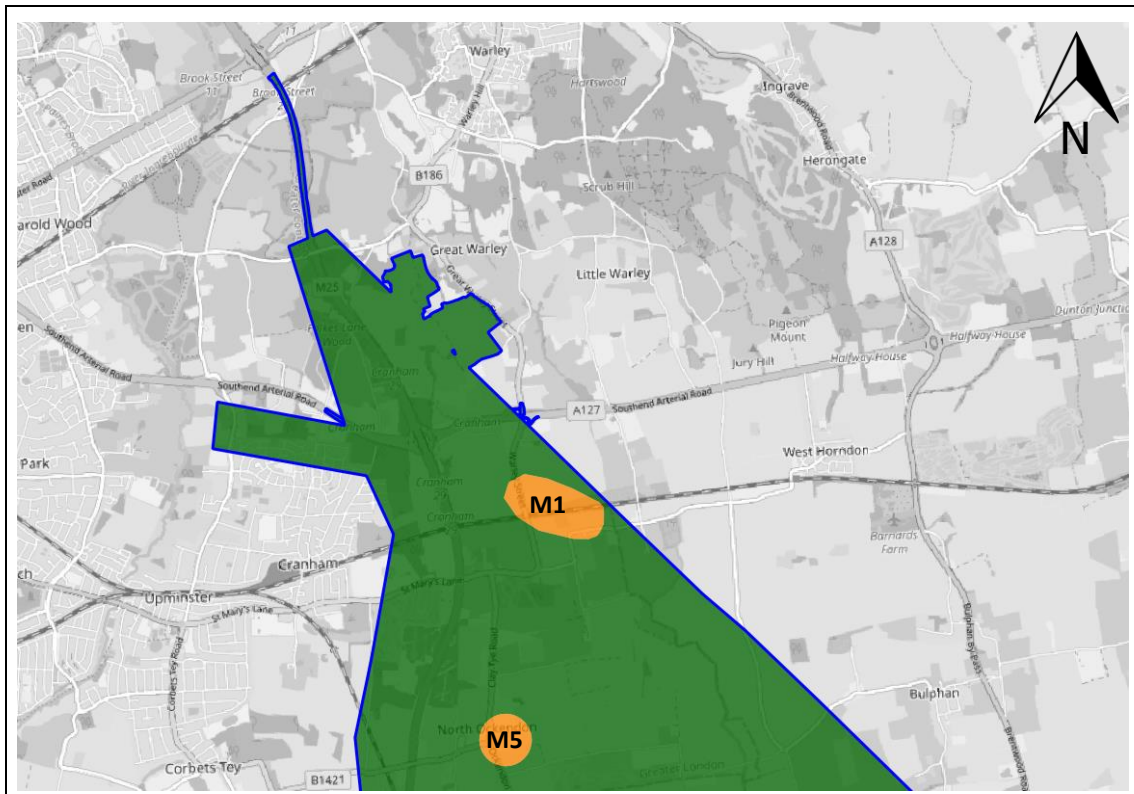
UXO hazard zone plan of the Site (Great Warley to Upminster)

The Figures below, reproduced as **Figures 21 to 25** in the main report, provide more detailed extracts of the moderate UXO hazard level zones on the Site.

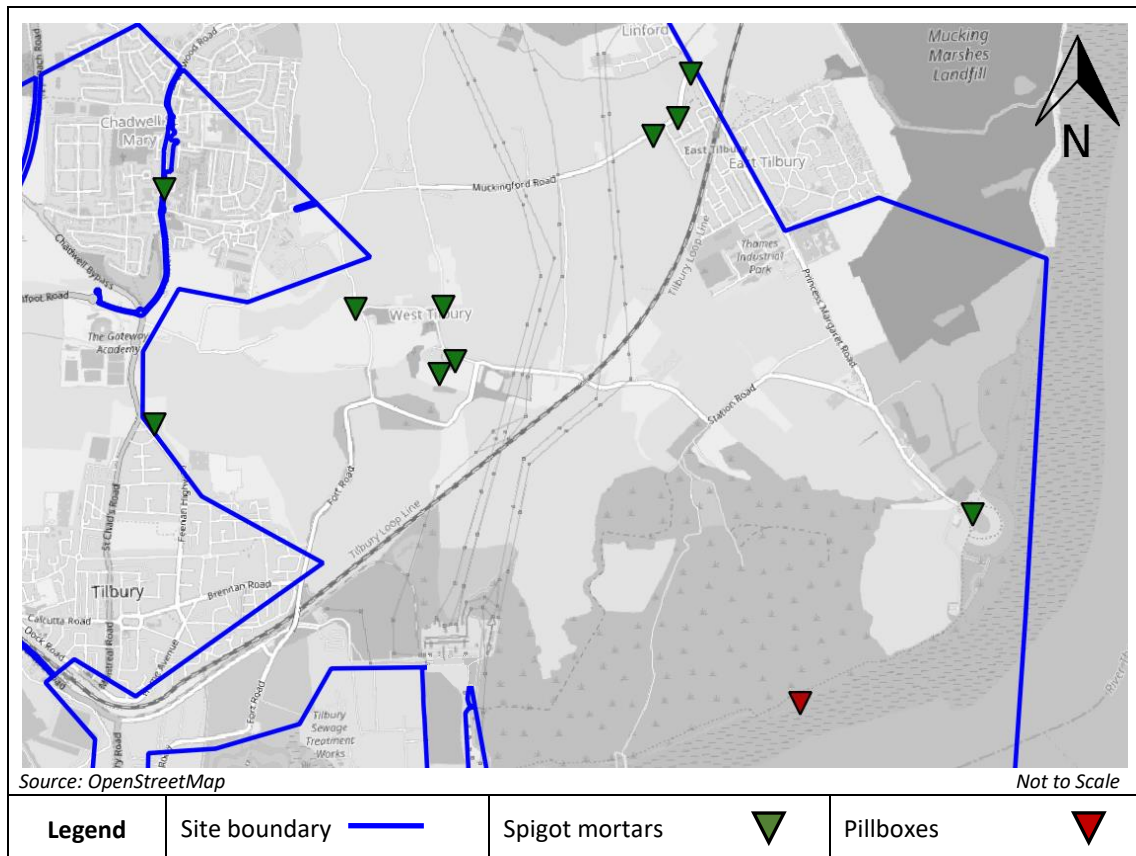
Figure 2 Map of spigot mortars and pillboxes on the Site

Spigot mortar positions could be either fixed or mobile. At static positions, they were either affixed to a large cruciform platform or an immobile concrete pedestal and were usually emplaced in a pit with ammunition lockers nearby.

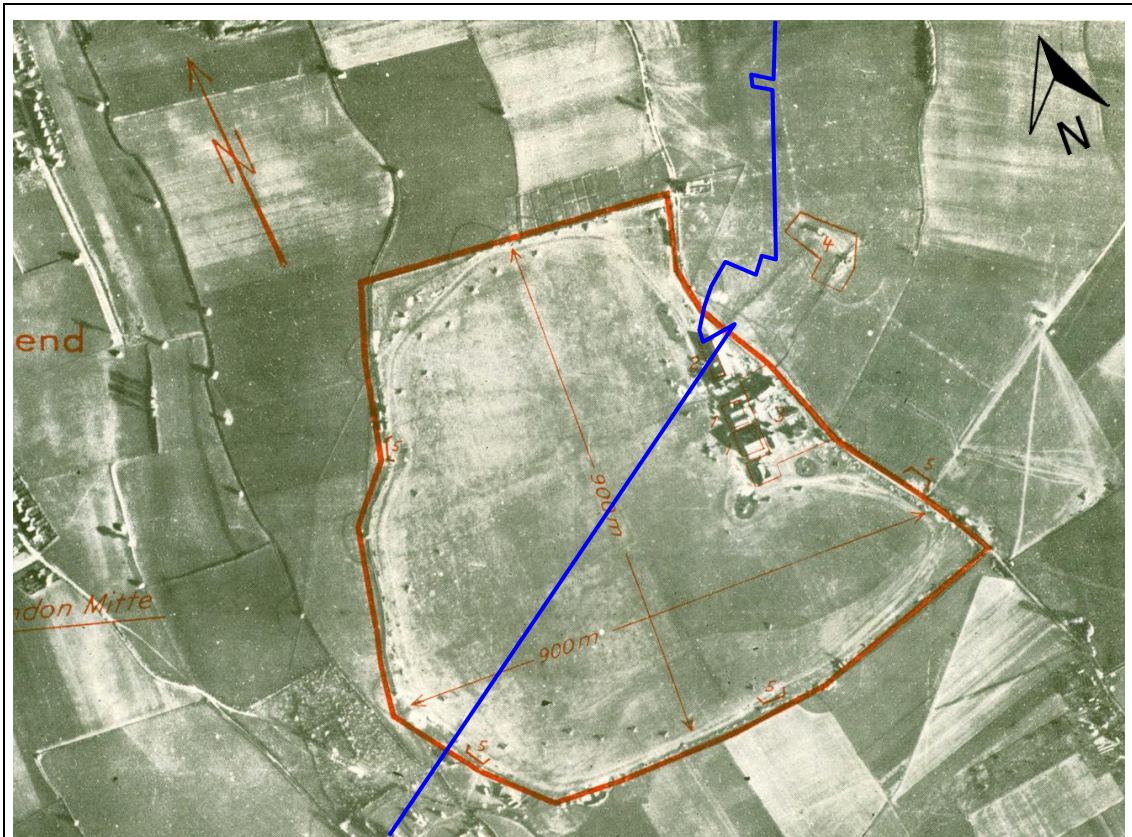
Plate 7 Luftwaffe target photograph of RAF Gravesend, 8th November 1940

Plate 7 is a Luftwaffe target photograph of RAF Gravesend, dated the 8th November 1940. It shows the airfield's boundary (GB 10 89), highlighted in red, encroaching on the southern part of the Site.

RAF Gravesend, encroaching on the southern part of the Site, was used to station squadrons of Fighter Command. A Luftwaffe target photograph of RAF Gravesend is presented in Plate 7 (Section 3.2.2).

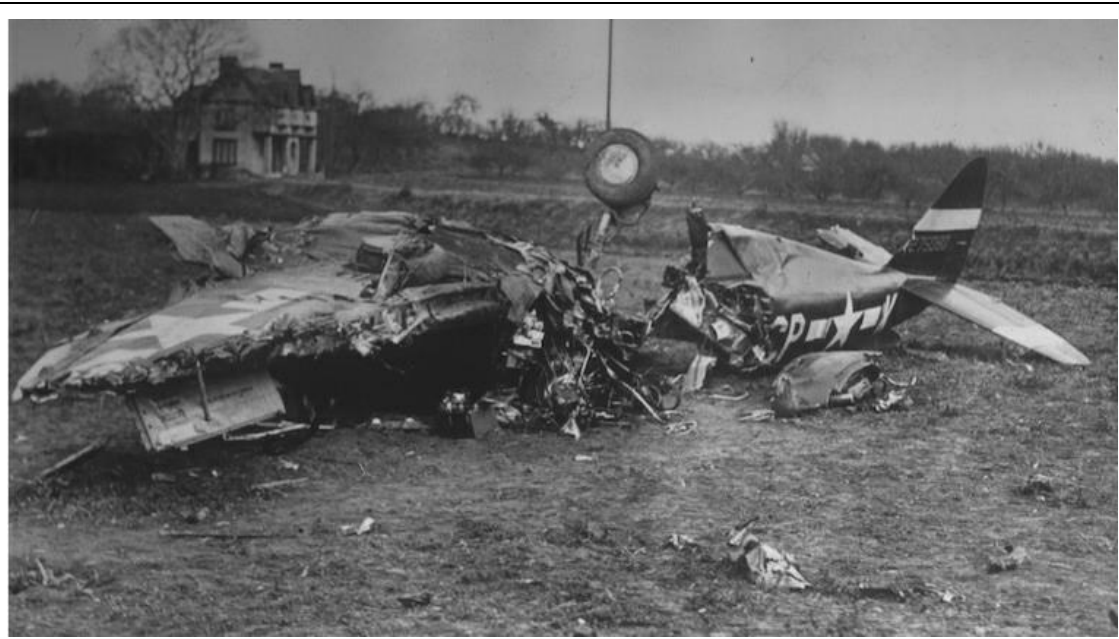
Plate 9 Photograph showing crashed Republic Thunderbolt (42-47080), Shorne, 1943

Plate 9 is a photograph of the crash dating from 1943. This demonstrates how a fighter aircraft wreckage can lead to the spread of both debris and SAA over a wide area.

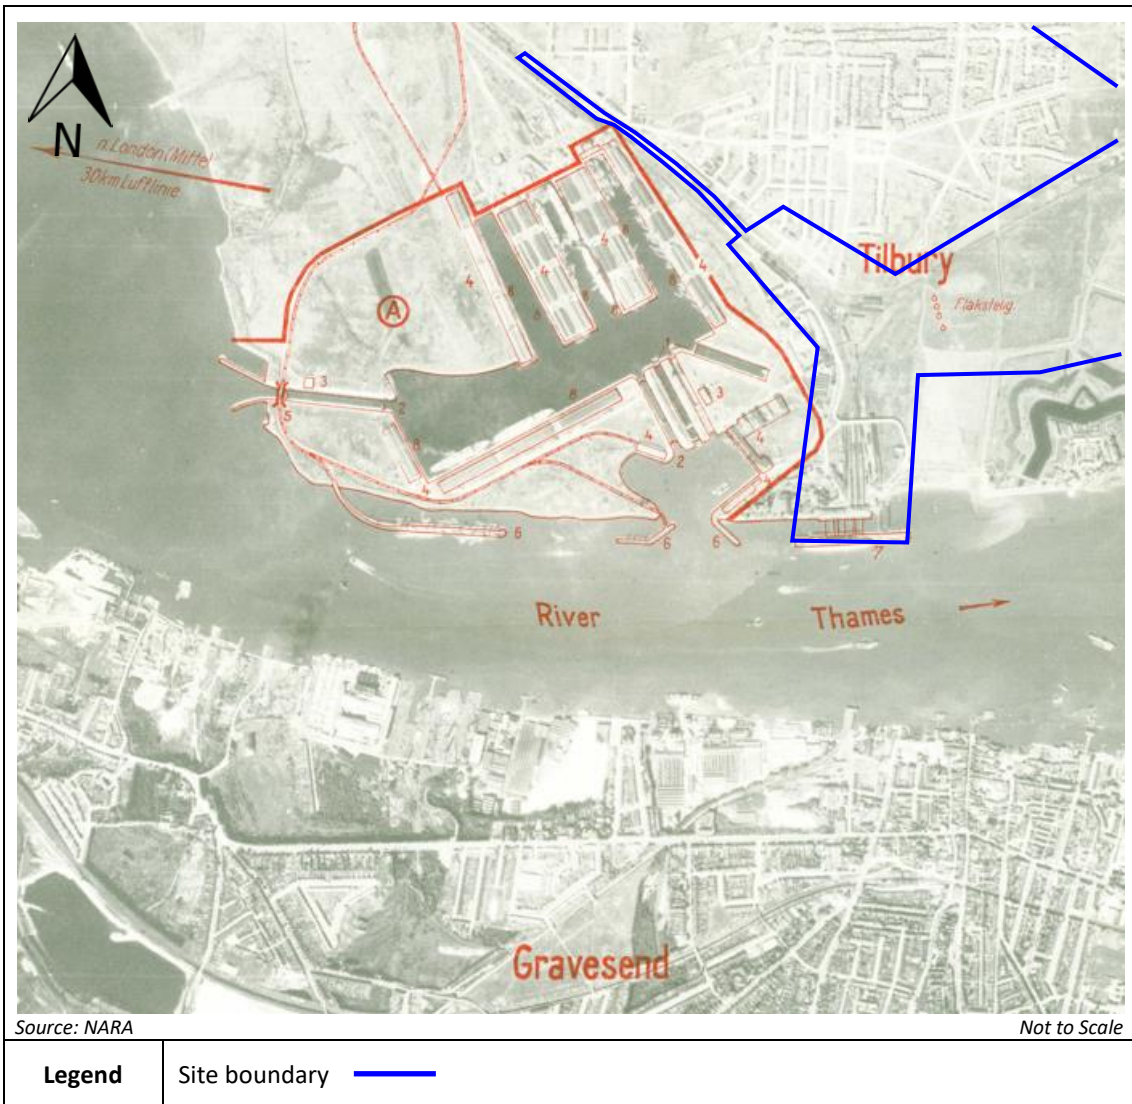
Plate 14 Luftwaffe target photograph of Tilbury Docks, August 1938

Plate 14 is a Luftwaffe target photograph of Tilbury Docks (Target A), dating from August 1938.

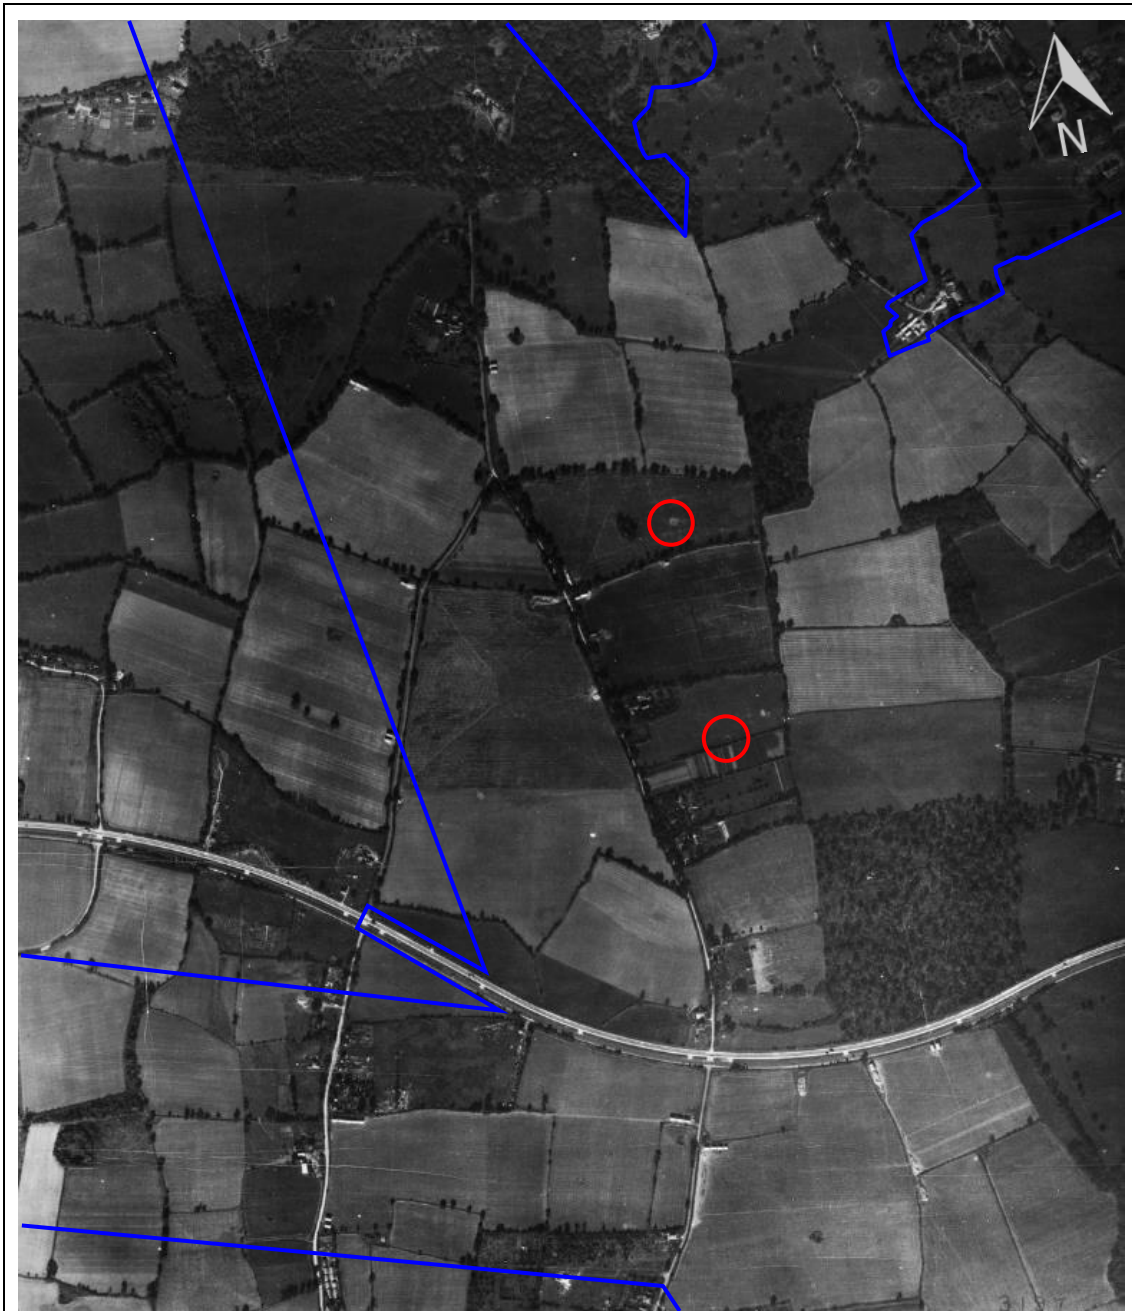
Plate 16 Aerial photograph, 11th October 1946 (Great Warley)

Plate 16 is an aerial photograph of the Great Warley area of the Site, dated the 11th October 1946.

Only 2No. possible bomb craters have been identified on the Site and there is no evidence of any heavy cratering.

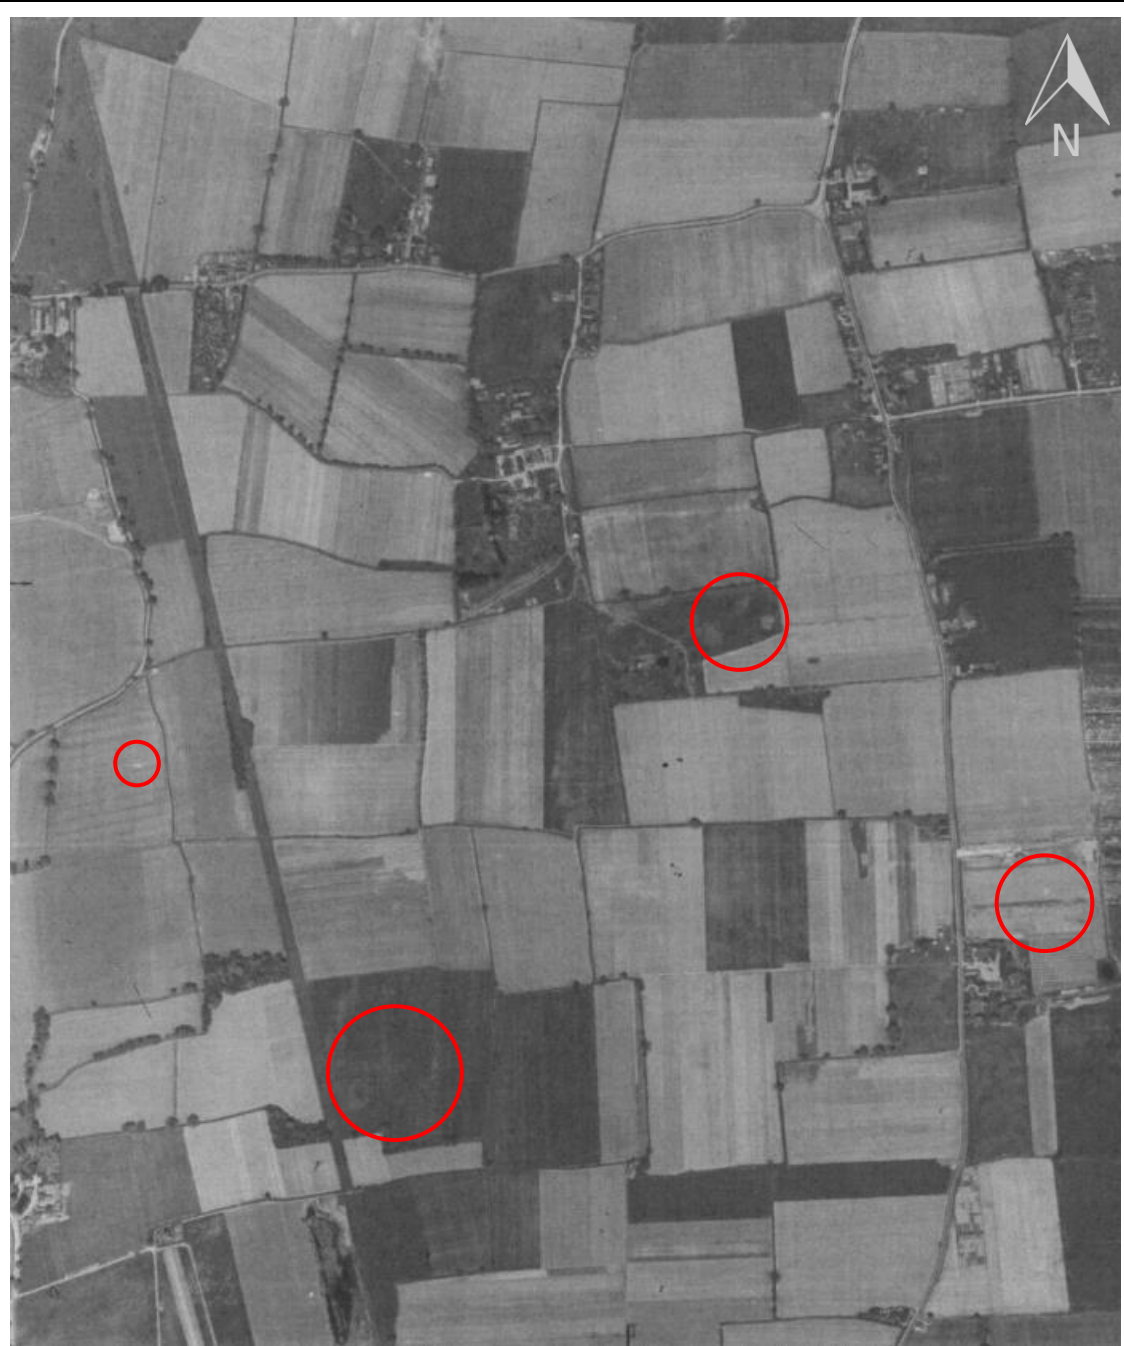
Plate 18 Aerial photograph, 1st May 1946 (Upminster)

Plate 18 is an aerial photograph of the Upminster area of the Site, dated the 1st May 1946.

Some possible residual bomb damage has been identified on the Site, although there is no evidence of any heavy cratering.

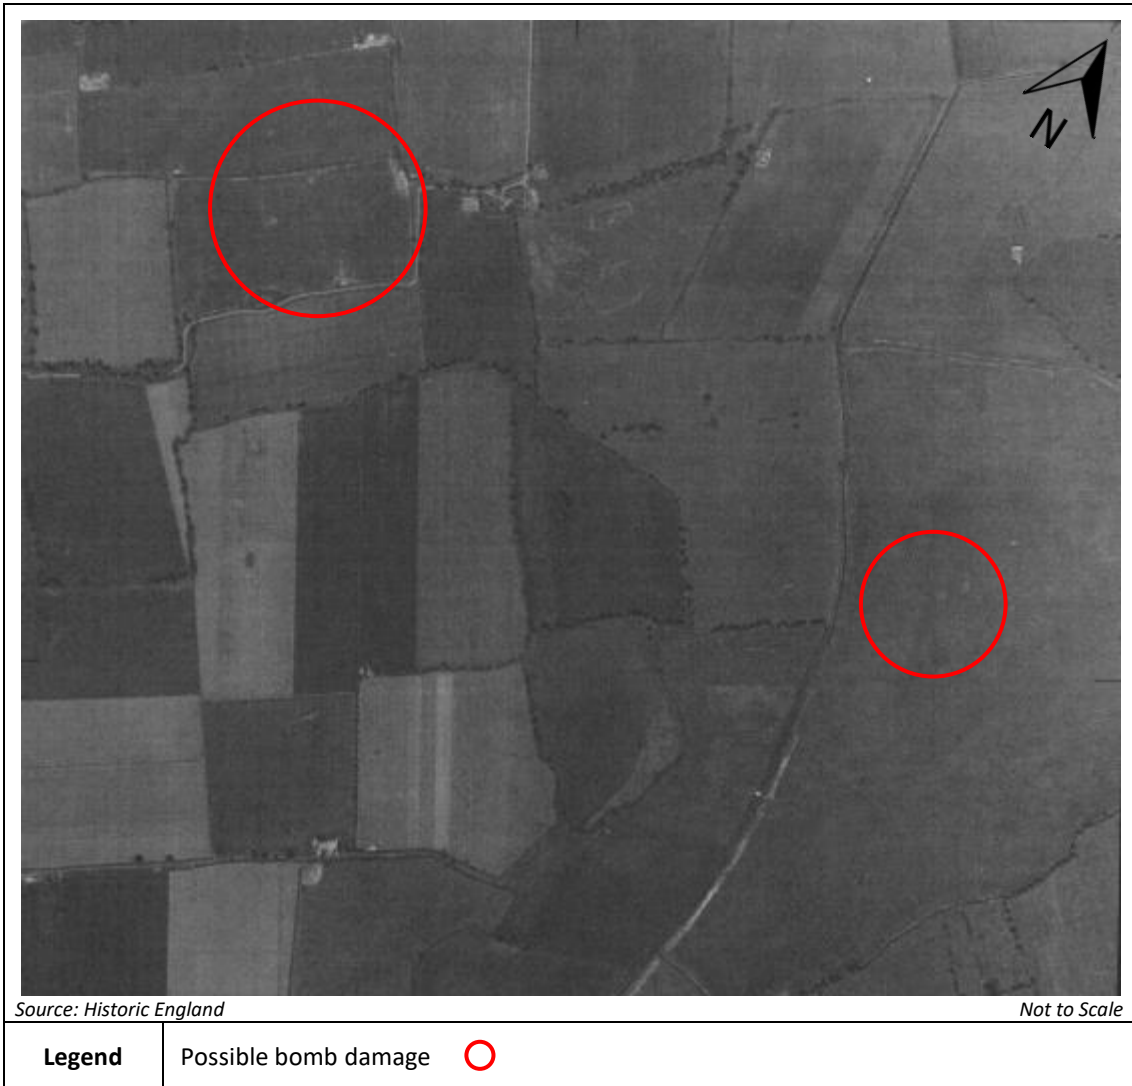
Plate 21 Aerial photograph, 1st May 1946 (South Ockendon)

Plate 21 is an aerial photograph of the South Ockendon area of the Site, dated the 1st May 1946.

Some possible bomb cratering has been identified on the Site.

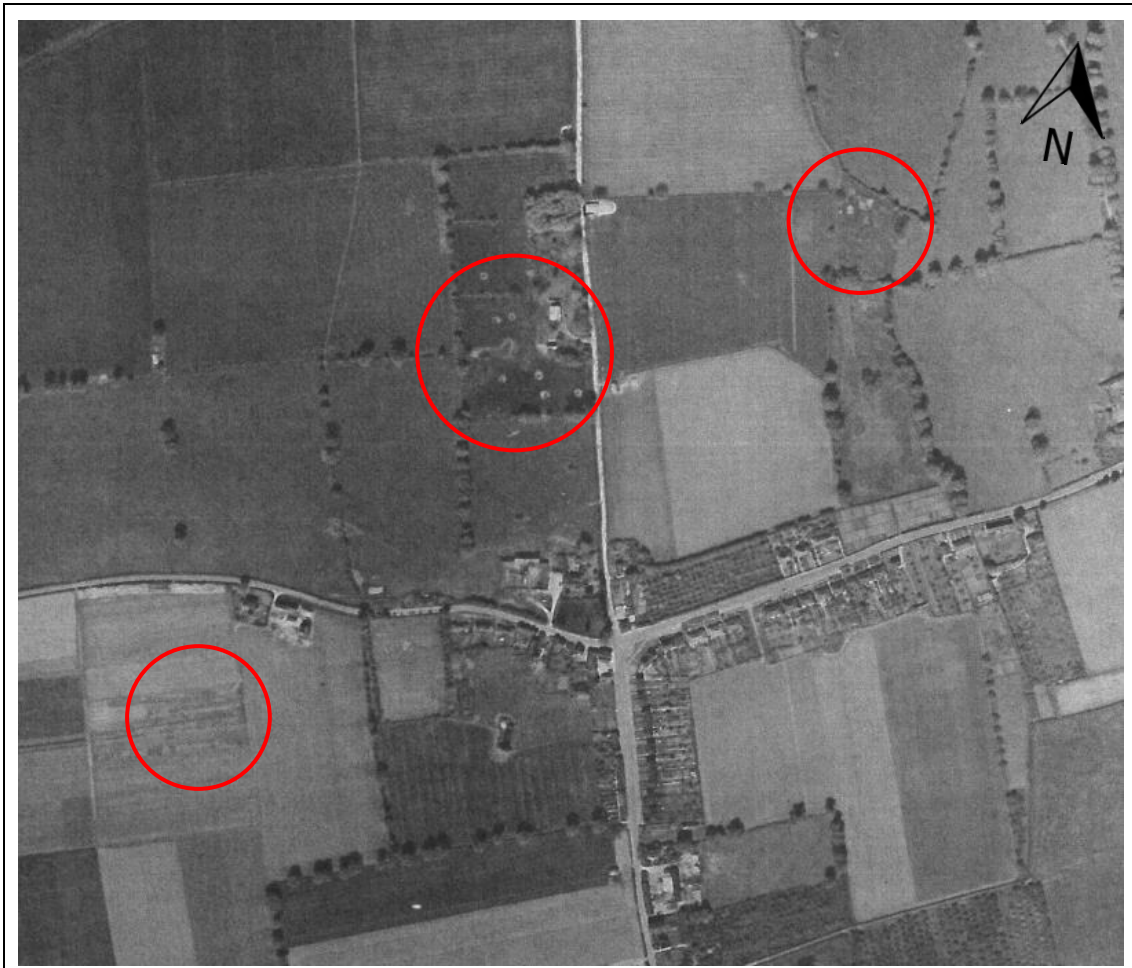
Plate 23 Aerial photograph, 1st May 1946 (Baker Street)

Plate 23 is an aerial photograph of the Baker Street area of the Site, dated the 1st May 1946, Some possible residual bomb damage has been identified on the Site.

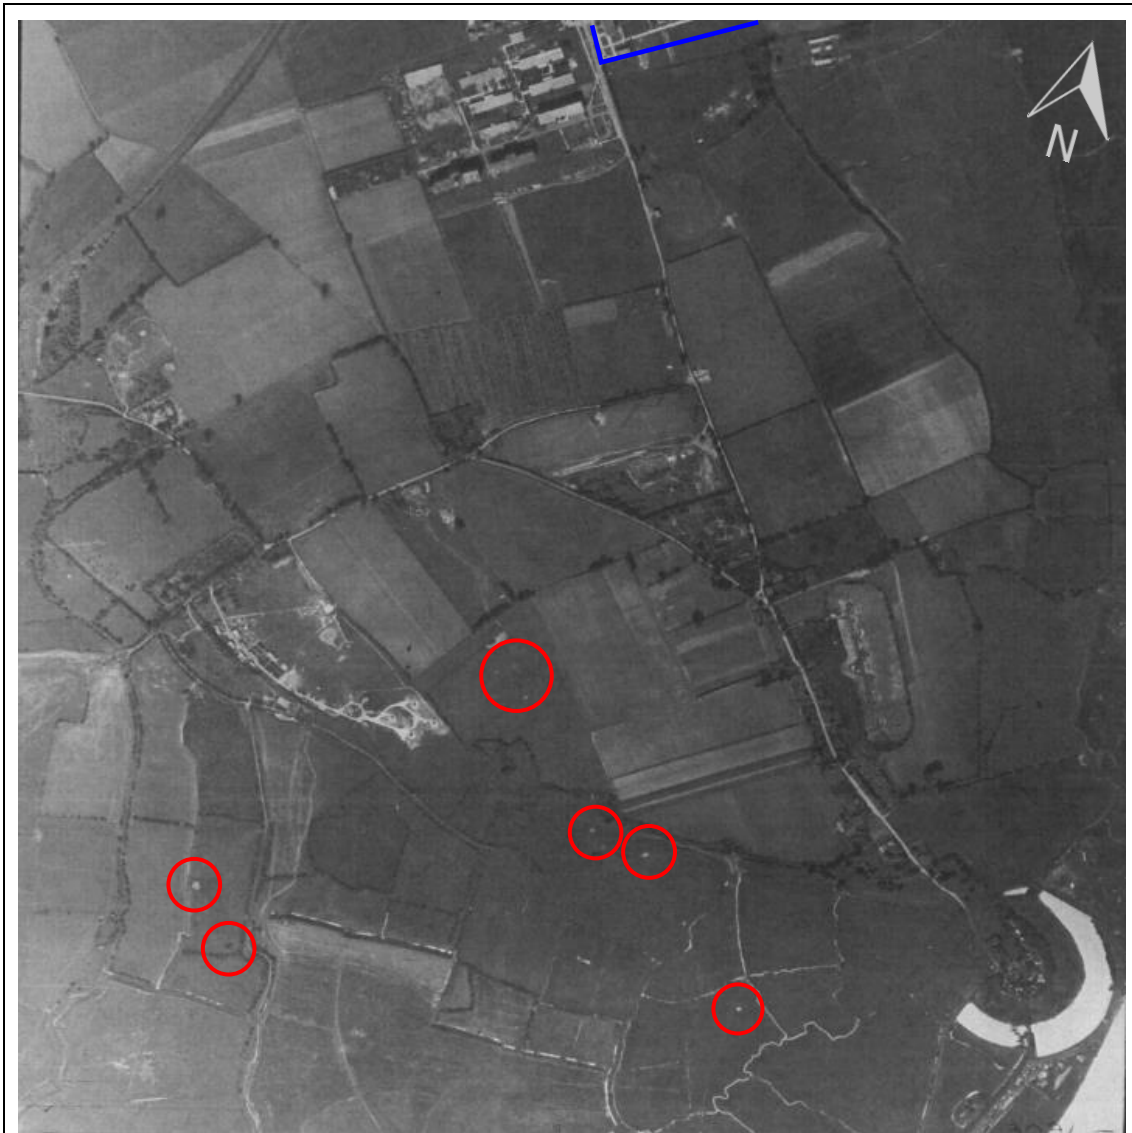
Plate 25 Aerial photograph, 1st May 1946 (Coalhouse Fort)

Plate 25 is an aerial photograph of the Coalhouse Fort area of the Site, dated the 1st May 1946, Some possible bomb cratering has been identified on the Site.

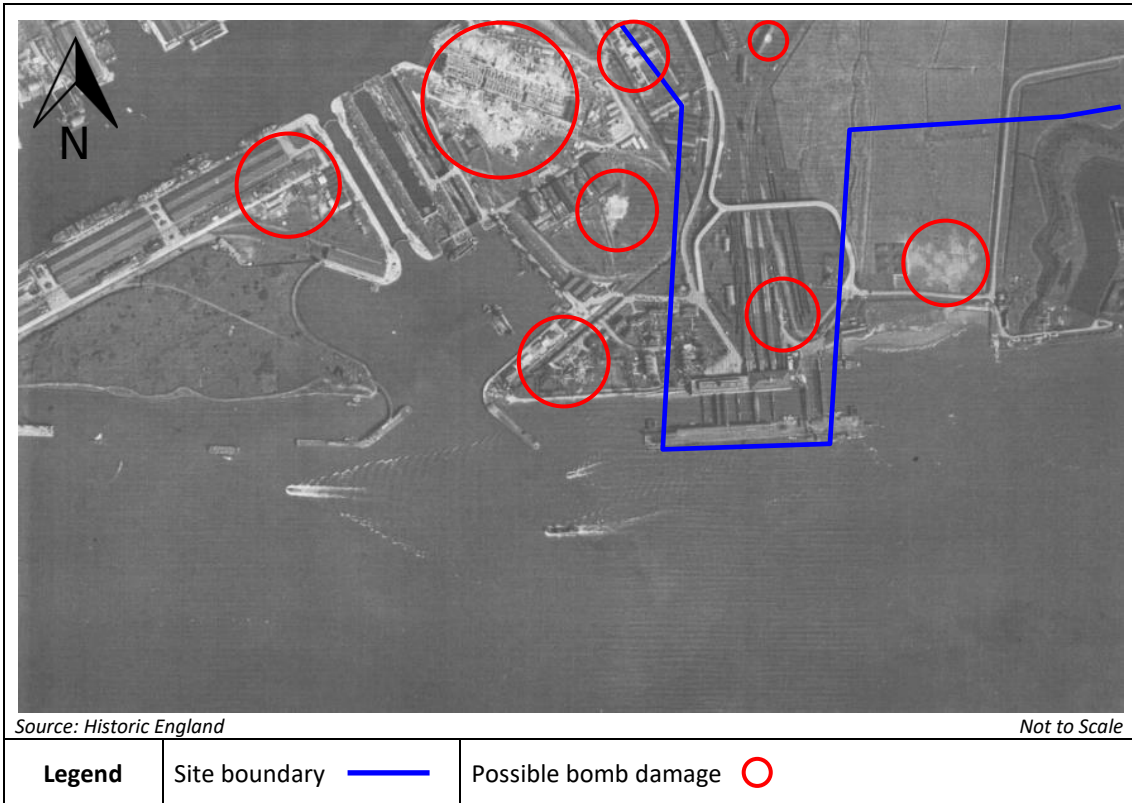
Plate 27 Aerial photograph, 18th April 1944 (Tilbury Docks)

Plate 27 is an aerial photograph of the Tilbury Docks area of the Site, dated the 18th April 1944. Significant bomb damage has been identified on and in the immediate vicinity of the Site, notably in the area surrounding Tilbury Docks, which sustained heavy damage during several air raids.

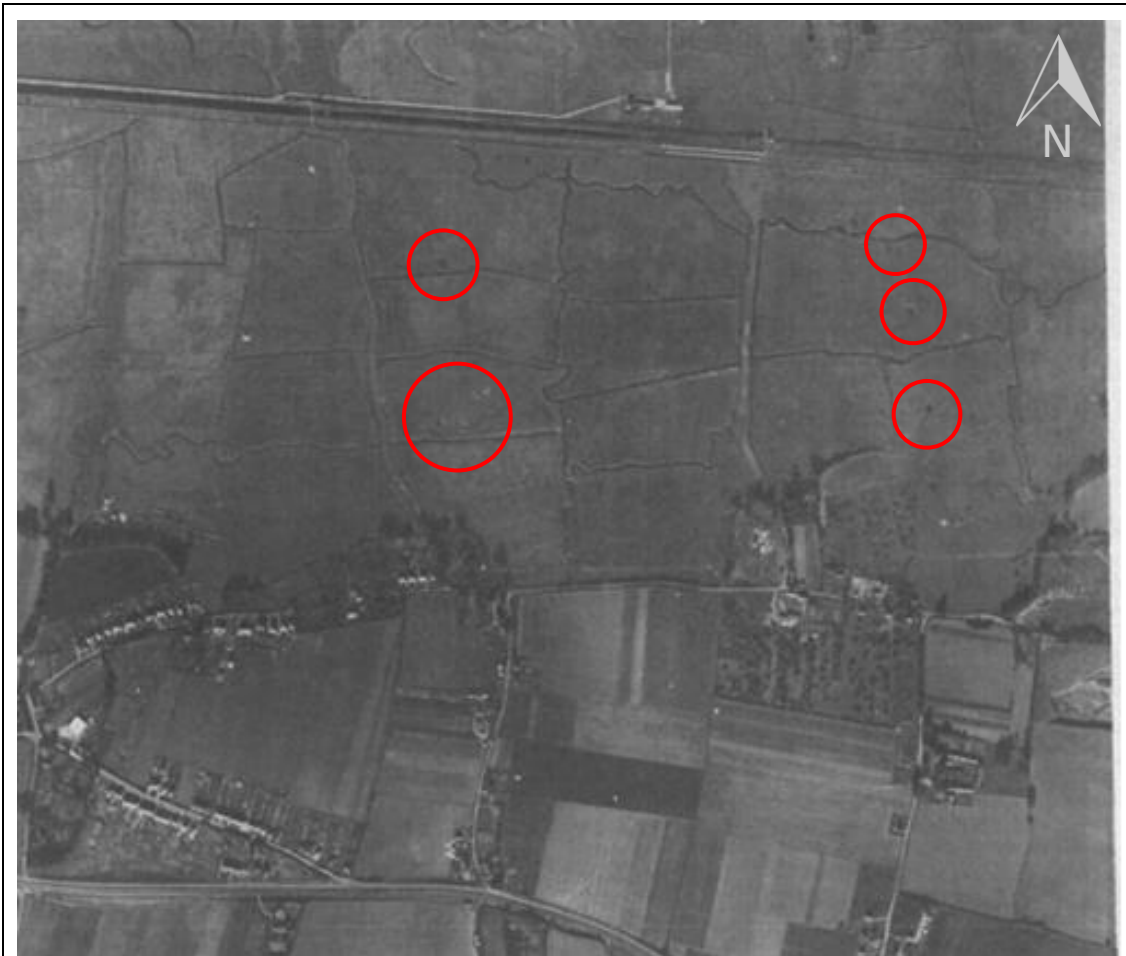
Plate 29 Aerial photograph, 11th October 1946 (Filborough Marshes)

Plate 29 is an aerial photograph of the Filborough Marshes area of the Site, dated the 11th October 1946.

Some possible bomb cratering has been identified on the Site.

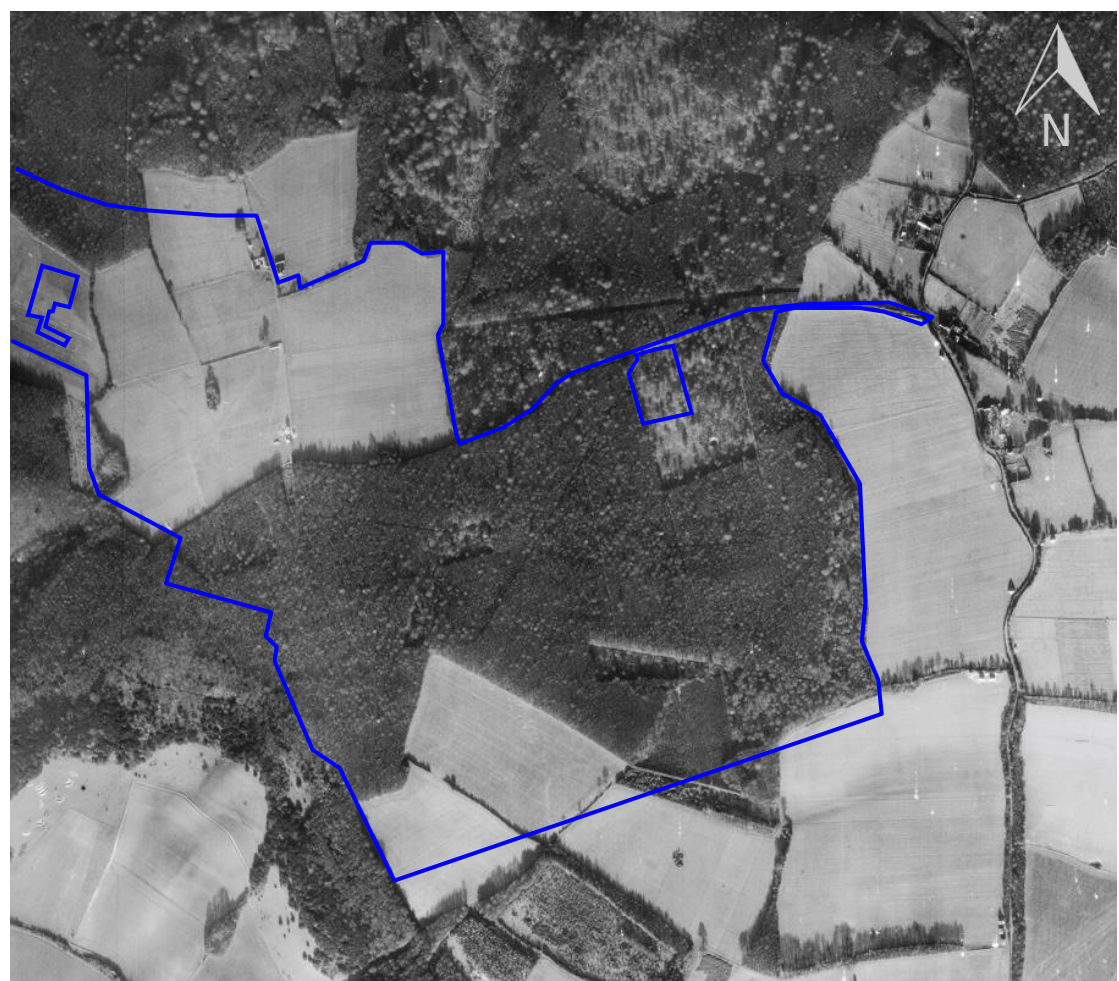
Plate 35 Aerial photograph, 20th December 1945 (Westfield Sole)

Plate 35 is an aerial photograph of the Westfield Sole area of the Site, dated the 20th December 1945.

No bomb damage or cratering has been identified on or in close proximity to the Site.

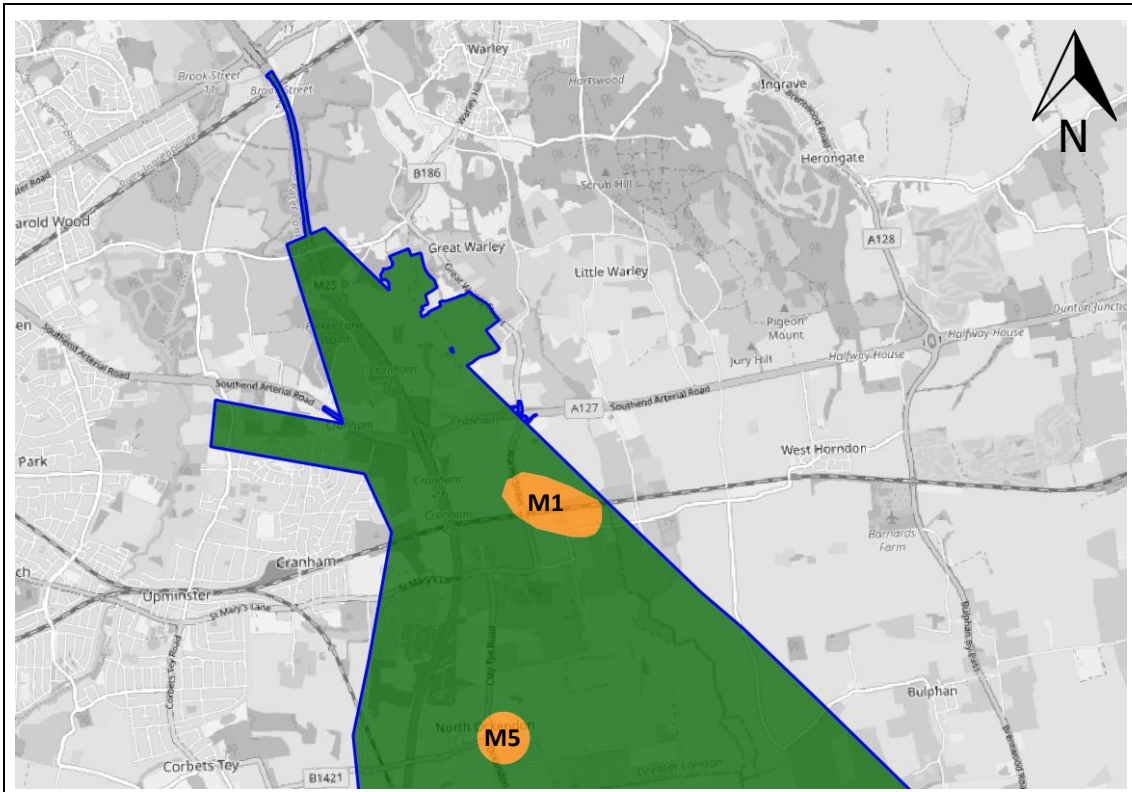
Figure 21 UXO hazard zone plan of the Site (Great Warley to Upminster)

Figures 21 to 25 below, provide more detailed extracts of the moderate UXO hazard level zones on the Site.

This area is identified as M1 on **Figure 21** and shown on HE540039-ZET-GEN-GEN-MAP-GEO-00001-P05.

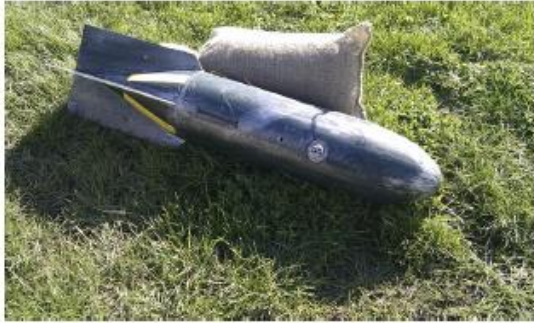
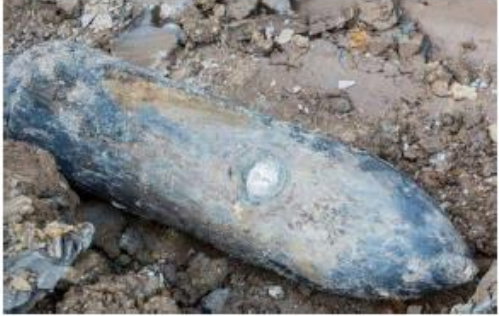
Category	Bomb (Luftwaffe)
Type	Sprengbombe-Cylindrisch (SC) 50kg
Variants	8
Body Dimensions	762 x 200mm (30" x 7.9")
Weight	55kg (122lbs)
Charge Weight	25kg (54lbs)
Fuze	Single electric impact fuze. Some have short time delay
Composition	Sheet steel
Description	Thick nose welded to a steel body. Nose may be attached to Kopfring (a triangular section steel ring) or spike. Suspension bolt in eye/body and sheet metal tail attached to body with rivets/screws. Originally painted green-grey with a yellow stripe on the tail. Cast TNT, Amatol or Trialen filling.
Function	Designed to maximise shock waves through air, water and earth and for general demolition. Used against easily damageable targets, including roads, aircraft hangars, rolling stock and small buildings. Spike bombs/ 'Stabo' (SC 50 with spikes attached to nose) were used against rail lines and country roads, with Kopfring used against naval targets.

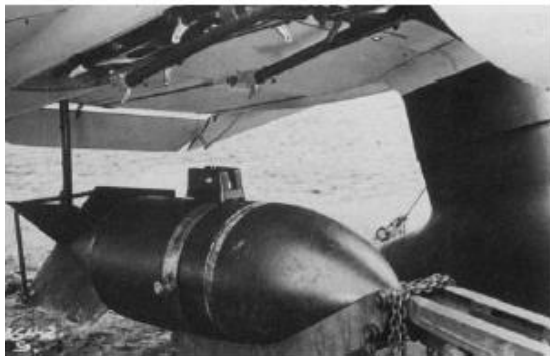
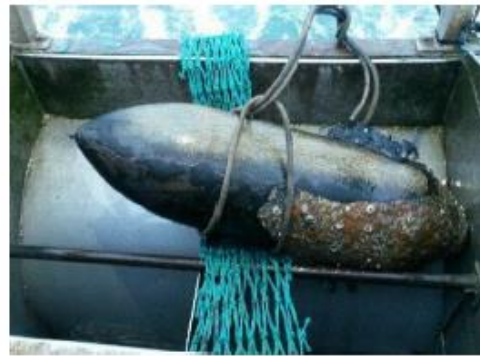
Description Thick nose welded to steel body. Nose may be attached to Kopfring (triangular section steel ring) or spike. Sheet metal tail attached to body with rivets/ screws. Suspension eye bolt in the nose/body. Originally painted green-grey with a yellow stripe on the tail. TNT; amatol; TNT and aluminium powder, naphthalene, ammonium nitrate and wax/ wood meal filling.

Function Designed to maximise shock waves through air, water and earth and general demolition. Used against railway installations, large buildings, ammunition depots and below-ground installations (to 8m). Spike bombs/ 'Stabo' (SC 50 with spikes attached to nose) used against rail lines and country roads.

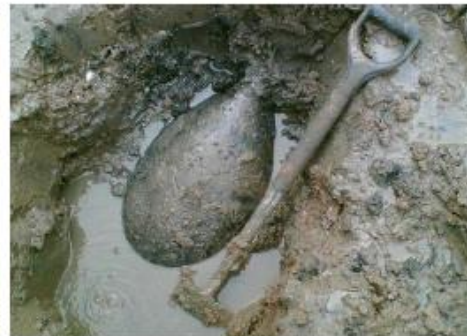
Description Thick nose welded to steel body. Nose may be attached to Kopfring (triangular section steel ring). Tail either steel sheet or drum-shaped. Suspension band. Originally painted green-grey/ buff (some later versions sky blue) with yellow stripe on tail. Filled with amatol, TNT or trialen.

Function Designed to maximise shock waves through air, water and earth and for general demolition. Used against railway property, large buildings, shipping and below-ground installations.

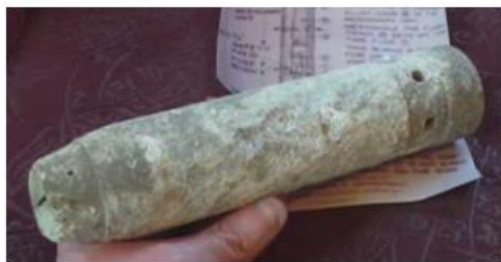
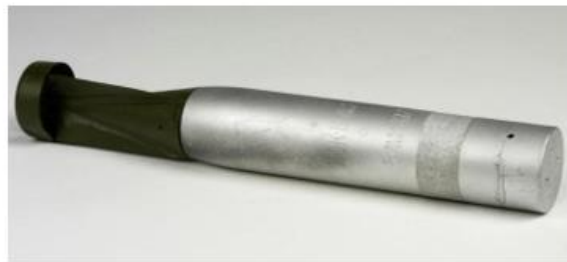
Description The body is a cylindrical alloy casting threaded internally at the nose to receive the fuze holder and fuze. The after body is tapered to receive the sheet metal, three-fined drum-shrouded tail assembly. The bomb is unpainted magnesium; the tail is dark green.

Function Dropped in clusters against industrial and commercial targets to start conflagrations.

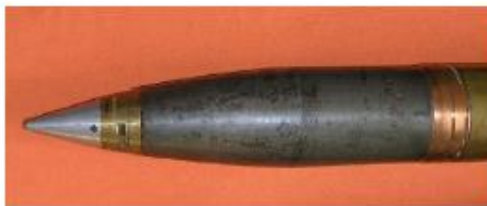
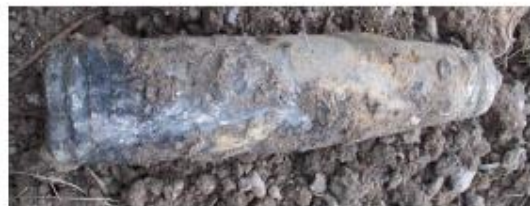
Description Brass cartridge case. Square-based shell with tapered nose, filled with Amatol, TNT or RDX/TNT. MK6 had forward centring bands and a wider driving band.

Function Used as a defence against enemy aircraft, fired from fixed batteries and mobile mountings. Could fire approximately 20 rounds per minute with a maximum ceiling of 41,000ft and horizontal range of 20,600 yards.

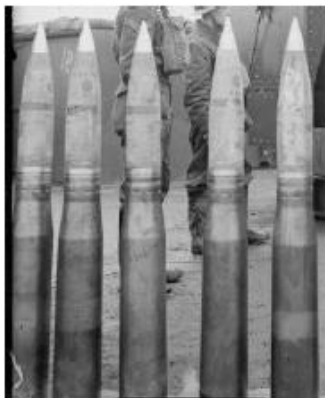
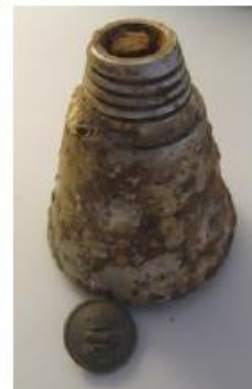
Description Square-based, tapered-nosed shell filled with TNT or Amatol. Steel casing, rotating band of either copper or gilding metal located 3.5" in front of the base end with single groove.

Function Used as field artillery and adapted for use in anti-aircraft defence from fixed batteries. Rate of fire of 8 rounds per minute, maximum ceiling of 44,000ft and horizontal range of 22,800 yards.

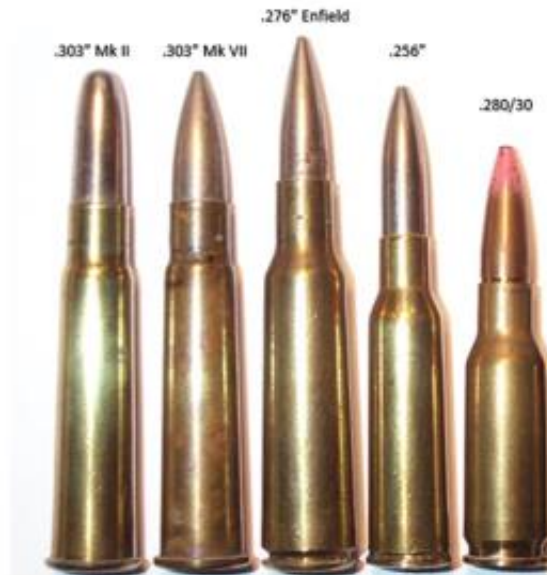
Category Small Arms Ammunition
Type Various

Description: Small Arms Ammunition (SAA) is one of the more recognisable categories of ordnance which is primarily designed for anti-personnel use. SAA include items such as bullets, generally up to a calibre (diameter) of 20mm.

Generally small arms ordnance has a relatively low risk as UXO, although the larger calibre categories may have the same detonation risk as larger high explosive ordnance.

SAA is often associated with discarded ammunition boxes around firing practice ranges and training areas and is often found scattered across former military airfields as a result of aircraft crashes and localised disposal.

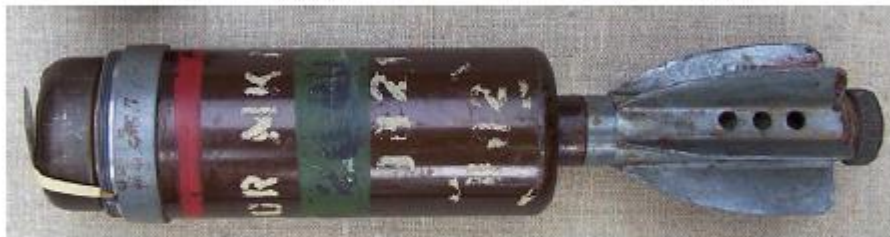
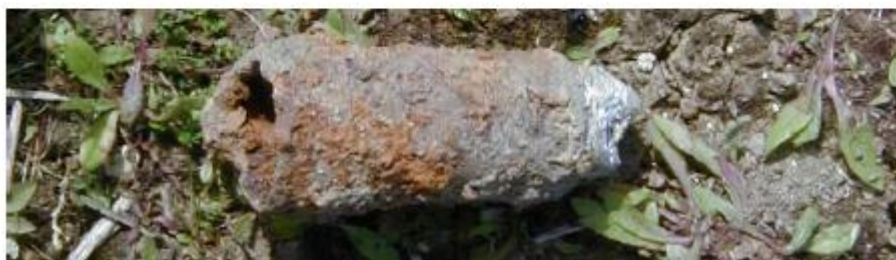
Description Pear-shaped steel body with vaned tail fin for stability in flight. Typically filled with high explosive or white phosphorus, the latter dispersing on detonation.

Function Range of up to 1,600 yards, the 3" mortar was used in an anti-personnel role.

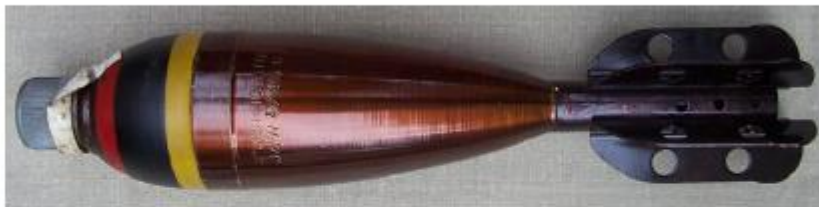
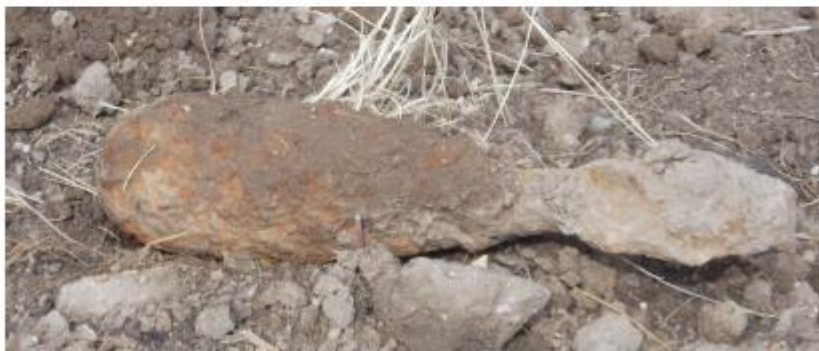
Description Steel casing and projectile with disintegrating belt links at centre and end. Typically a tetryl filling, with some incendiary versions.

Function Automatic cannon shell for use against ground targets and aircraft.

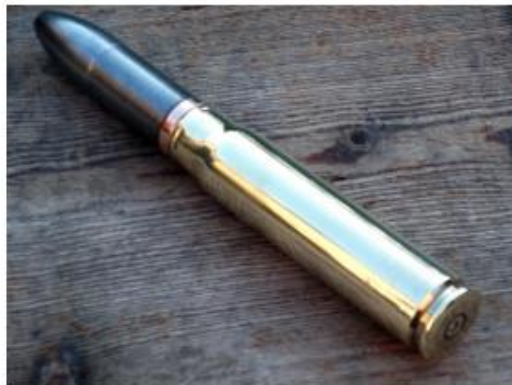
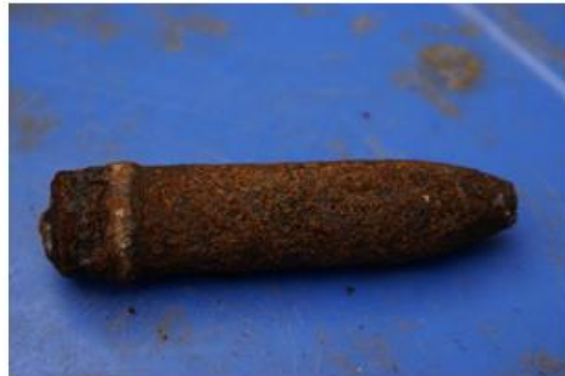
Description Steel-cased cartridge and projectile with copper expansion ring around base of projectile to allow release on firing.

Function Used as a rapid-fire defence against enemy aircraft, fired from fixed batteries and mobile mountings.

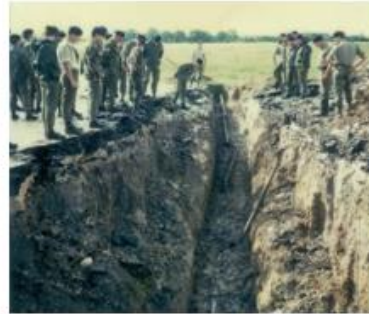
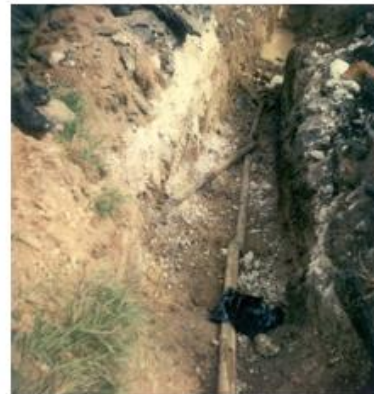
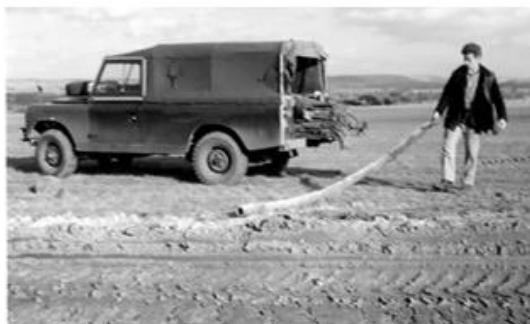
Description Often crudely made, pipe mines were bored, drilled or placed near-horizontally beneath critical infrastructure, such as airfield runways or roads. Usually in a grid pattern. The pipes were filled with nitro-glycerine or Polar Blasting Gelignite (PBG), over time these devices can become increasingly unstable. It is estimated that some 40,000 feet of pipe mines were installed across southern England alone.

Function Designed as an anti-tank weapon, but mainly saw use as a weapon to deny airfields to the enemy and to defend invasion pinch points.

Whilst the majority of the pipe mines at airfields were removed at the end of WWII, it is known that some were left in situ or were not detected during post-WWII clearance operations. Pipe mines are periodically found during development at former airfields.

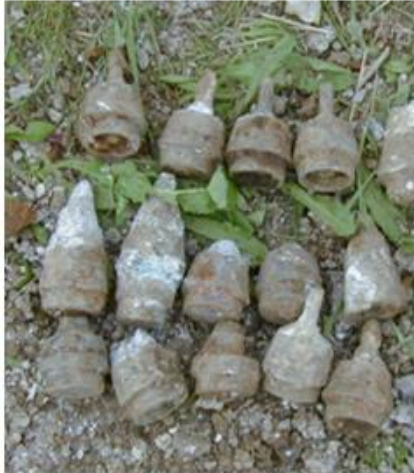
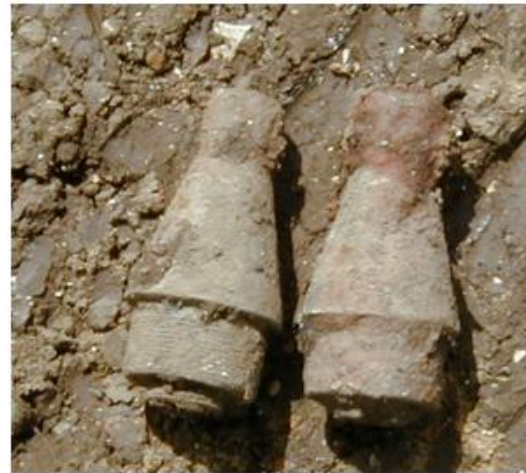
Information Data Sheet

Category Bomb Components
Type Fuzes, Gains and Detonators

Description Bomb components such as detonators, gaines, primers and fuzes typically contain some type of explosive charge to initiate the detonation of a munition. These components have numerous types, appearance and function depending on their intended use. They were stored in quantity at ammunition depots and operational airfields and are also likely to be found anywhere where munitions have been used or were intended to be used.

An indicative cross-section of components is pictured below, with some typical WWII fuzes above.

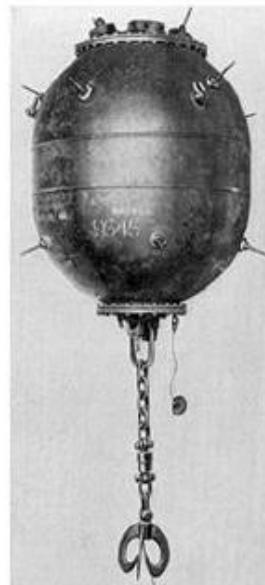
The MK XVII was the most commonly used British naval mine, and could be moored in waters up to 915m depth.

It was a moored contact mine which was frequently used in defensive minefields within UK territorial waters.
