Lower Thames Crossing
6.3 Environmental Statement
Appendices
Appendix 10.10 – Unexploded
Ordnance (UXO) Desk Study &
Risk Assessment

Lower Thames Crossing - UXO Desk Study & Risk Assessment

Document Title UXO Desk Study & Risk Assessment
Document Ref. HE540039-ZET-GEN-GEN-REP-GEO-00001
Revision 5
Project Location Lower Thames Crossing
Client Arcadis/National Highways
Date 11th October 2022

UXO DESK STUDY & RISK ASSESSMENT

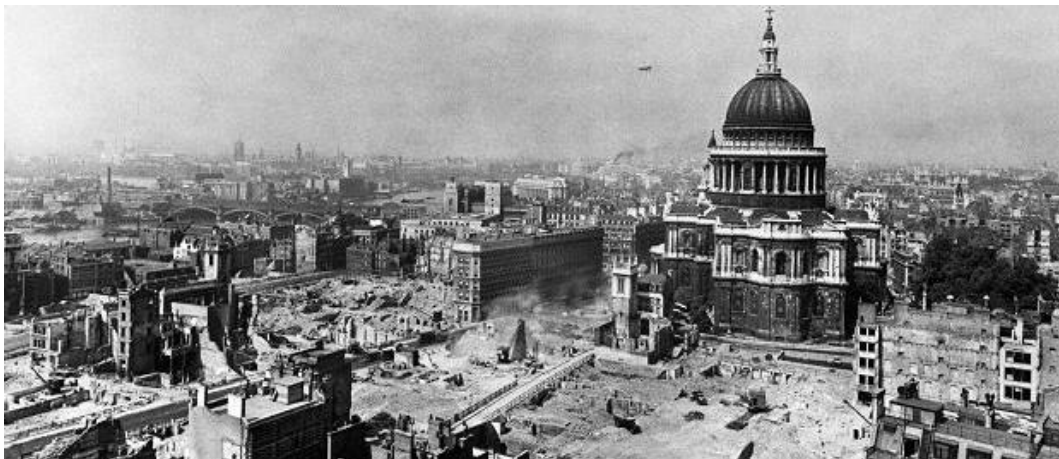
Incendiary devices ranged from small 1kg thermite filled, magnesium bodied Incendiary Bombs (IBs) to a 250kg 'Oil Bomb' (OB) and a 500kg 'C300' IB. In some cases the IBs were fitted with a bursting charge. This exploded after the bomb had been alight for a few minutes causing burning debris to be scattered over a greater area. The C300 bombs were similar in appearance to 500kg HE bombs, although their design was sufficiently different to warrant a specially trained unit of the Royal Engineers to deal with their disposal.

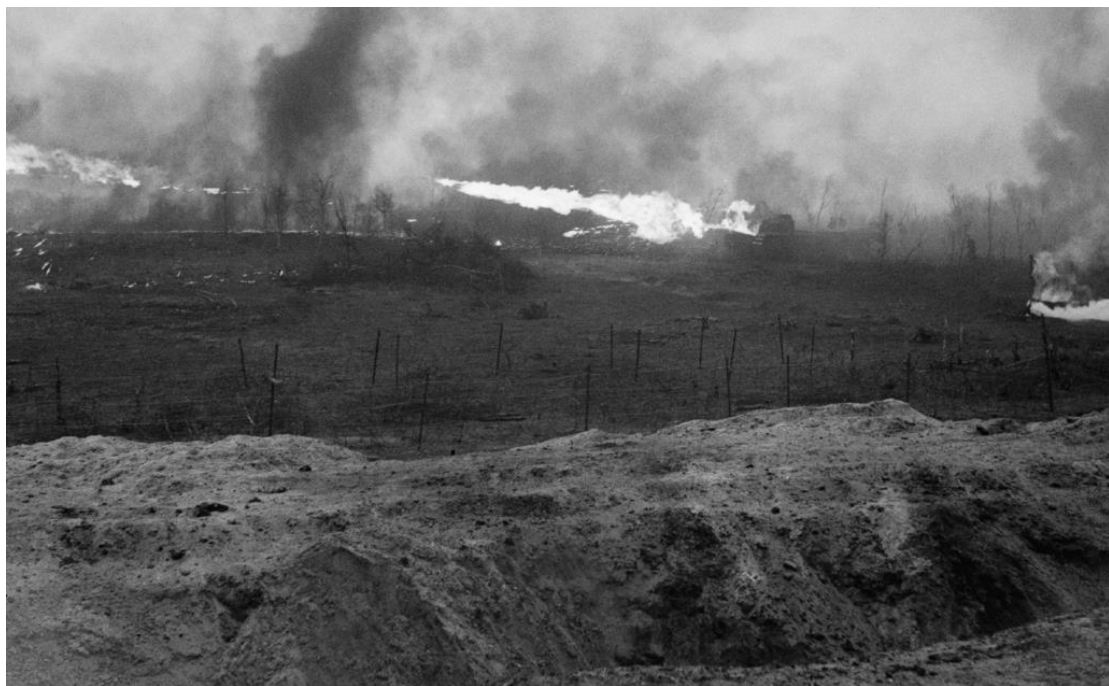
Testing flamethrowers at a WWII Battle Training Area

The types of UXO that could be present at former military training areas varies depending on their operational history. Ordnance used during exercises ranged from small arms ammunition to grenades, defensive mines, mortars and shells, and unconventional weapons such as flamethrowers.

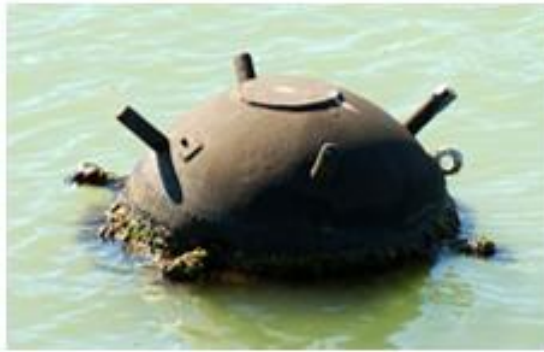
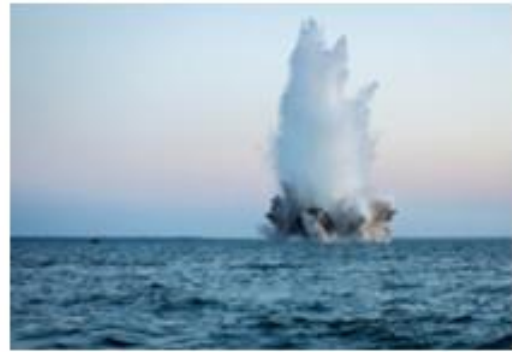
Both wartime and peace time military and naval activities provide numerous sources of UXO within the marine environment. In addition to coastal and offshore artillery and bombing ranges, the principal sources of marine UXO hazards are from ordnance disposal at sea; aerial or ship laid mines, depth charges and torpedoes; projectiles, shells and bombs left in battle conflict zones; mines laid as beach defences; crashed aircraft and wrecks containing ordnance.

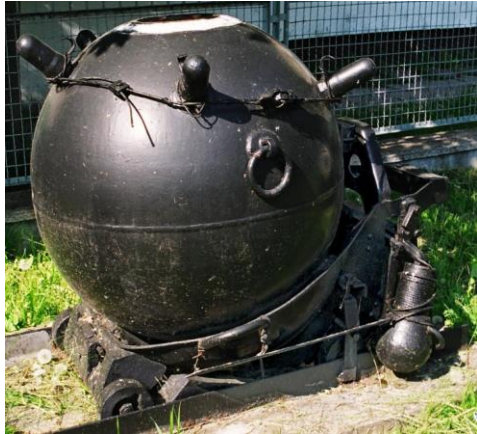
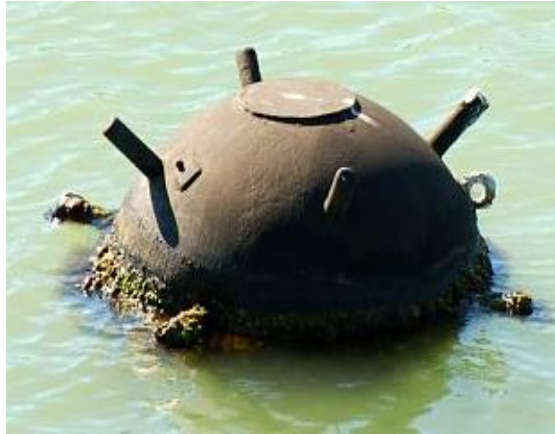
Marine mines typically carried 100 to 500lbs (50 to 250kg) of explosive. They were detonated by contact (being struck) or by influence (a vessel interfering with the mine's electromagnetic field).

Marine mines deployed during WWI were mostly activated by contact mechanisms, those during WWII were activated by either contact or influence mechanisms, or a combination of both.

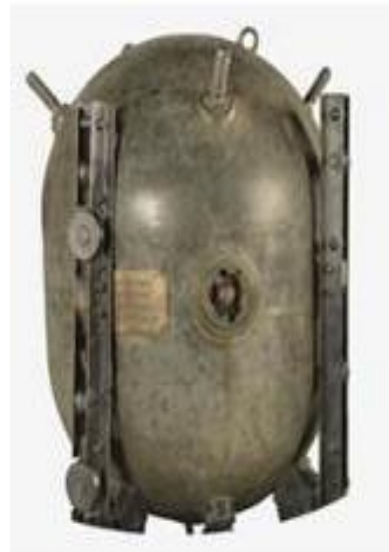
German ground mines (Luftmine) were air-deployed naval mines which were also modified for deployment from submarines and surface craft. Although primarily designed to lie on the seabed, many were also moored or buoyant. Designed as an anti-shipping weapon, the WWII Luftmine was also often used on land based targets.

Luftmines typically comprised a cylindrical body with a hemispherical nose and tapered tail, with charges weighing between 675lbs and 1,500lbs (305 to 680kg).

Some German marine mines were composed of aluminium or manganese steel depending on the variant, whereas British mines were typically made of steel
