Lower Thames Crossing

Appendix 10.3 - Site Walkover Factual Report

DATE: October 2022

Planning Inspectorate Scheme Ref: TR010032
Application Document Ref: TR010032/APP/6.3

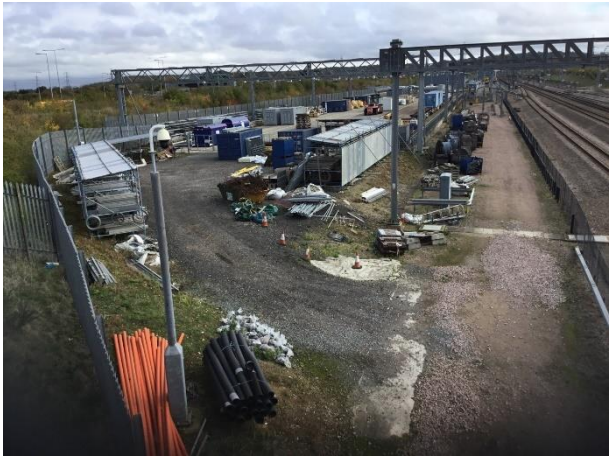
Area name	Site/location description	Photographs	ID
<p>A2 Trunk Road and surroundings (Area 1)</p>	<p>Singlewell infrastructure maintenance is on the HS1 between Church Road and the A2. The depot appears to be used for the maintenance of trains. Materials (such as large cable reels, scrap metal, scaffolding poles, railway sleepers and plastic piping) and waste storage were noted along with electricity transformers and potential tank-like structures.</p>

<p>Photo taken from public footpath (bridge over the high-speed rail line), looking east.</p>	<p>1.1</p>
	<p>Fly-tipped waste noted in hedge by public footpath comprising construction waste, insulation, plastic, foam and polystyrene.</p>

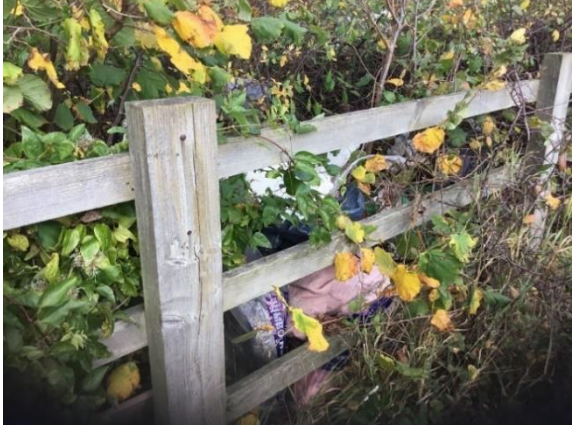
<p>Fly-tipping viewed from public road, looking north.</p>	<p>1.2</p>
	<p>Highway maintenance depot between Henhurst Road and the A2. Storage of vehicles and materials (such as aggregate and scaffolding poles) were noted.</p>

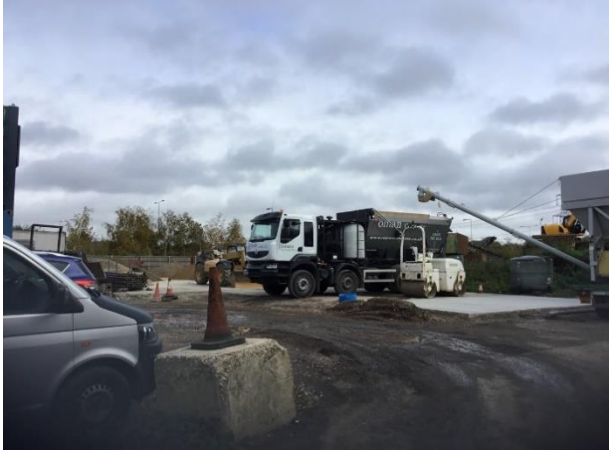
<p>Viewed from public footpath, looking north.</p>	<p>1.3</p>

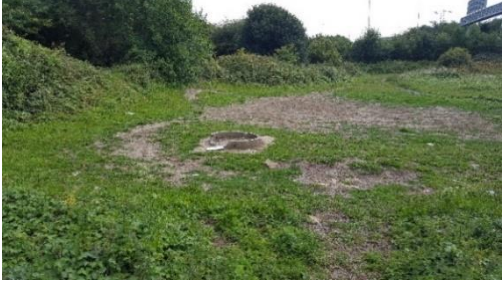
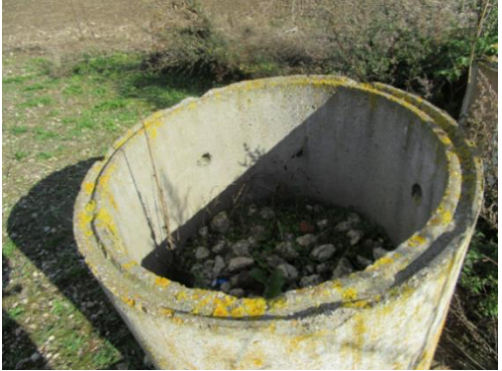
Area name	Site/location description	Photographs	ID
<p>A2 Trunk Road and surroundings (Area 1)</p>	<p>Fly-tipping of discarded concrete rings and made ground (presence of man-made material) was noted immediately north of the A2.</p>

<p>Precast concrete drainage piping.</p>

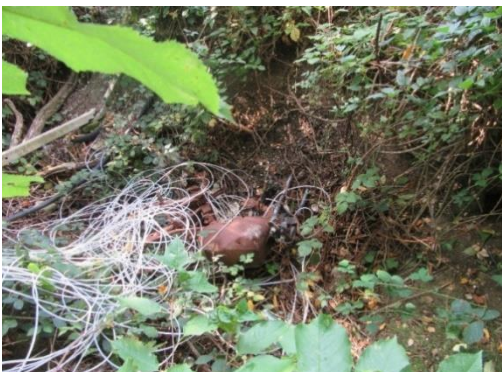
<p>Fly-tipping (plastic tubing and metal) was noted in a ditch at the southern end of the former Gravesend airport.</p> <p>Fly-tipping was also noted at two locations along a footpath that runs through Claylane Wood towards the A2.</p>	<p>1.4</p>

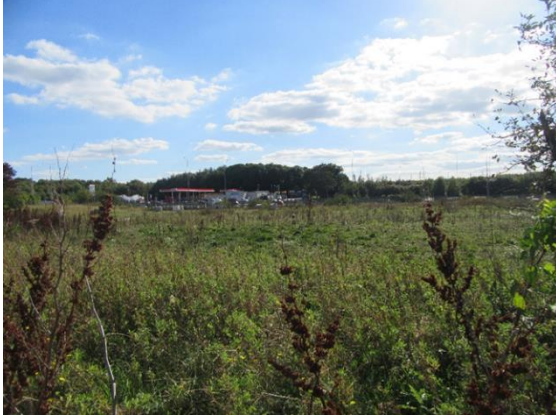
Area name	Site/location description	Photographs	ID
<p>A2 Trunk Road and surroundings (Area 1)</p>	<p>Former petrol filling station adjacent to north of A2.</p>	<p>Seen from the former Gravesend Airport land to the north. The former petrol station appeared overgrown, with all visible above ground infrastructure removed.</p>

<p>Former petrol station, viewed from the north. Current Esso Petrol station is in the background.</p>	<p>1.7</p>
	<p>Shorne Woods Country Park. The site is now a country park which comprises predominantly woodland with ponds, a visitor centre and car park. The land was previously used as a quarry, which included clay pits and associated infrastructure. It is understood that the former clay pits are now ponds. No visible evidence of the former clay mining infrastructure was seen.</p>

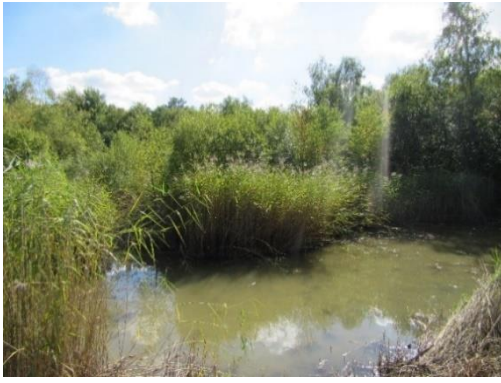
<p>Former clay pit, now a pond.</p>

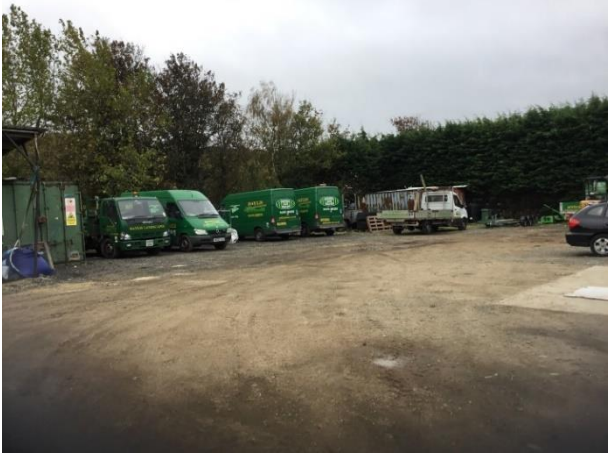
Area name	Site/location description	Photographs	ID
	<p>The southern part of the site comprises vehicle storage (not on hardstanding) and a workshop for vehicle and equipment maintenance.</p>

<p>Vehicle storage area viewed from the north-west.</p>	2.3
	<p>Red and white diesel storage tanks (5,400 and 1,500 litres) were sited on hardstanding. A stained metal oil can was noted adjacent to the tanks (possibly used for topping up vehicles). There was evidence of oil staining on the hardstanding floor and an oil-stained blanket (possibly used to mop up spills).</p>

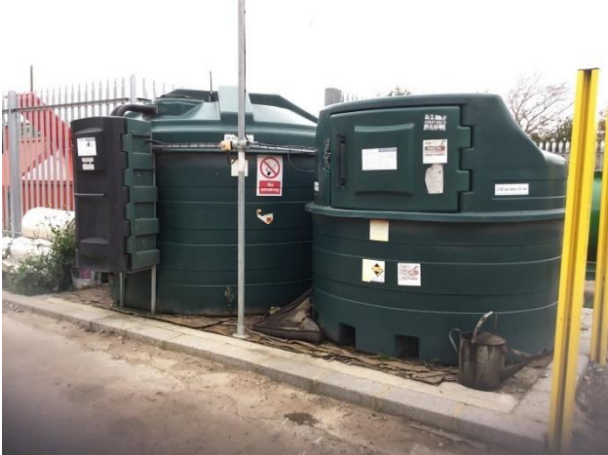
<p>Fuel tanks viewed from the south.</p>	2.4
	<p>Waste skips noted for general waste and recyclables. Scattered waste (such as artificial turf and plastic) was noted outside the skips.</p>	  <p>Skips viewed from the north.</p>	2.5

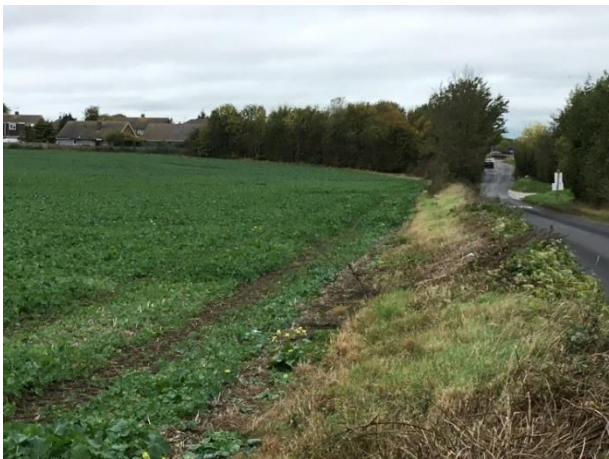
Area name	Site/location description	Photographs	ID
<p>Former quarries on the western side of Thong Lane (Area 3)</p>	<p>No evidence was identified of the two former quarries identified from historical mapping. The land is arable farmland with a small area of scrub woodland in the northern corner of the field.</p>

<p>Viewed from side of public road (Thong Lane), looking north.</p>	<p>3.1</p>
<p>Southern Valley Golf Club on the eastern side of Thong Lane (Area 4)</p>	<p>The golf course comprises landscaped areas, electricity pylons and overhead power lines, a public footpath and existing boreholes that irrigate the site. According to anecdotal evidence, made ground and fill associated with the construction of Bluewater Shopping Centre was used to form the landscaped mounds.</p>

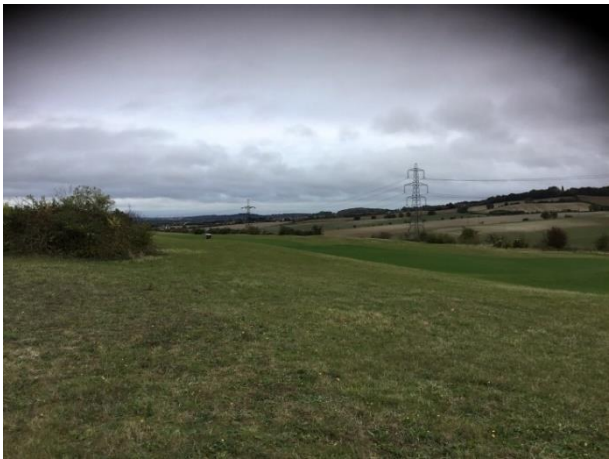
<p>Southern end of the golf course, looking north-east.</p>	<p>4.1</p>

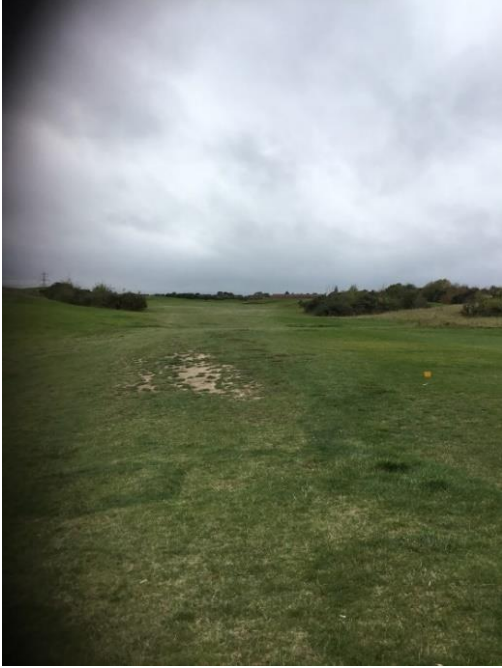
Area name	Site/location description	Photographs	ID
<p>Southern Valley Golf Club on the eastern side of Thong Lane (Area 4)</p>	<p>According to anecdotal evidence, the north-eastern side of the golf course was an airfield during WWII, but all ordnance was cleared when the site was developed into a golf course circa 1990. No evidence of the former airfield was apparent apart from a relatively level area that used to be the runway. There is a gas tank and waste storage compound to the north-west of the clubhouse.</p>

<p>Location of former airfield, looking south-west.</p>	<p>4.2</p>

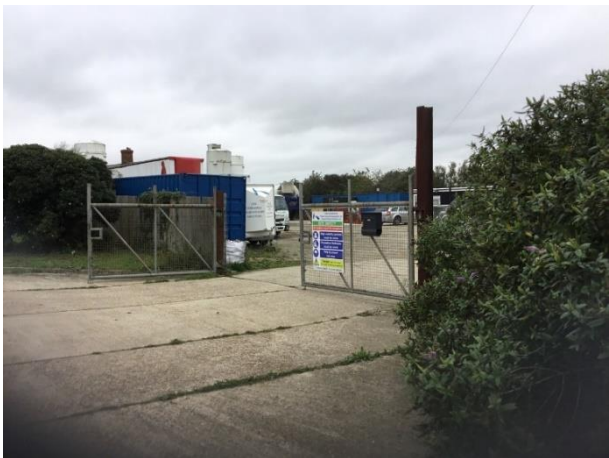
Area name	Site/location description	Photographs	ID
Lower Higham Road (Area 5)	Foam concrete works on Lower Higham Road, which is the location of Filborough Farm (a former historical landfill site).

<p data-bbox="683 752 1198 819">Photo taken from Lower Higham Road, looking north.</p>	5.2
	Fly-tipped construction waste was noted on a footpath to the west of the concrete works, comprising concrete, plastic, tiles, metal and ash.

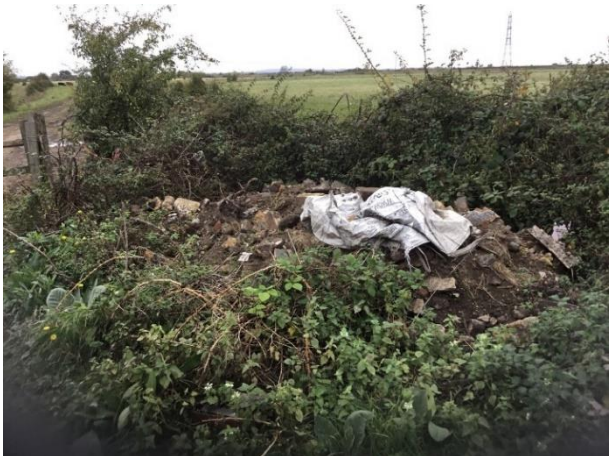
<p data-bbox="683 1296 1305 1364">Photo taken from public footpath, looking north-east.</p>	5.3
	Former gravel pit adjacent to the north of Lower Higham Road (seen from offsite). Apart from a shallow depression in the ground surface, no evidence of the former gravel pit was identified.

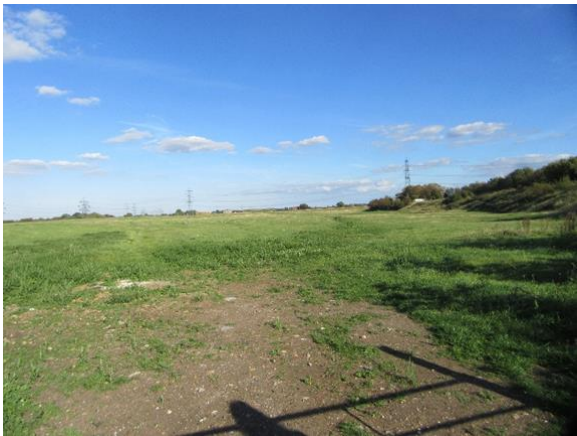
<p data-bbox="683 1821 1222 1888">Former gravel pit at Lower Higham Road (viewed from offsite).</p>	5.4

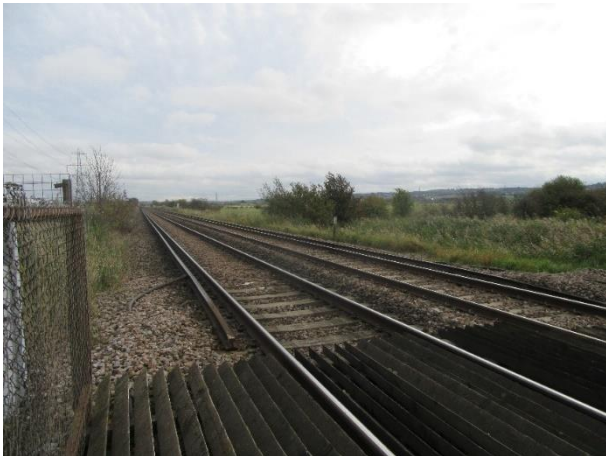
<p data-bbox="683 1079 1292 1146">North Kent Railway Line viewed from a public crossing point.</p>	7.1
	The canal is overgrown with vegetation and potentially infilled at the eastern end.

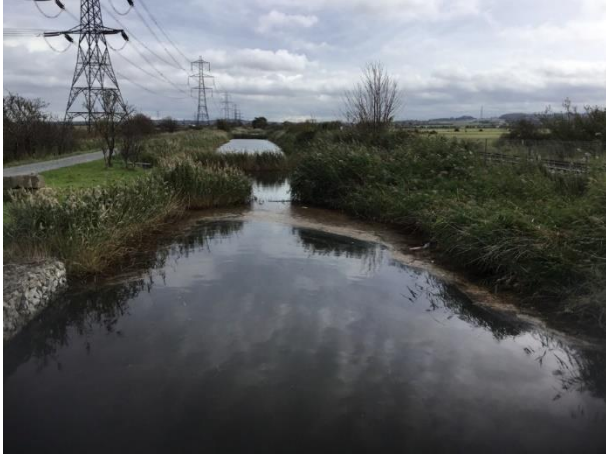
<p data-bbox="683 1628 1292 1724">Thames and Medway Canal, looking east. Shorne Marshes is in the background to the right.</p>	7.2

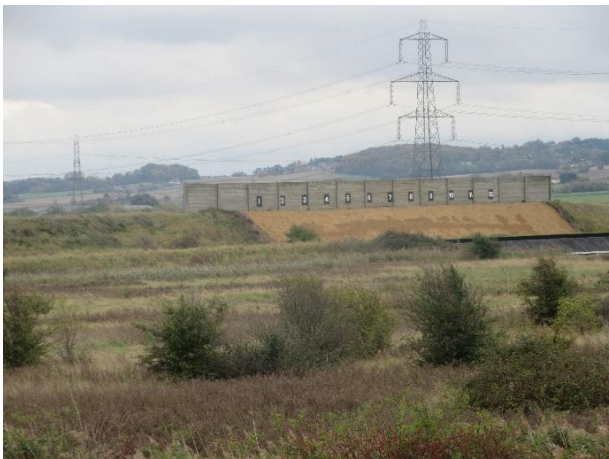
Area name	Site/location description	Photographs	ID
<p>Milton Rifle Range – adjacent to south of River Thames (Area 8)</p>	<p>The periphery of the rifle range comprises scrub and rough grassland. The central area forms the ‘firing range floor’, comprising short grass and a series of raised mounds at approximately 100m intervals. The range is orientated east to west, firing towards a brick target butt in the east of the site.</p> <p>A designated watercourse runs approximately east-west along the southern area of the site, which is fed by a series of internal drainage ditches.</p> <p>The site is enclosed with a chain link fence, with locked access gates in the south-west corner.</p>

<p>Photo taken from a public footpath, looking south-east towards the firing range.</p>	<p>8.1</p>
<p>Adjacent to east/north-east of Milton Rifle Range (Area 9)</p>	<p>Several drainage ditches with sluice gates are present around Milton Rifle Range.</p>

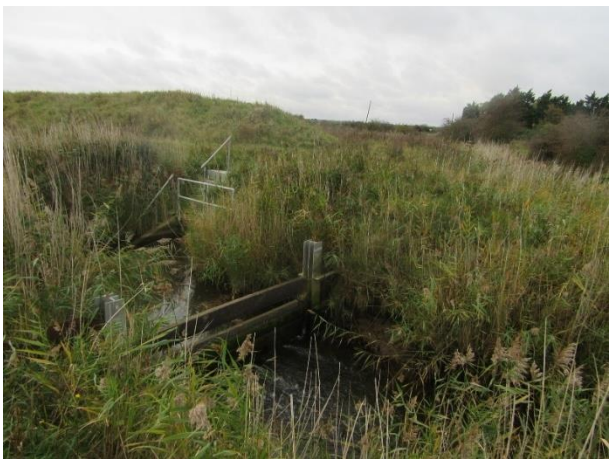
<p>Surface water channel viewed from a public footpath, looking south-west.</p>	<p>9.1</p>

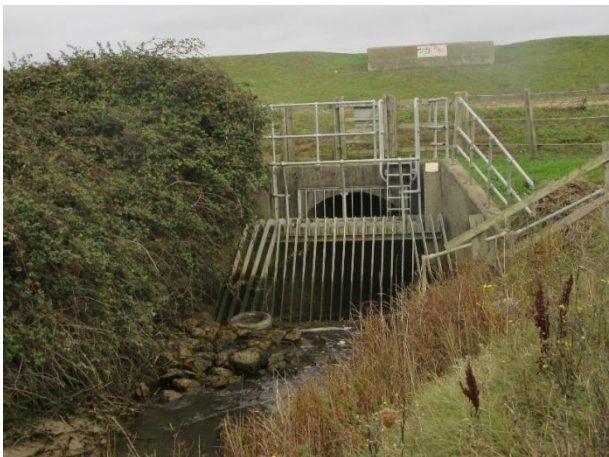
Area name	Site/location description	Photographs	ID
<p>Adjacent to east/north-east of Milton Rifle Range (Area 9)</p>	<p>The drainage ditches appear to discharge into the River Thames via an outfall.</p>

<p>Surface water outfall into the River Thames viewed from a public footpath, looking north.</p>	<p>9.2</p>
	<p>Large electricity substation adjacent to the west of Milton Rifle Range with hardstanding/gravel floor, brick building, pylons and electricity transformers.</p>

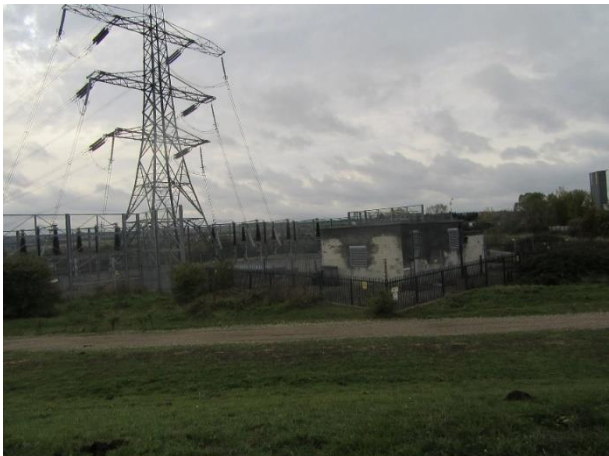
<p>Photo taken from a public footpath, looking south-west.</p>	<p>9.3</p>

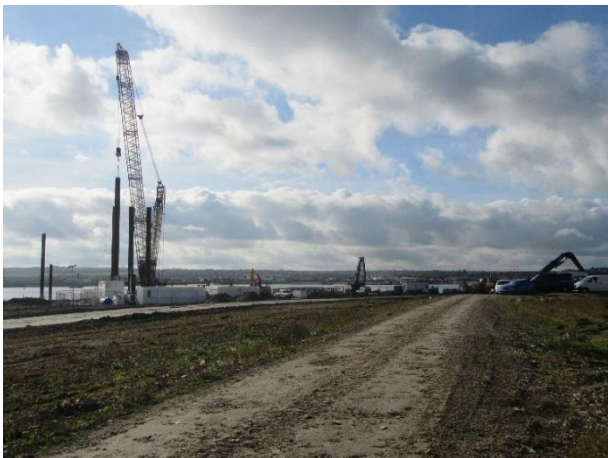
Area name	Site/location description	Photographs	ID
<p>Ingrebourne Valley land raise area and RWE/Tilbury Power Station – adjacent to north of River Thames (Area 10)</p>	<p>The site also comprises a north-east to south-west haul road. There is a public footpath that runs parallel to the northern bank of the River Thames. A construction project was being carried out on the northern bank of the River Thames (southern side of the land raise area).</p>

<p>Construction project and haul road viewed from the north,</p>	<p>10.2</p>
	<p>Man-made valley present at the eastern edge of the land raise area which serves as habitat to amphibians and reptiles relocated from various parts of the site. It was estimated to be up to 40m wide at the time of the walkover survey.</p>

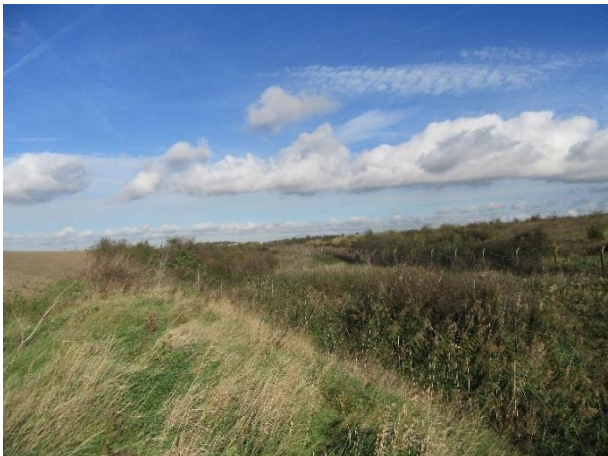
<p>Man-made valley at the eastern edge of land raise area, looking north.</p>	<p>10.3</p>
	<p>Area of PFA landfilling from adjacent Tilbury Power Station (now demolished). The northerly area was capped and vegetated with small hummocks/mounds. The southerly area was landscaped with small hummocks to provide reptile habitats.</p>

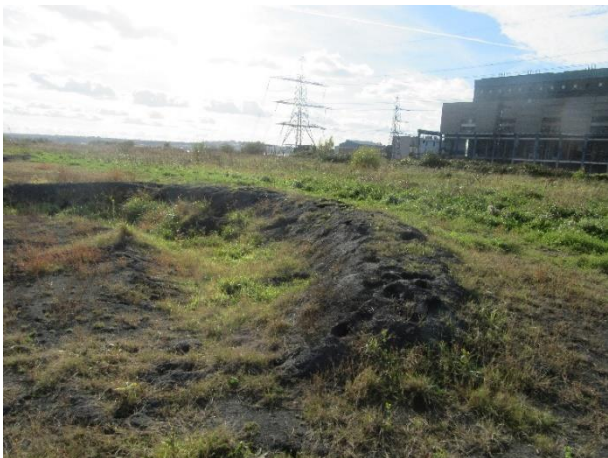
<p>Landscaped reptile habitat on PFA landfill, looking south-west.</p>	<p>10.4</p>

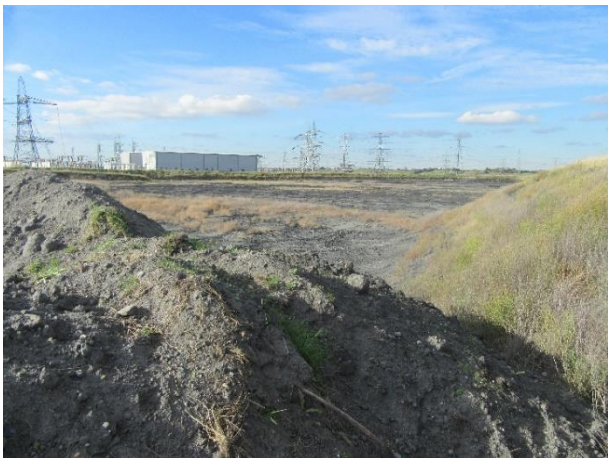
Area name	Site/location description	Photographs	ID
Ingrebourne Valley land raise area and RWE/Tilbury Power Station – adjacent to north of River Thames (Area 10)	Area of Tilbury Ash Disposal landfill (PFA landfill) to the north of the power station (now demolished), which had been mined for construction materials.

<p>Area of PFA mining/land stripping looking, north-east.</p>	10.5
	Waterlogged area of landfill, which had been used for PFA aggregate storage.

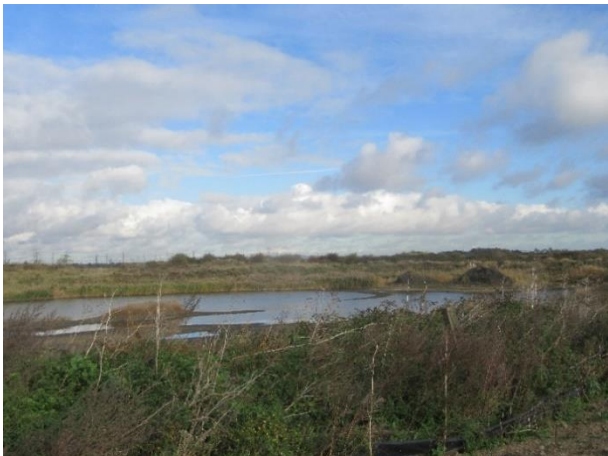
<p>Waterlogged former PFA storage area, looking north.</p>	10.6
	Surface drainage ditches noted between land raise area and the RWE site. The water appeared to be stagnant and discoloured.

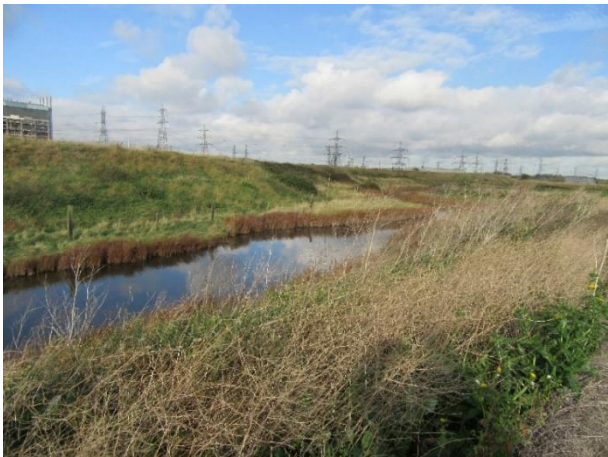
<p>Surface water channel, looking north.</p>	10.7

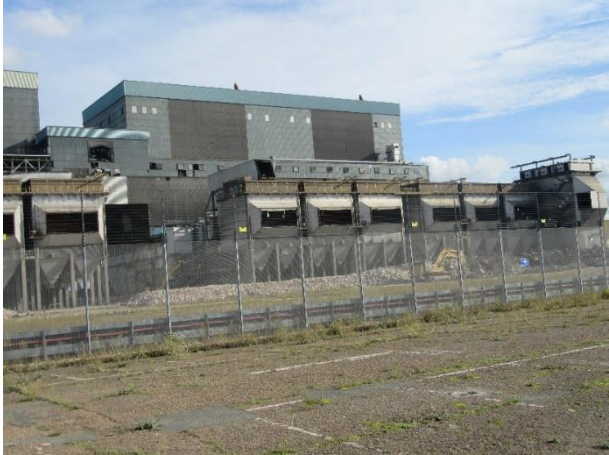
Area name	Site/location description	Photographs	ID
<p>Ingrebourne Valley land raise area and RWE/Tilbury Power Station – adjacent to north of River Thames (Area 10)</p>	<p>The former Tilbury Power Station buildings were in the process of being demolished. Large piles of metal, concrete and demolition waste, heavy machinery and demolition compounds were present.</p> <p>Former coal storage area and National Grid substation area adjacent to the north of the power station.</p>

<p>Photo shows partially dismantled Tilbury Power Station (now demolished), viewed from the west, looking east.</p>	<p>10.8</p>

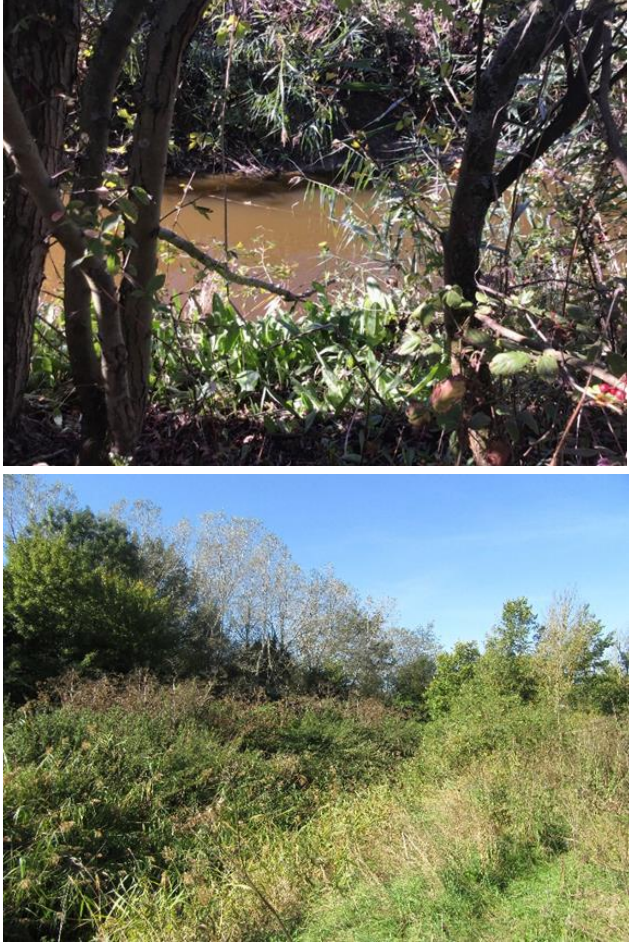
Area name	Site/location description	Photographs	ID
<p>Ingrebourne Valley land raise area and RWE/Tilbury Power Station – adjacent to north of River Thames (Area 10)</p>	<p>Former chalk pit and gun battery (defensive installation), (East Tilbury). No evidence of the former gun battery or chalk pit remaining apart from a raised bank which was very overgrown and surrounded by a water-filled ditch.</p>

<p>Overgrown mound – potentially the former gun battery.</p>	<p>10.10</p>

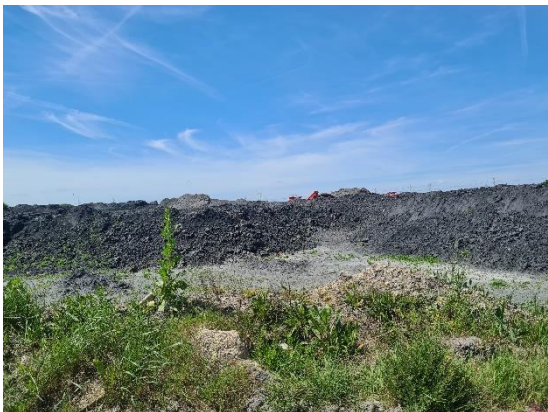
<p>Working stockpile area to the west of the IVL site</p>

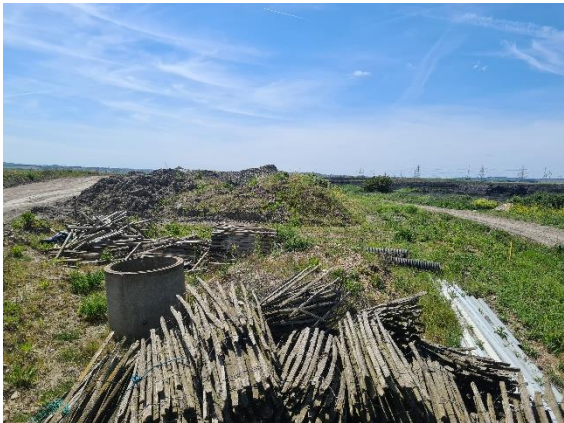
<p>Piles of stored or waste wood bundles and concrete rings next to main haul road</p>

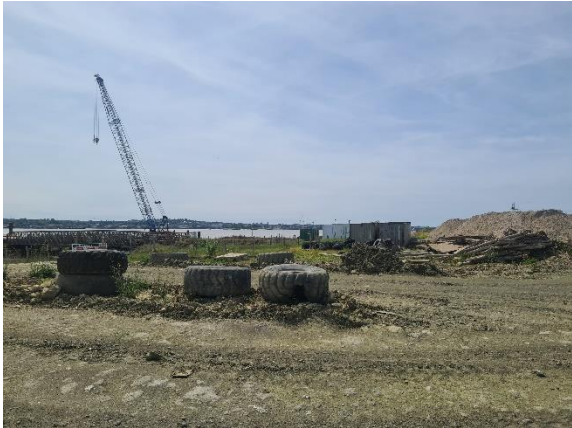
<p>Informal compound and loading dock on the edge of the raised area</p>	<p>10.11</p>

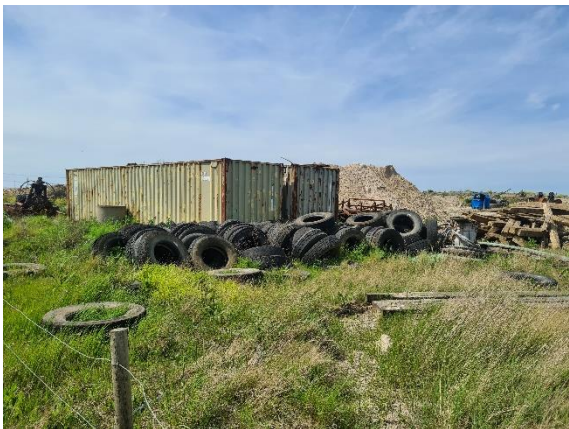
<p>Shipping containers onshore from the dock area used for storage – one marked as containing oil surrounded by waste tyres and wood pallets.</p>

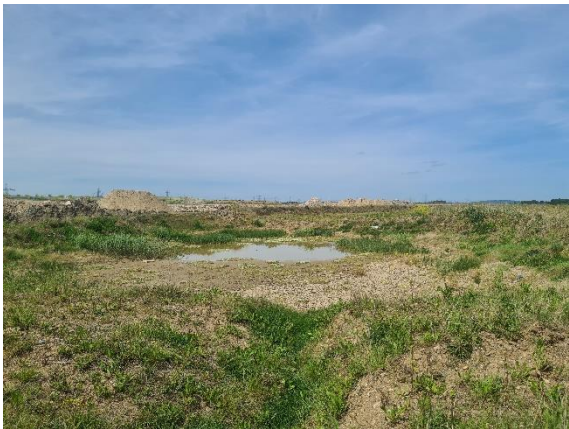
<p>Small waterlogged area of the raised land close to the the southwest corner of Goshem's Farm</p>

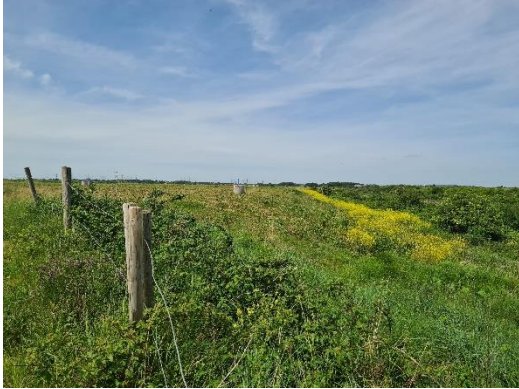
<p>View of eastern edge of Goshem's Farm raised area and monitoring boreholes.</p>

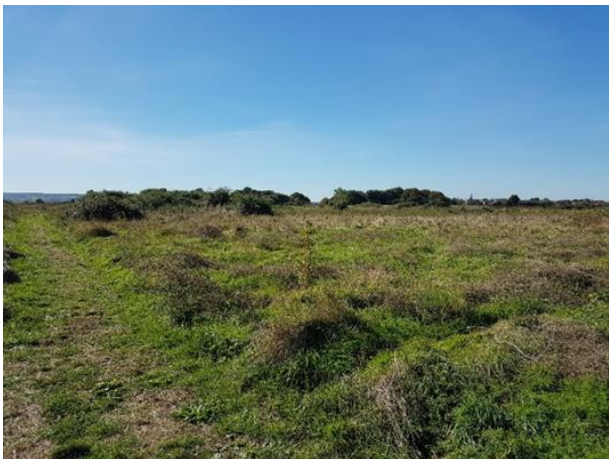
Area name	Site/location description	Photographs	ID
<p>Saltings Landfill (Area 11)</p>	<p>Saltings Landfill East Tilbury (adjacent to the north of Coalhouse Fort). The landfill is now a designated wildlife site (Site of Special Scientific Interest (SSSI)/Special Protection Area (SPA)/Special Area of Conservation (SAC)) and local nature reserve, which is part of the Coalhouse Fort estate. The site manager stated that the landfill bund was constructed from sacks of mud and silt. The landfill used to receive dredging waste from the River Thames, but has long since dried up and re-vegetated into rough grassland and scrub. Several protected plant, insect and bird species were stated to be present.</p>

<p>Typical rough grassland vegetation covering the former Saltings Landfill.</p>

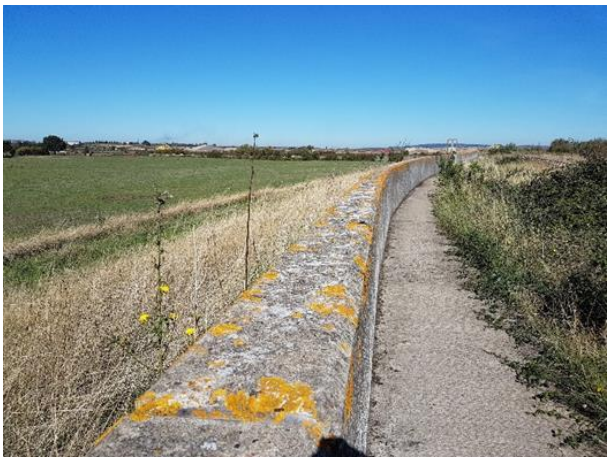
<p>Flood defence wall along the western boundary of the landfill site.</p>	<p>11.1</p>

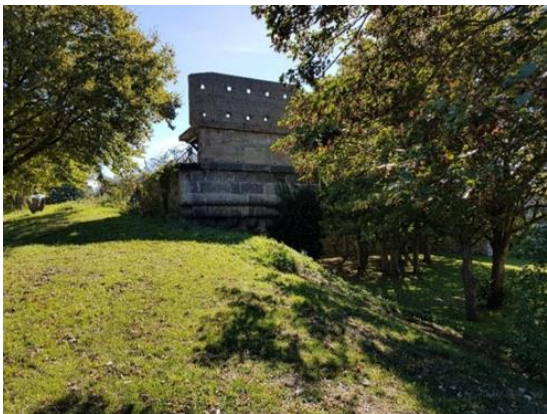
Area name	Site/location description	Photographs	ID
<p>Coalhouse Fort (Area 12)</p>	<p>The fort was stated to be from the late Victorian era, with WWII fortifications. The fort is surrounded by parkland and rough grassland/marshland. Parts of the site have scheduled monument status for military heritage. At the time of the site visit, the Victorian fort was undergoing repairs to the roof.</p>

<p>Part of the original fort, which is under repair.</p>

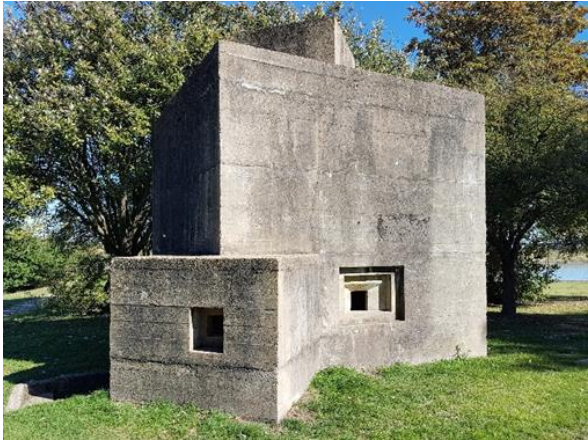
<p>Part of the WWII fortifications.</p>	<p>12.1</p>

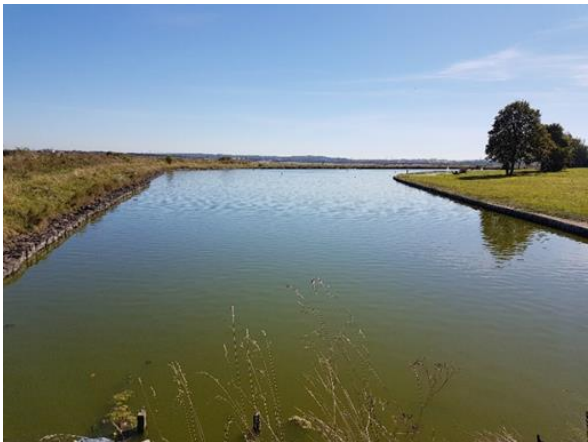
<p>There is a moat and boating lake around the east side of the fort.</p>	<p>12.2</p>

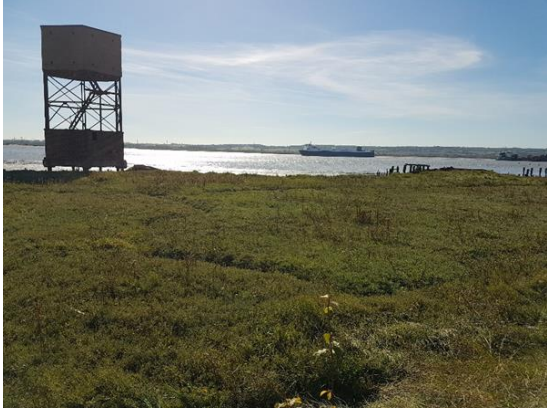
<p data-bbox="683 707 1283 808">WWII radio tower on marshland at Coalhouse Fort (part of the scheduled monument designation of the site).</p>

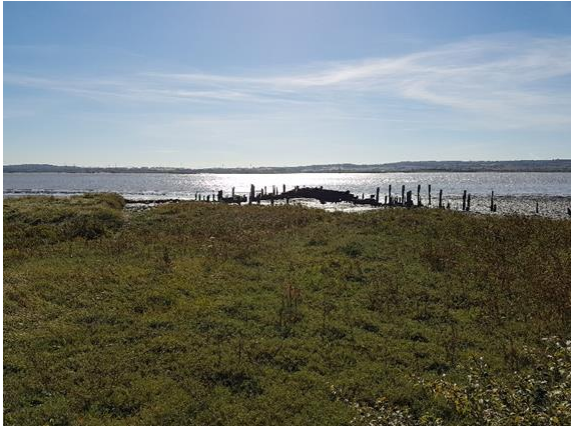
<p data-bbox="683 1247 1283 1319">Former jetty at Coalhouse Fort (part of the scheduled monument designation of the site).</p>	12.3

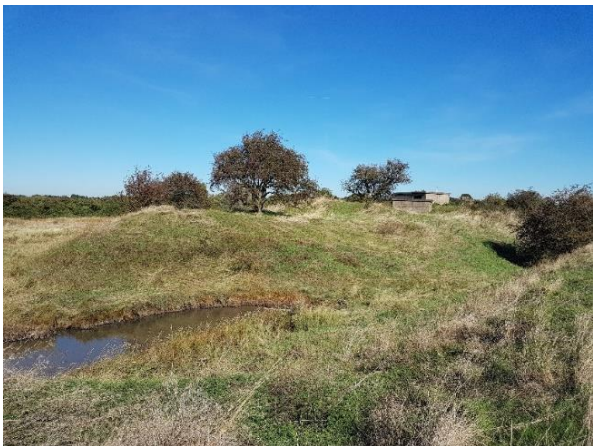
<p data-bbox="683 745 1257 846">Part of the moat system (in the foreground), with former Victorian quickfire battery and searchlight building (in the background).</p>

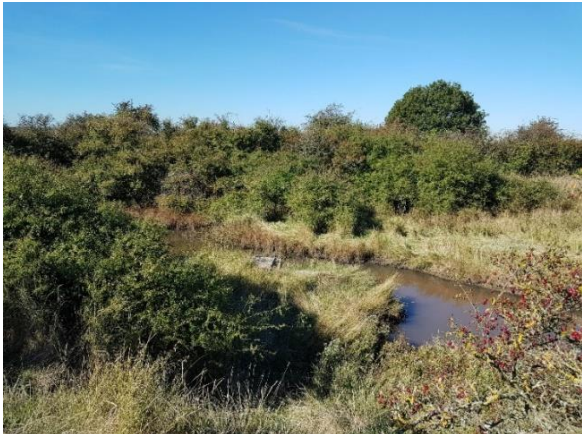
<p data-bbox="683 1310 1203 1377">Former sewage infrastructure (pumping chamber). which is no longer in use.</p>	12.4

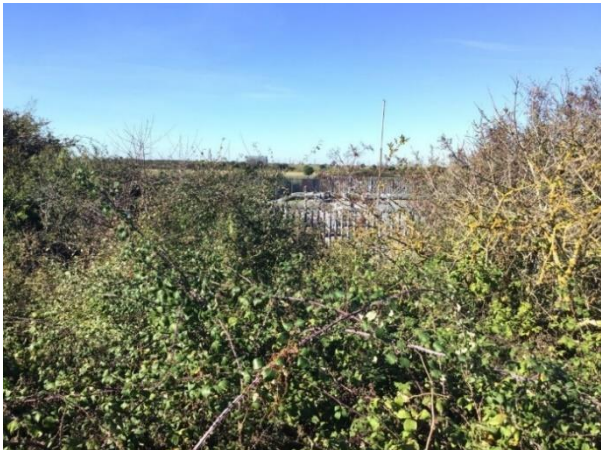
<p data-bbox="683 1859 1300 2027">Gas valve compound at Coalhouse Fort. There is a gas pipeline from the gas compound passing in a southerly direction under the Thames and in a north-westerly direction beneath fields.</p>	12.5

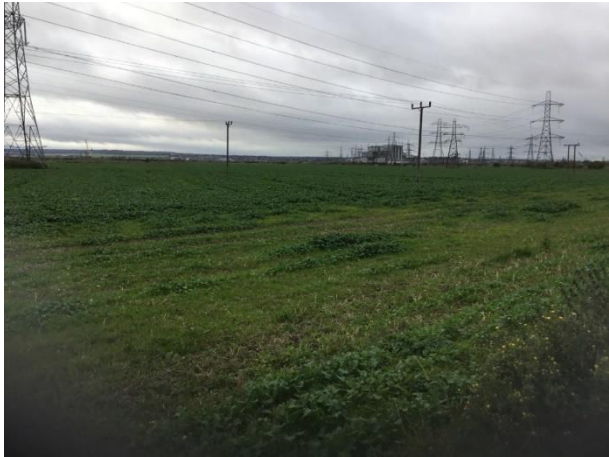
<p>Cole land, looking south-west.</p>	<p>13.1</p>
<p>Cole land (Area 13)</p>	<p>Railway line that bisects Cole land.</p>

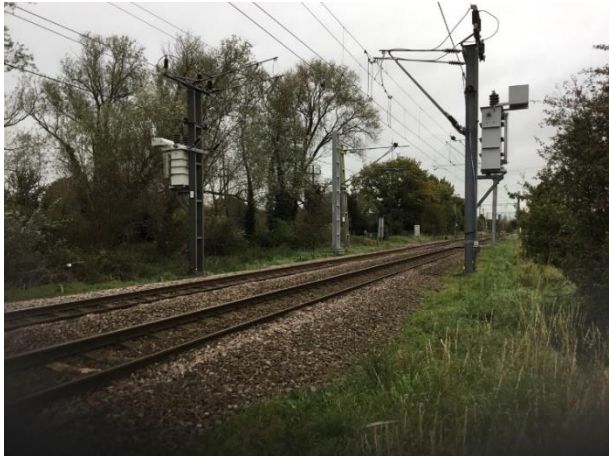
<p>Railway line bisecting Cole land, looking north-east.</p>	<p>13.2</p>

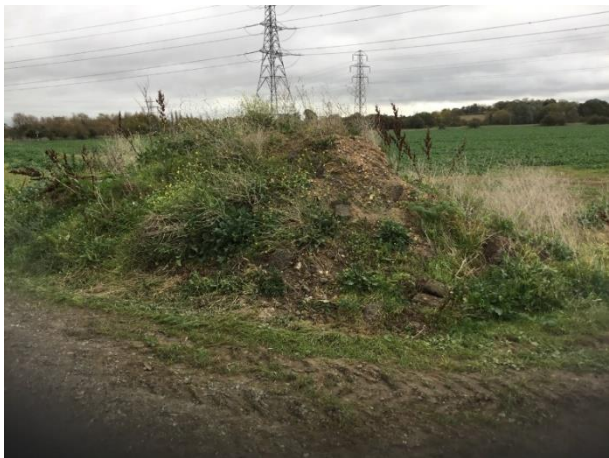
Area name	Site/location description	Photographs	ID
Cole land (Area 13)	A stockpile of soil was noted on Cole land at the side of the railway tracks, along with railway sleepers, wooden pallets and rubber matting.

<p data-bbox="619 748 1267 786">Stockpile of soil on Cole land, looking south-east.</p>	13.3
	There is a pond on Cole land which, according to anecdotal evidence, is groundwater fed.	No photo available.	13.4
	There is a small active sand and gravel extraction quarry to the north of Muckingford Road on Cole land.

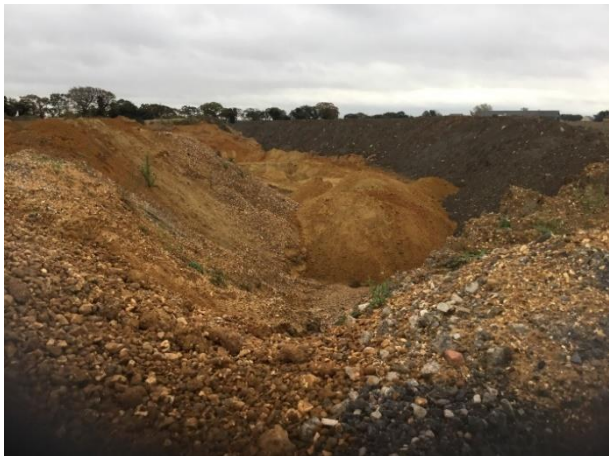
<p data-bbox="619 1545 1075 1583">Sand and gravel extraction quarry.</p>	13.5

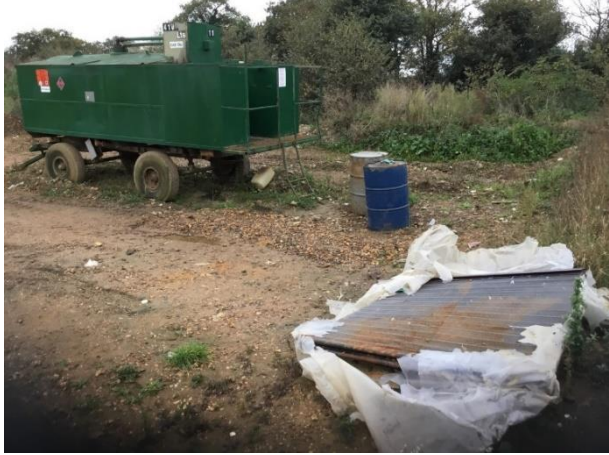
Area name	Site/location description	Photographs	ID
<p>Cole land (Area 13)</p>	<p>On the north-western edge of the quarry there is a derelict house, shipping container, large fuel tank and drums of engine oil unbanded and on bare ground. There was a skip containing plastic waste and scattered metal waste.</p>

<p>Large fuel tank, viewed from the east.</p>

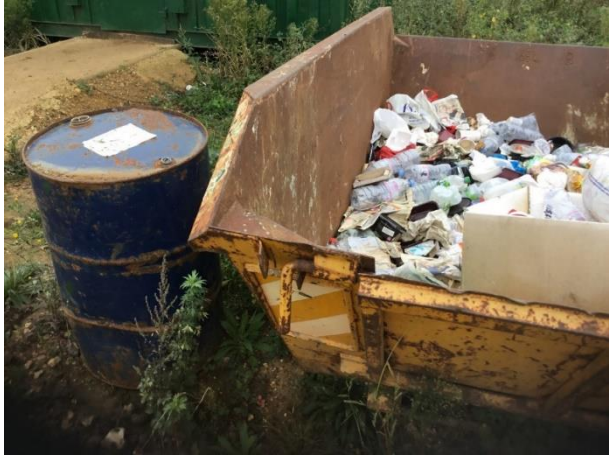
<p>Fuel drums and waste skip, viewed from the east.</p>	<p>13.6</p>
<p>Gun Hill – Potential LGS</p>	<p>View of Gun Hill taken from the road, with geological exposure evident to the north (first photo).</p>

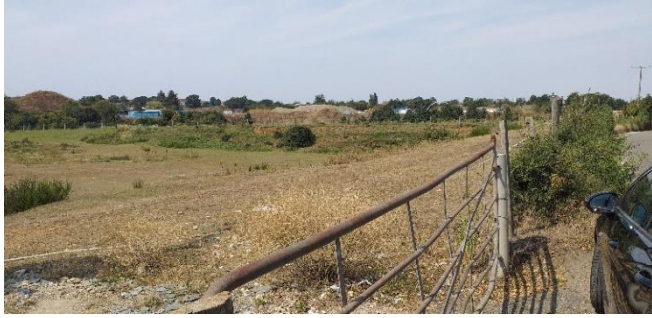
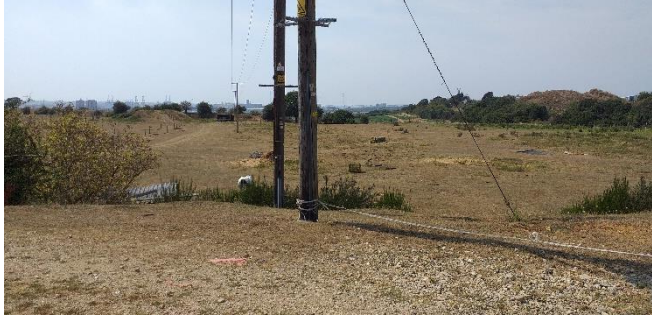
<p>13.7</p>

<p>Geological exposure of Gun Hill</p>

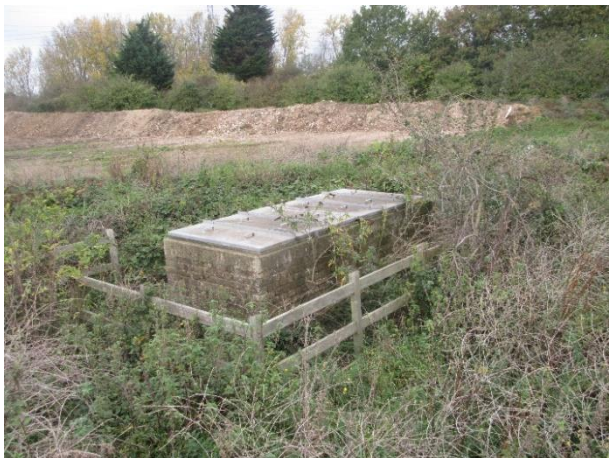
Area name	Site/location description	Photographs	ID
<p>Low Street former landfill (and EMR scrapyards) (Area 14)</p>	<p>Two boreholes onsite in brick housing which, according to anecdotal evidence, were used to supply water to the Tilbury Power Station. It was stated that there are below-ground water pipes and electrical cables beneath the site.</p>

<p>Brick housing for borehole onsite, viewed from the north.</p>	<p>14.1</p>
	<p>Small brick building on the north-western edge of the site, which appeared to be a substation for the adjacent railway or a pumping station.</p>

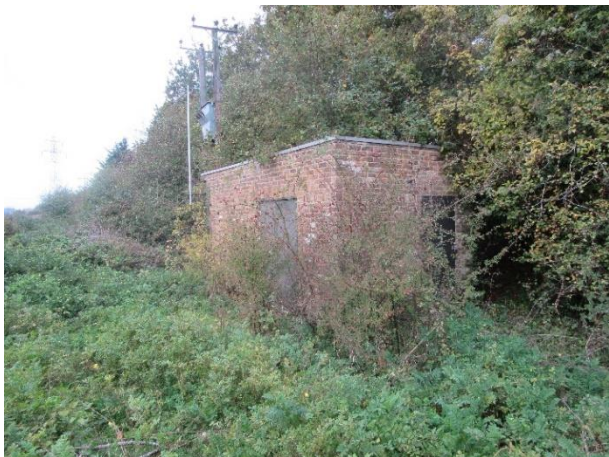
<p>Brick building onsite, viewed from the north-east.</p>	
	<p>The EMR scrapyards are adjacent to the east of the former Low Street landfill site. The scrapyards currently process and recycle scrap metal from local activities such as the dismantling of Tilbury Power Station.</p>

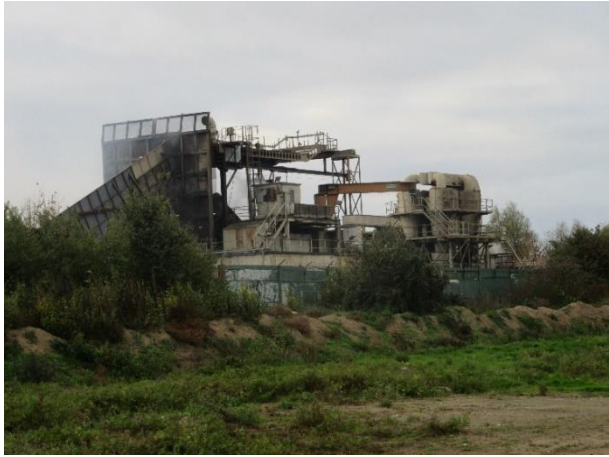
<p>EMR scrapyards viewed from the north-west (formerly the Low Street landfill site). Access onto the EMR scrapyards was not available.</p>	<p>14.2</p>

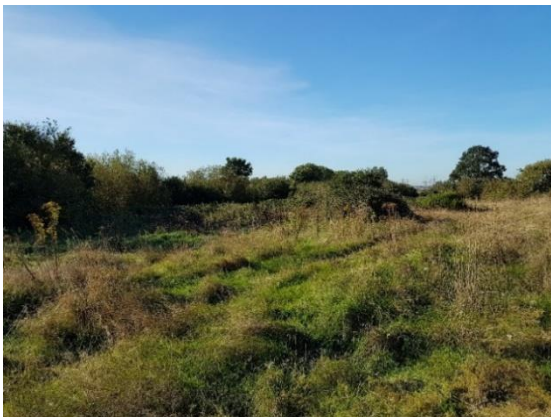
<p>Overgrown with rough grassland and scrub. No evidence of the former gravel pit remaining.</p>

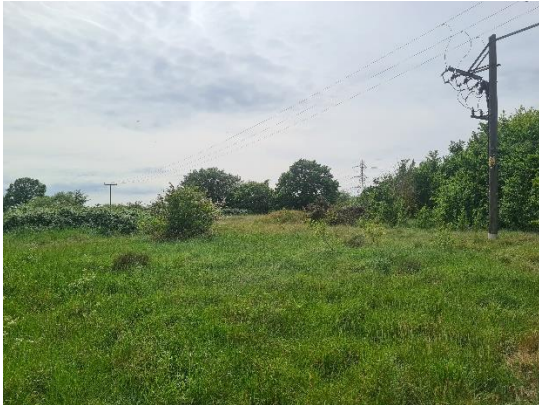
<p>Revisited May 2022: Still overgrown with rough grassland and scrub.</p>

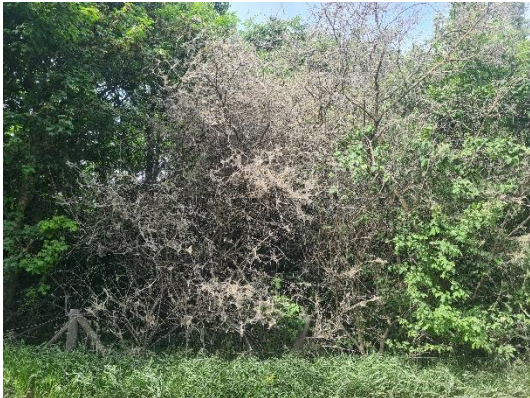
<p>Infestations of ermine moth caterpillars observed in several hawthorn bushes along the northern boundary (Station Rd)</p>	<p>14.3</p>

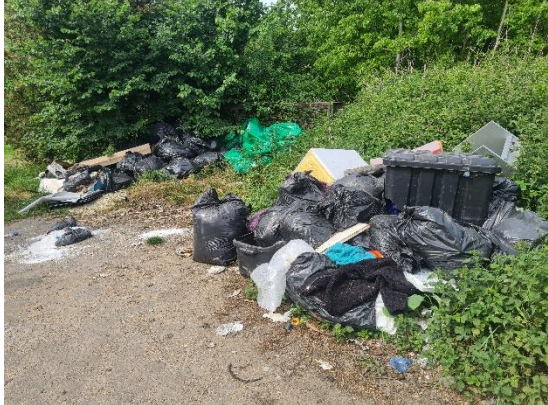
<p data-bbox="619 701 1238 763">Fly tipping and remnants of burned waste were observed along Station Rd</p>	
<p data-bbox="164 786 312 891">Low Street Lane (Area 15)</p>	<p data-bbox="376 786 592 1016">Fly-tipping noted on Low Street Lane, including tyres, plastic, furniture and electrical goods.</p>

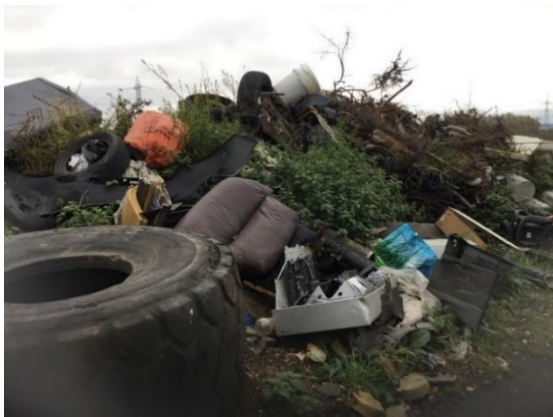
<p data-bbox="619 1205 1246 1267">Fly-tipping on Low Street Lane, viewed from the north.</p>	<p data-bbox="1294 786 1353 815">15.1</p>
<p data-bbox="164 1285 352 1361">Love Lane Pit (Area 16)</p>	<p data-bbox="376 1285 580 1753">Former landfill site, which is now a solar farm. It is mainly grassed with an area of concrete adjacent to the gate. Access onto the site was not available (viewed from the road).</p>

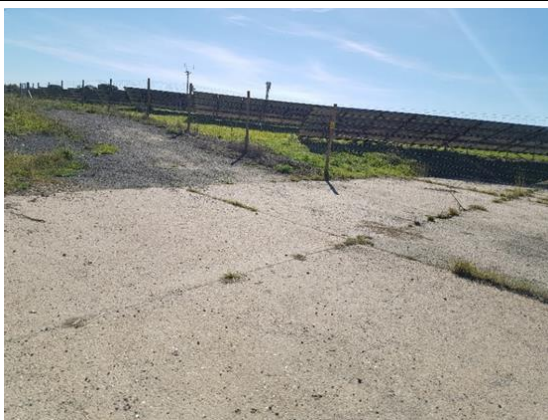
<p data-bbox="619 1709 1086 1738">Solar panels, viewed from the road.</p>	<p data-bbox="1294 1285 1353 1314">16.1</p>

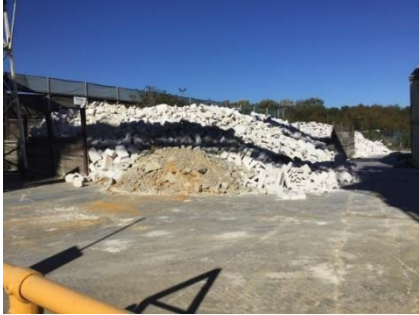
<p>Rejected blocks waiting to be sent to landfill.</p>

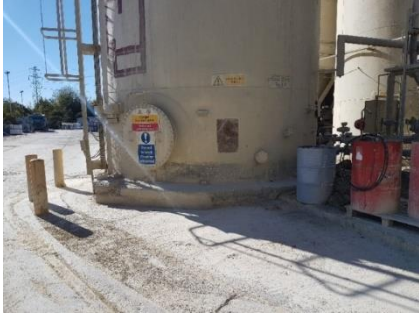
<p>Slurry tanks. Slurry from waste blocks is recycled into new blocks.</p>

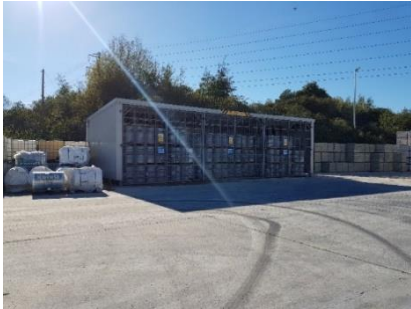
<p>Aluminium powder is used in the manufacturing process, which is tightly controlled (due to its highly flammable/explosive properties) in a secured area away from potential ignition sources.</p>

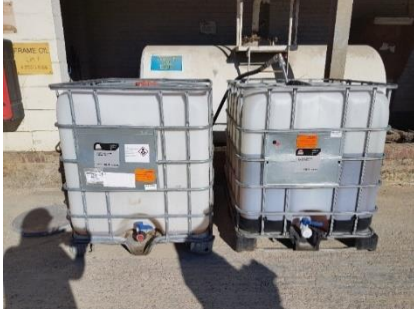
<p>'Frame oil'/tanks (in shallow brick bund and Adblue stored in intermediate bulk containers) (IBCs) (unbundled), used in the manufacturing process.</p>	<p>18.1 Continued</p>

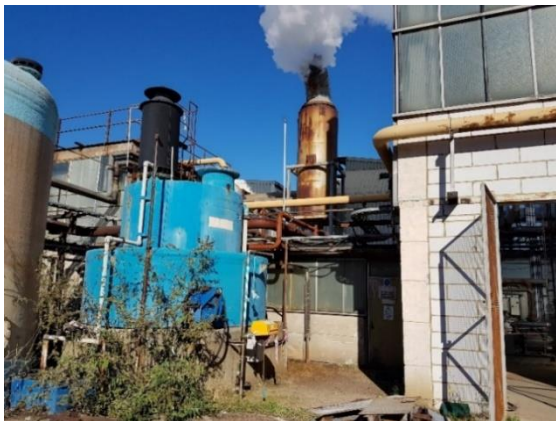
<p>Cooling system. The blue tank in the foreground contains hydrochloric acid.</p>

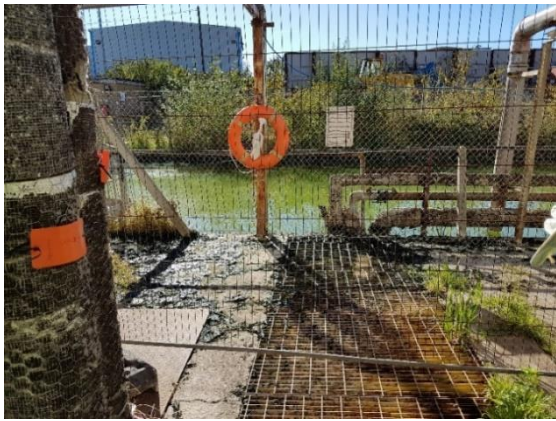
<p>Reservoir used in the cooling process.</p>

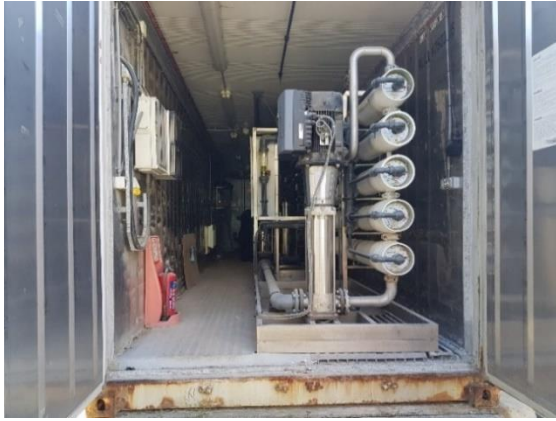
<p>Salt and brine plant used in the boiler/cooling process.</p>	<p>18.2</p>
