Lower Thames Crossing

Appendix 10.3 - Site Walkover Factual Report

DATE: October 2022

Planning Inspectorate Scheme Ref: TR010032
Application Document Ref: TR010032/APP/6.3

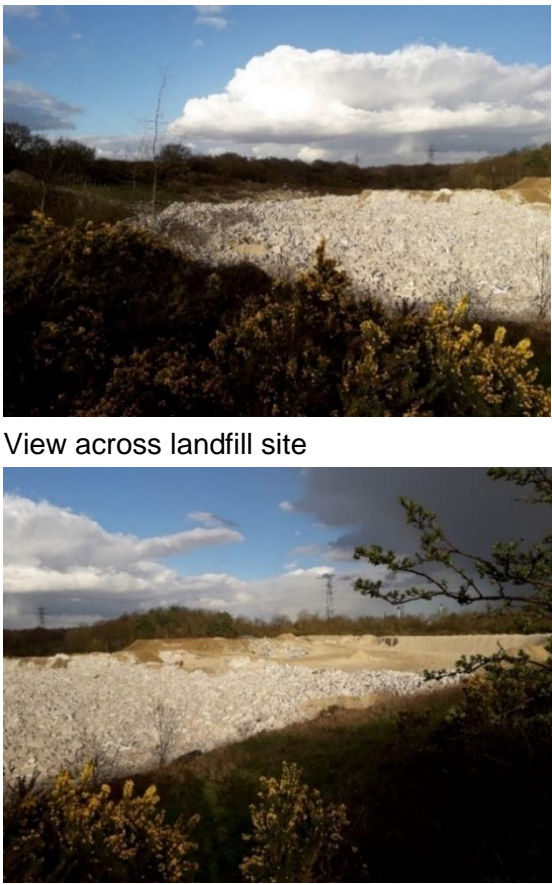
Area name	Site/location description	Photographs	ID
	<p>There is a landfill site in the western side, where rejected Durox blocks are sent to landfill.</p>

<p>The top photograph shows a wide view of a landfill site with a large pile of white, rectangular blocks. The bottom photograph shows a similar view from a slightly different angle, with some trees in the foreground.</p> <p>View across landfill site</p> <p>View across landfill site</p>	18.3
Turners Farm Gravel Pit – potential LGS	<p>The gravel pit is now filled with water.</p>

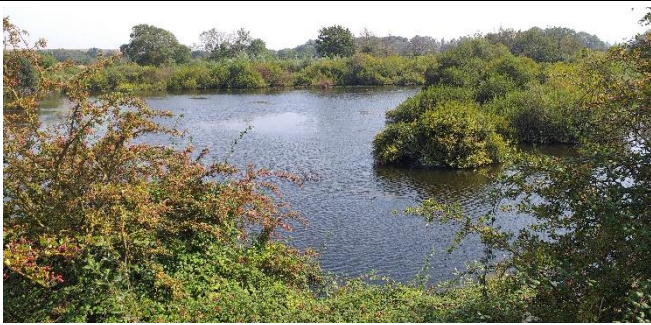
<p>A photograph showing a large body of water, likely a former gravel pit, surrounded by lush green trees and vegetation.</p>	18.4
Clearserve landfill site/aggregate recycling (formerly Rainbow Shaw Quarry) (Area 19)	<p>Former sand and gravel pit now used as an inert waste landfill site and aggregate recycling facility.</p>

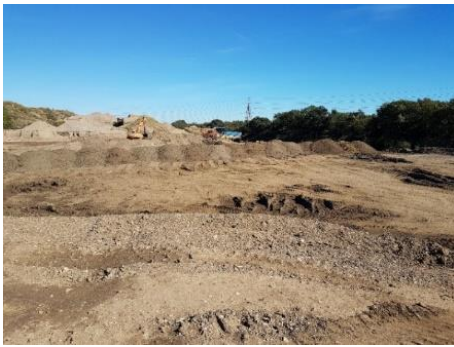
<p>A photograph showing an aggregate recycling area with several large piles of sand and gravel. There are some structures and equipment visible in the background.</p> <p>Aggregate recycling area.</p>	19.1

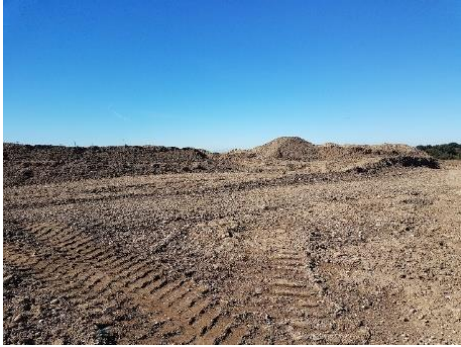
<p>Inert waste landfill (mostly soil and stones). The landfill area is nearly full.</p>

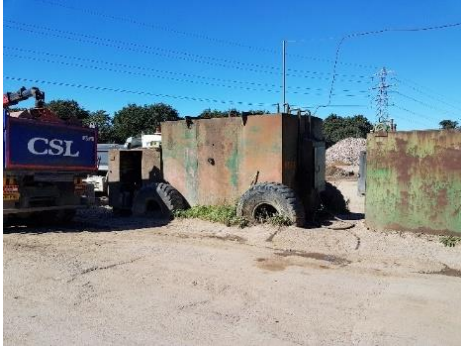
<p>Unbunded fuel tanks noted onsite on broken hardstanding.</p>

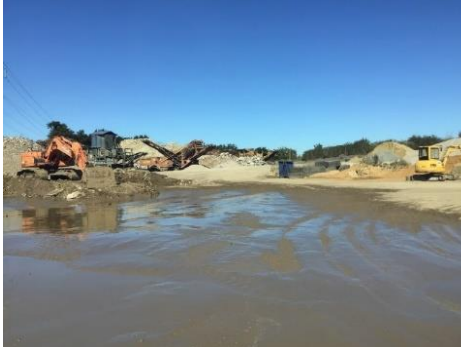
<p>Plant, equipment and materials storage onsite.</p>

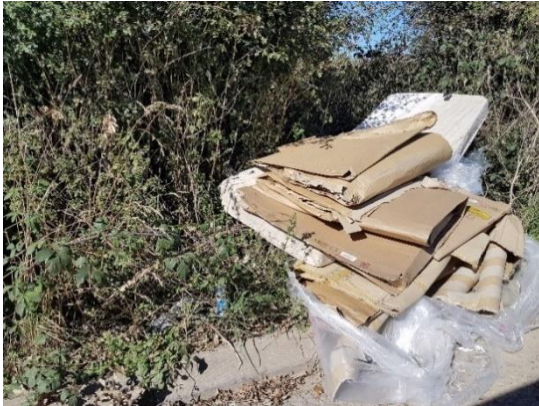
<p>Fly-tipped furniture, cardboard and plastic noted in a layby at the site entrance.</p>	19.2

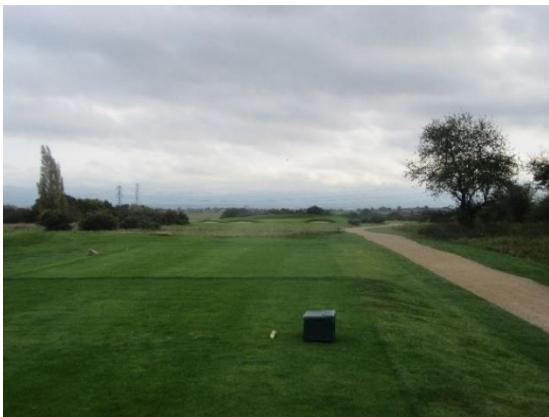
<p>Golf course viewed from the north-west.</p>	<p>20.1</p>
<p>Orsett Depot Quarry potential LGS (Area 20)</p>	<p>Adjacent to the north of the golf course there is a disused quarry (sand and gravel) which is now densely vegetated.</p>

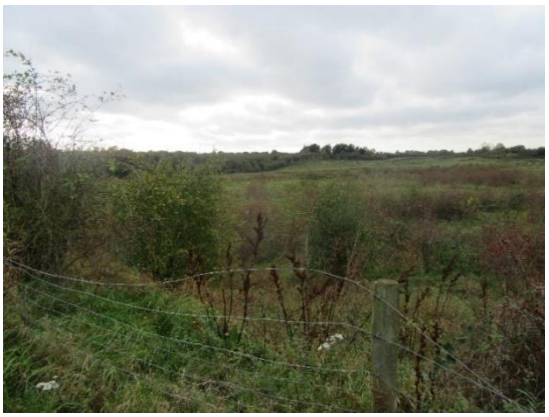
<p>Disused and overgrown former quarry, viewed from the east.</p>	<p>20.2</p>
<p>Dansand Quarry – between Brentwood Road and A13 (Area 21)</p>	<p>This active sand and gravel extraction quarry which is also used for stockpiling, processing and recycling aggregates, soils, concrete, rock, ceramics and asphalt. The site could potentially receive and process soils or made ground from construction or demolition sites.</p>

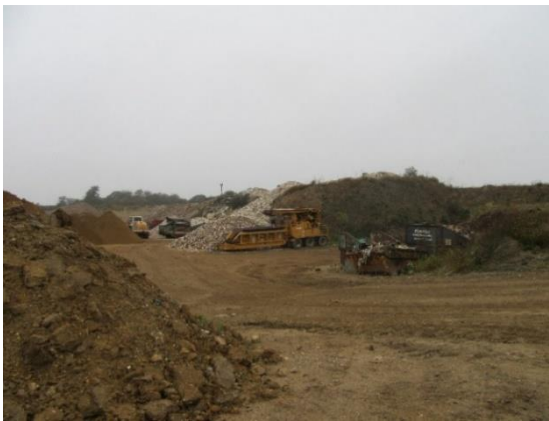
<p>Materials processing carried out at Dansand Quarry.</p>	<p>21.1</p>

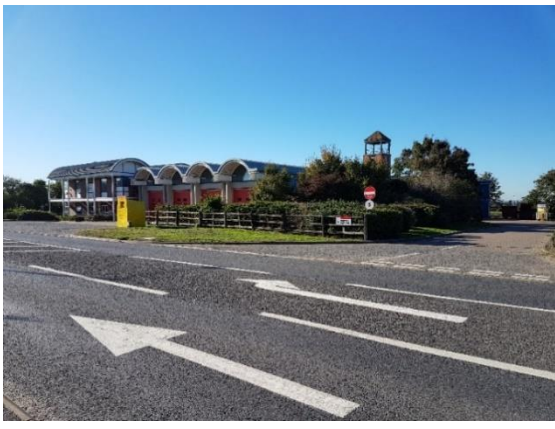
Area name	Site/location description	Photographs	ID
Fire station at A13 and gravel pit/quarry to the south (Area 22)	Fire station with waste skips and IBCs. Viewed from public road.

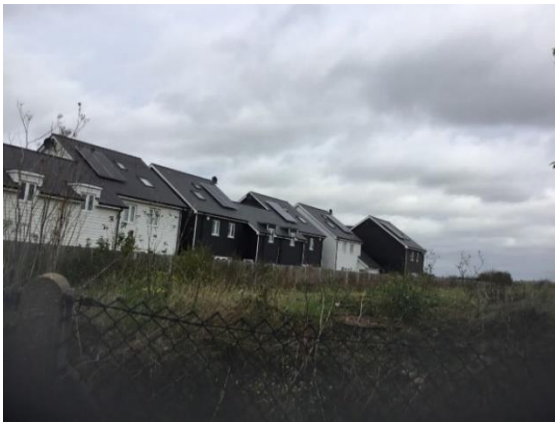
<p data-bbox="620 1149 1212 1220">Baker Street housing estate, viewed from the former landfill site to the south-east.</p>	23.1
Local authority landfills (former gravel pit) between Stanford Road and A1089, Orsett Heath (now a recreation area) (Area 24)	Former landfills are now grassed common land used for recreation. No evidence of the former landfills was seen. Construction work/earthworks were being carried out at the southerly landfill site, which was partially being redeveloped into housing.

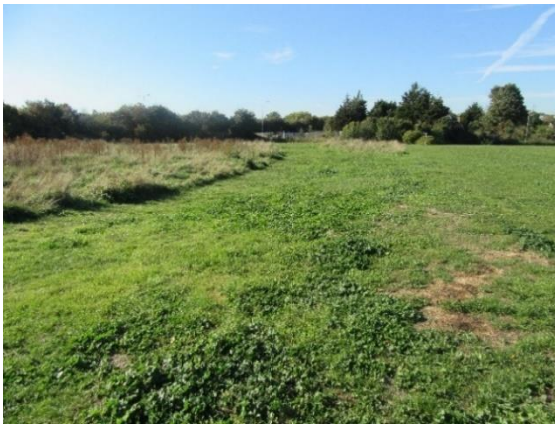
<p data-bbox="620 1657 1212 1729">Grassed common land at the former northern landfill site.</p>	24.1

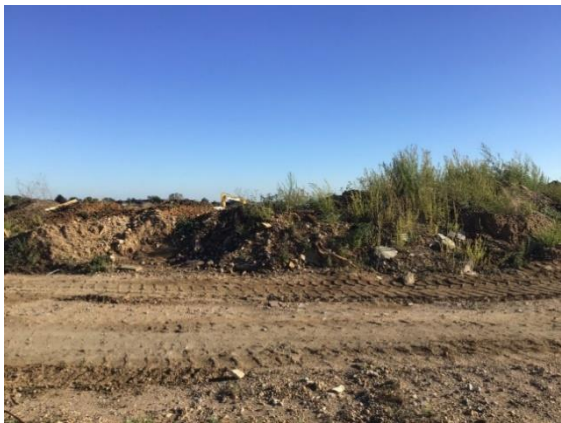
<p data-bbox="619 712 1254 779">Earthworks/construction works being carried out at the southerly landfill site.</p>	24.2
Former sand and gravel pit (now wooded recreation area) (Area 25)	Former sand and gravel pit, now a publicly accessible wooded nature reserve. No evidence of the former quarry was seen, although the site was very overgrown and observations were made from the footpath only.

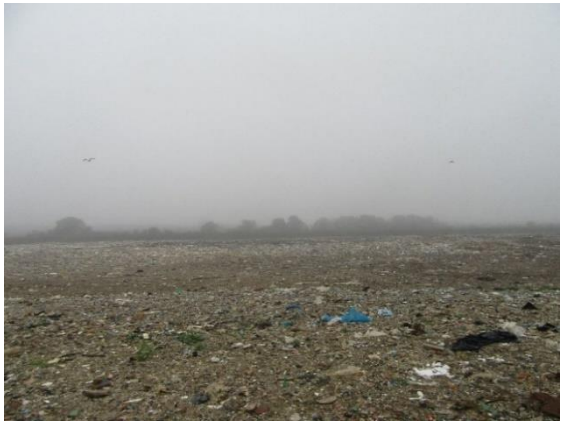
<p data-bbox="619 1778 1174 1812">Active landfill area, viewed from the south.</p>	26.1

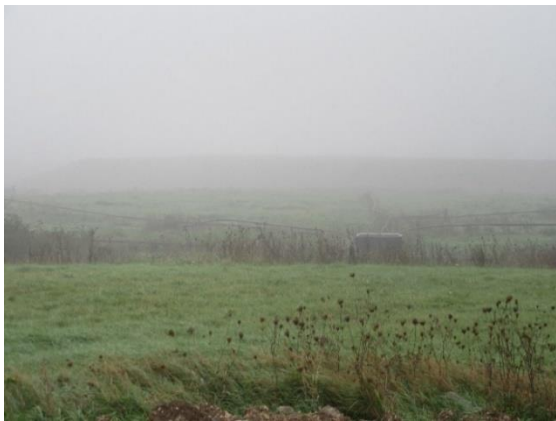
Area name	Site/location description	Photographs	ID
	<p>The historic landfill has been restored/capped and has leachate and gas monitoring systems.</p>

<p>Historic landfill area with gas/leachate monitoring systems.</p>	26.2
	<p>There is a pond (assumed to be man-made) onsite, which is being drained by Veolia.</p>	No photo available.	26.3
Former Hall Farm landfill site (Area 27)	Former landfill site, now vacant and very overgrown with scrub, rough grassland, reeds and bushes.

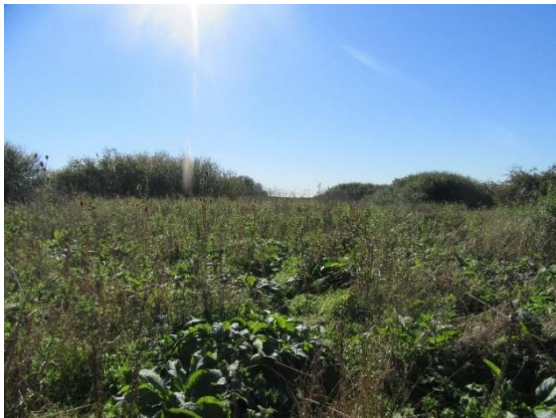
<p>Typical scrub vegetation covering the site.</p>

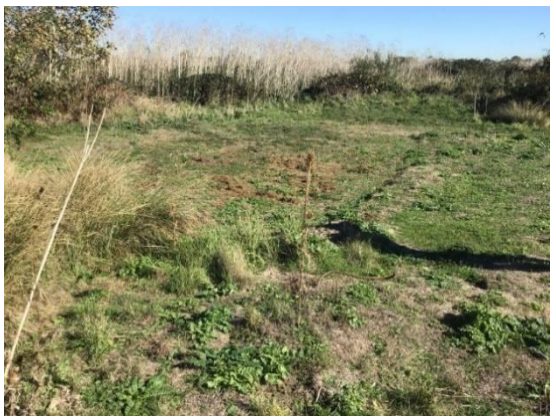
<p>Area of potentially disturbed ground in the foreground.</p>	27.1

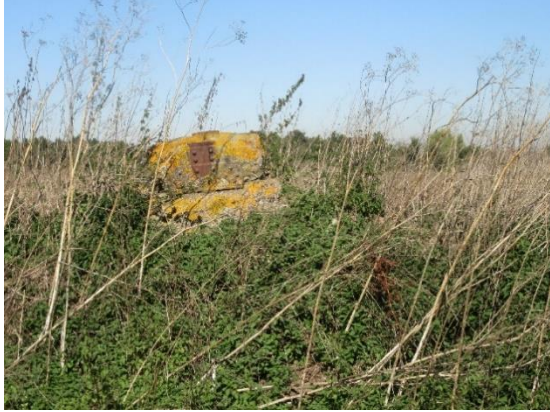
Area name	Site/location description	Photographs	ID
	<p>Occasional large concrete blocks were noted towards the centre of the site where there was an embankment, with concrete visible on the surface.</p>

<p>Large concrete block.</p>

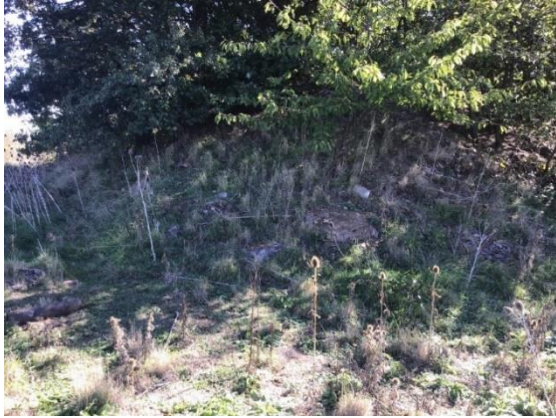
<p>Embankment with pieces of concrete.</p>	<p>27.1 Continued</p>
	<p>There is an artificial fishing pond to the north-west of the landfill site.</p>

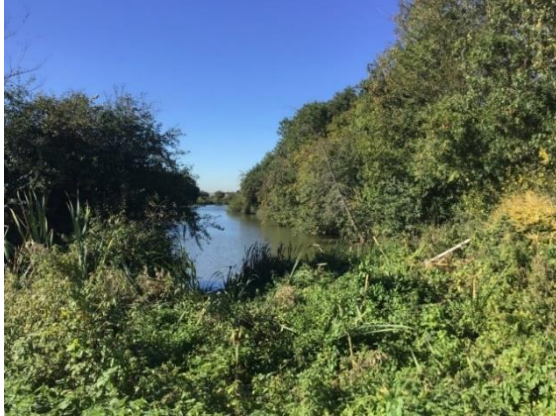
<p>Fishing pond to the north-west of the Hall Farm landfill site</p>	<p>27.2</p>

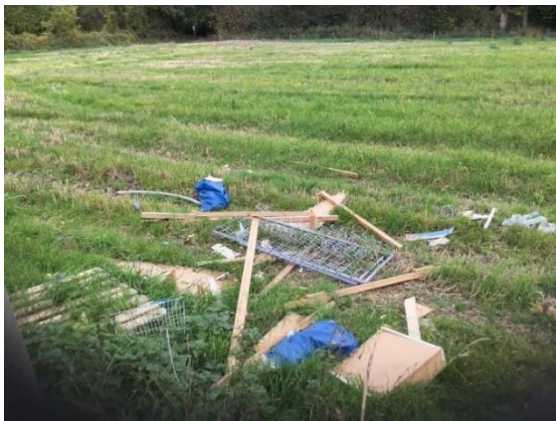
<p data-bbox="619 712 1254 779">Fly-tipped wood, metal and furniture in a field on agricultural land, viewed from the west.</p>	29.2
	Fishing lake adjacent to agricultural land, which is assumed to be artificial. Water appeared to be stagnant. Evidence of fly-tipped car tyres were noted around the lake.

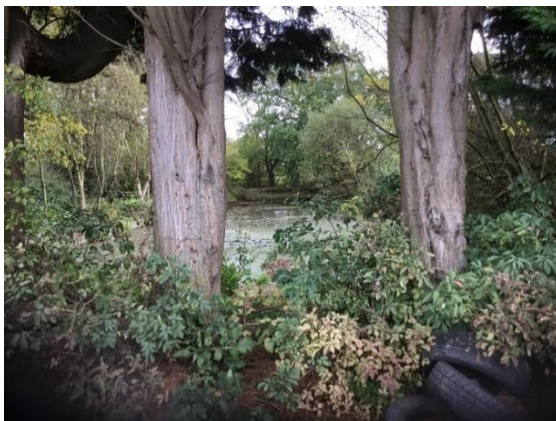
<p data-bbox="619 1218 1086 1256">Fishing lake, viewed from the north.</p>	29.3
Agricultural farmland – between Ockendon Road and B186 (Area 29)	Railway line that bisects farmland.

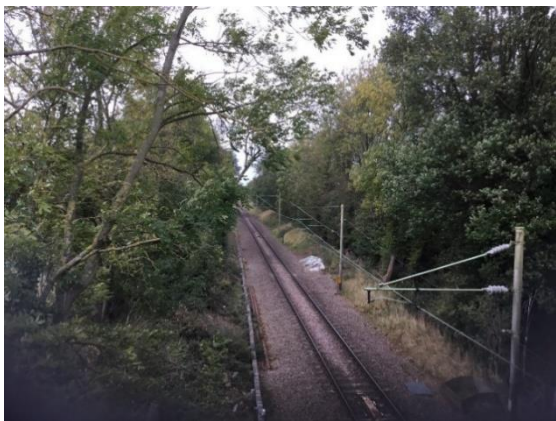
<p data-bbox="619 1693 1225 1760">Railway viewed from a railway bridge from the south.</p>	29.4

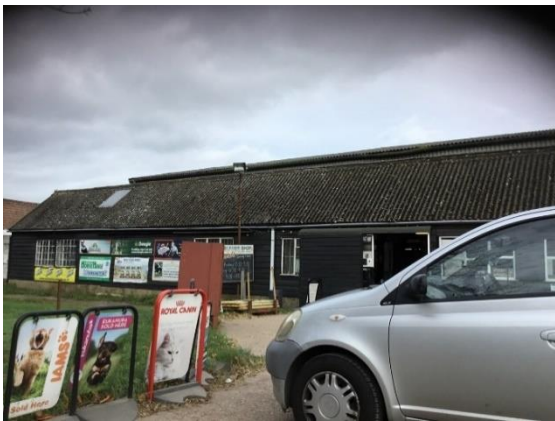
Area name	Site/location description	Photographs	ID
	Potential asbestos roof on farm buildings at farm shop.

<p data-bbox="620 712 1066 745">Farm shop, viewed from the west.</p>	29.5
Light industrial activities around the B187 road (Area 30)	Industrial estate off B187 road includes a range of light industrial and commercial businesses, including garage doors, software and media, wholesale garage supplies, and an MOT centre.

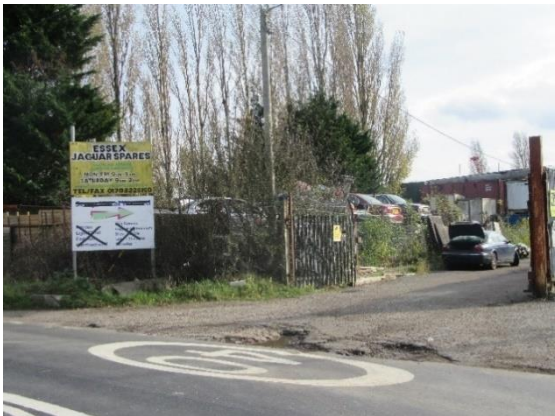
30.1
Light industrial activities around the B187 (Area 30)	Scrap metal works off the B187.

<p data-bbox="620 1704 1246 1771">Entrance to the scrap metal works, viewed from a public road to the north.</p>	30.2

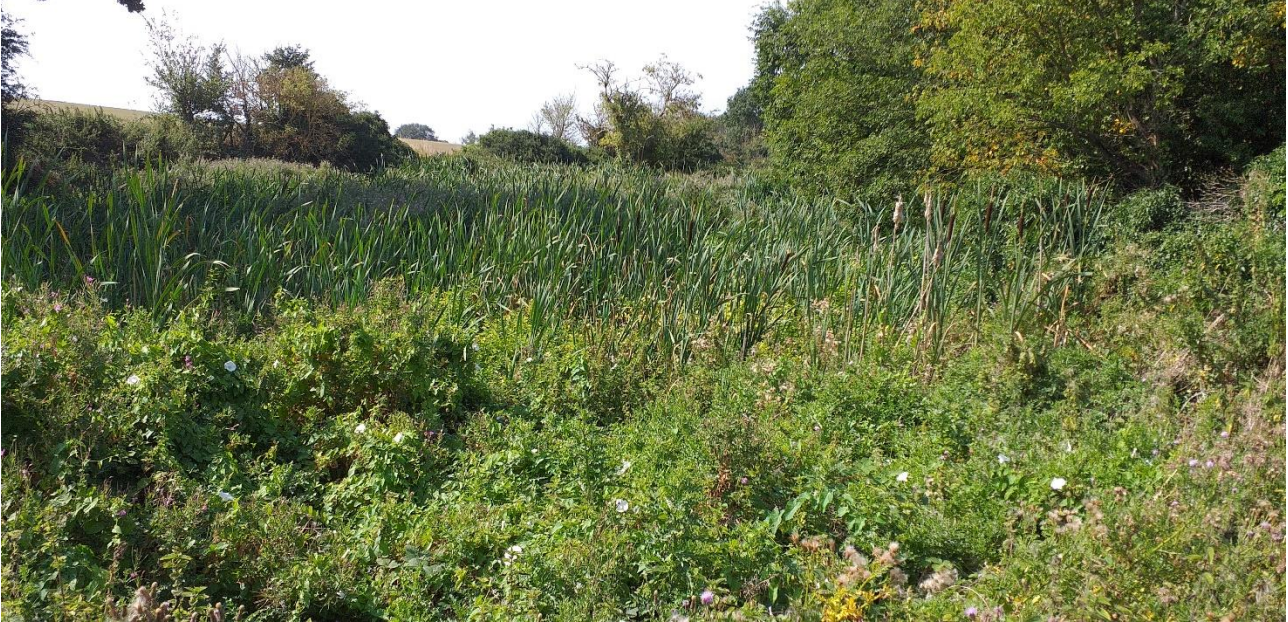
Plate B.1 Pond in east of site

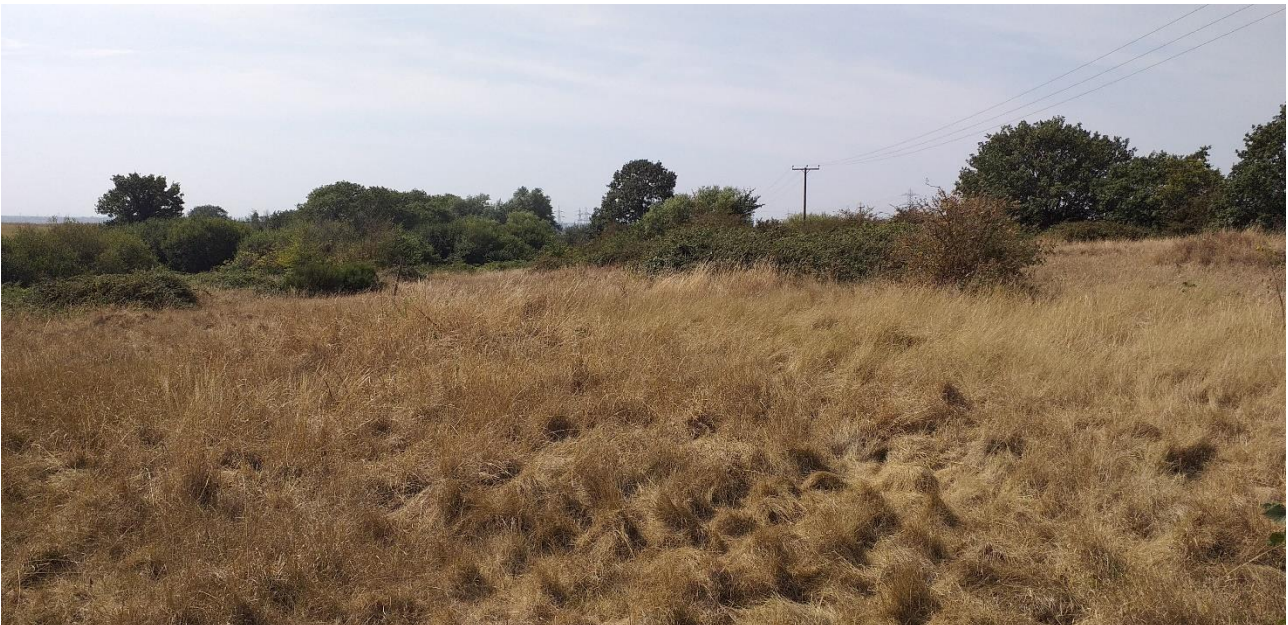
Plate B.2 North-east area of site

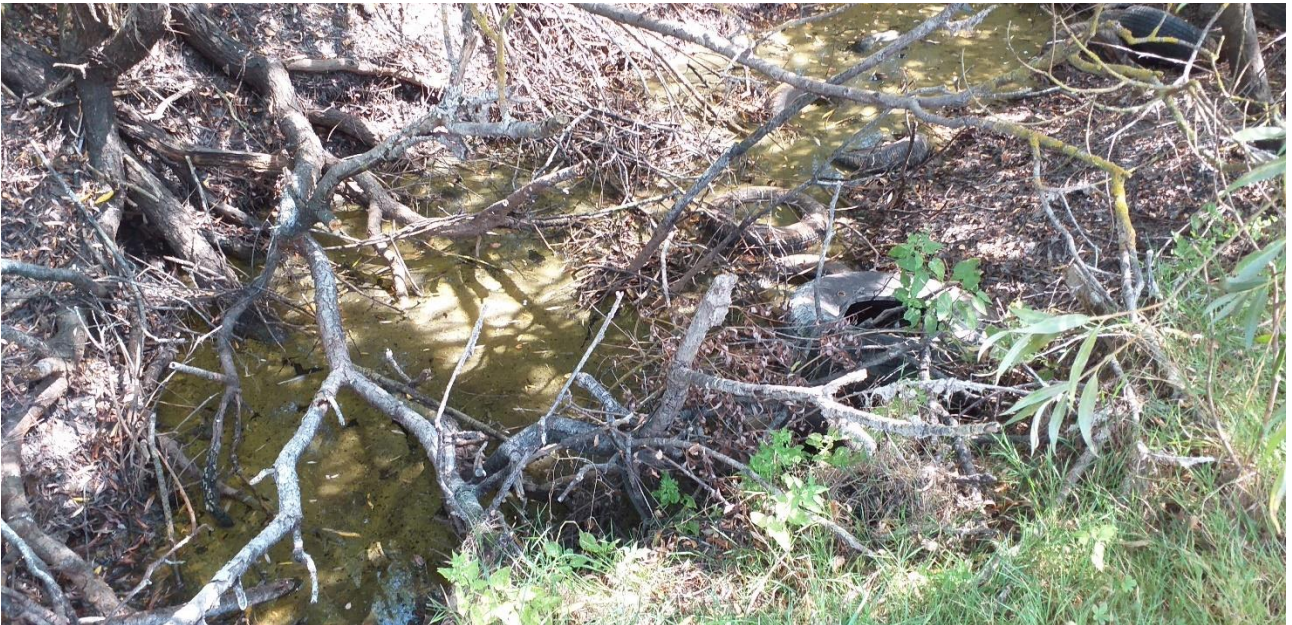
Plate B.4 Ditch in base of quarry

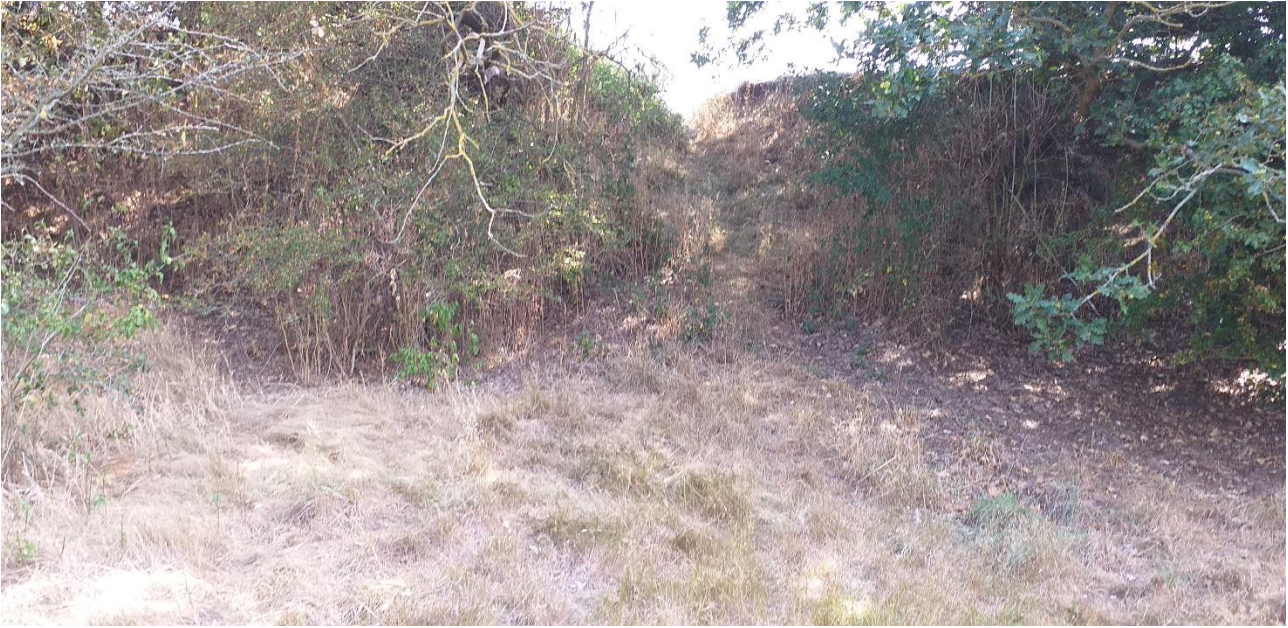
Plate B.5 Eastern quarry slope

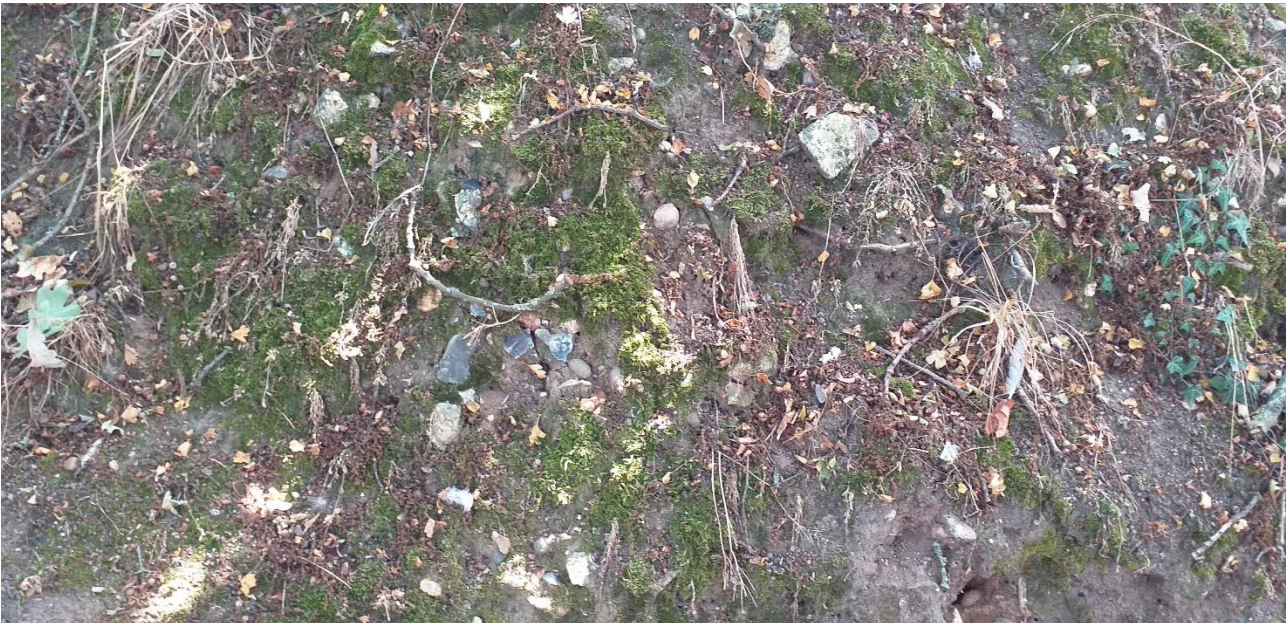
Plate B.6 Eastern quarry slope material

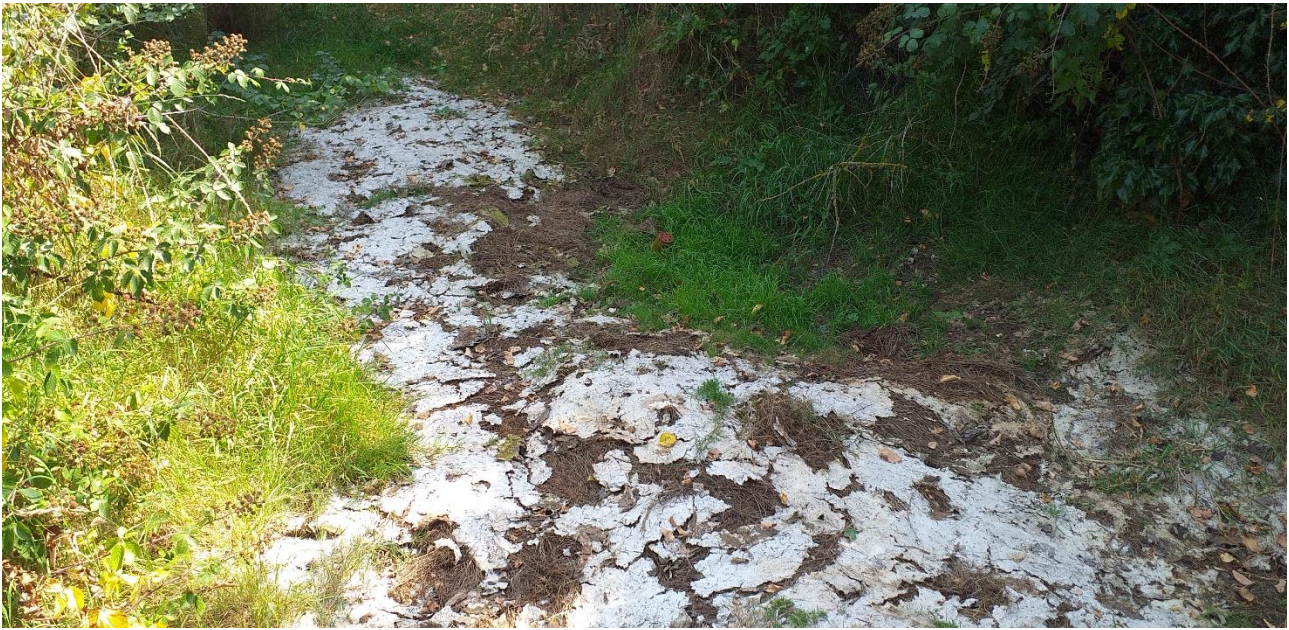
Plate B.7 Area of vegetation dieback

- A.3.29 No evidence of structures, hardstandings or quarry machinery was seen.
- A.3.30 Some patches of vegetation dieback were seen in the former quarry. The cause of this is unknown but a small area in the north of the site appeared burnt.
- A.3.31 Overhead electrical lines run from the east of the site opposite the industrial estate to the west over the former quarry.
