**Specialist Professional and Technical  
Services (SPATS) Framework  
Lot 1 & Lot 2**

**Task 1127  
Smart Motorway Incident and Infrastructure  
Investigation – M1 Junction 10 to 13**

July 2021

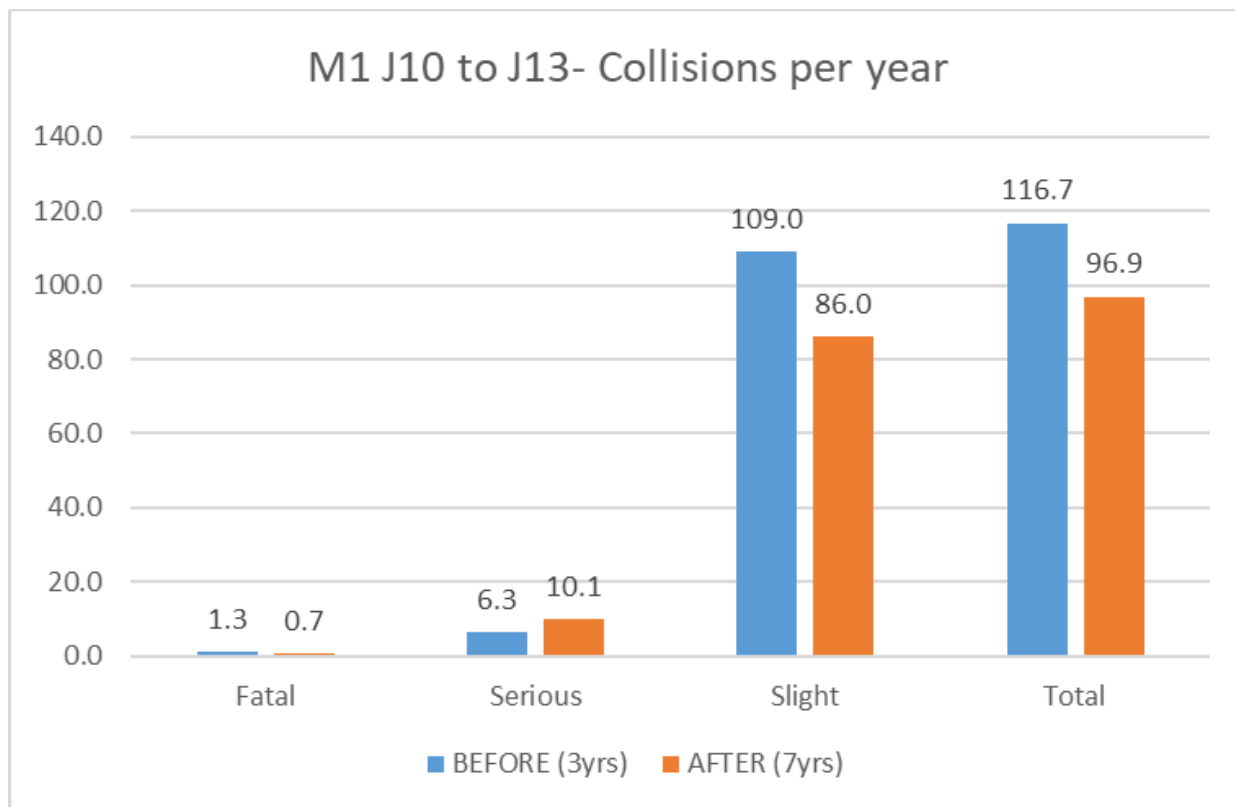
**Figure 4.1 Collision severity for the before and after data periods**

Table 4.2 and Figure 4.1 show that over the seven year after period from December 2012 slight, fatal and total average number of collisions per year have reduced while serious collisions have risen compared to the three year before period. The average number of collisions per year has decreased by approximately 16%, while traffic growth has increased by 27% on average. Table 4.2 indicates that in year 6 and year 7 post opening (i.e. from December 2017 to November 2019 inclusive) there has been a decrease in collisions compared to prior years.

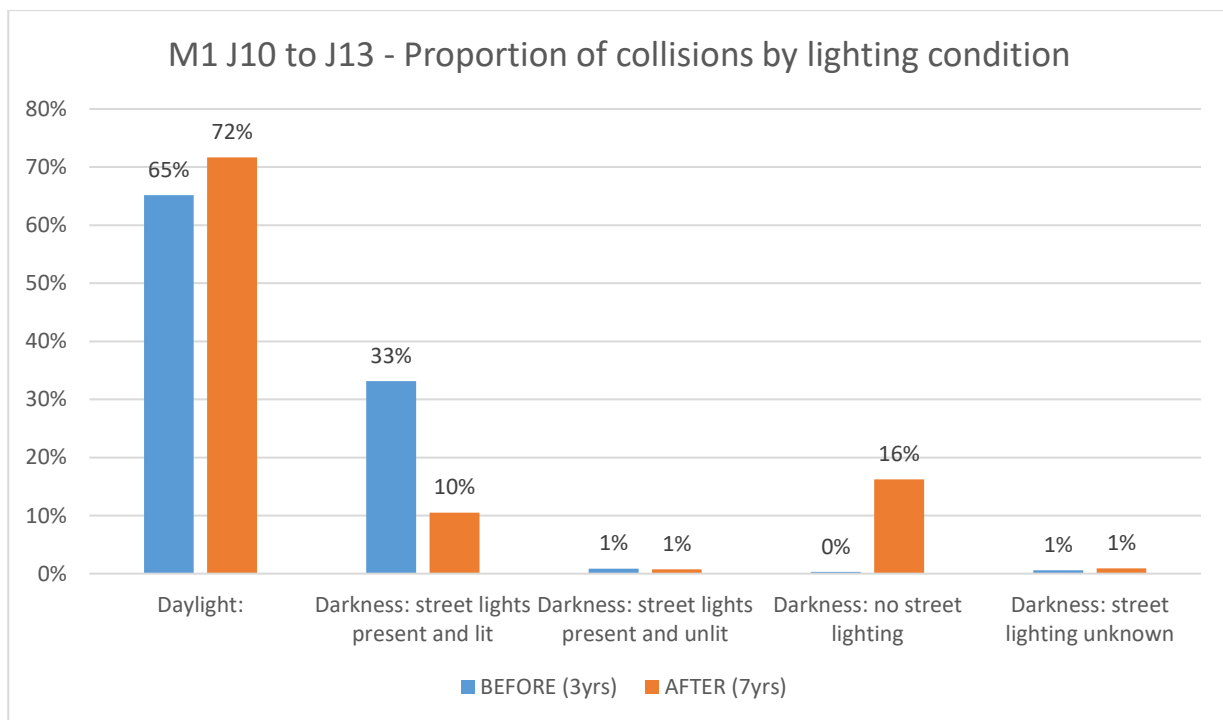
**Figure 4.2 Proportion of collisions by lighting condition for the before and after periods**

Figure 4.2 shows an increase in the proportion of collisions occurring during daylight from 65% to 72%. The decrease in ‘darkness: street lights present and lit’ collisions and increase in ‘darkness: no street lighting’ is likely to be as a result of the removal of much of the lighting along this section with only junction 10 and junction 11 retaining lighting. The removal of the lighting along the majority of this section does not appear to have had a detrimental effect on the overall proportion of injury collisions being reported in the dark. The impact of the removal of lighting specifically between Toddington motorway service area and junction 12 is assessed in section 5.3 of this report.

Figure 4.2 indicated that the number of collisions occurring during darkness on this section of the M1 between junctions 10 to 13 has decreased from 35% in the three years before opening to 28% in the

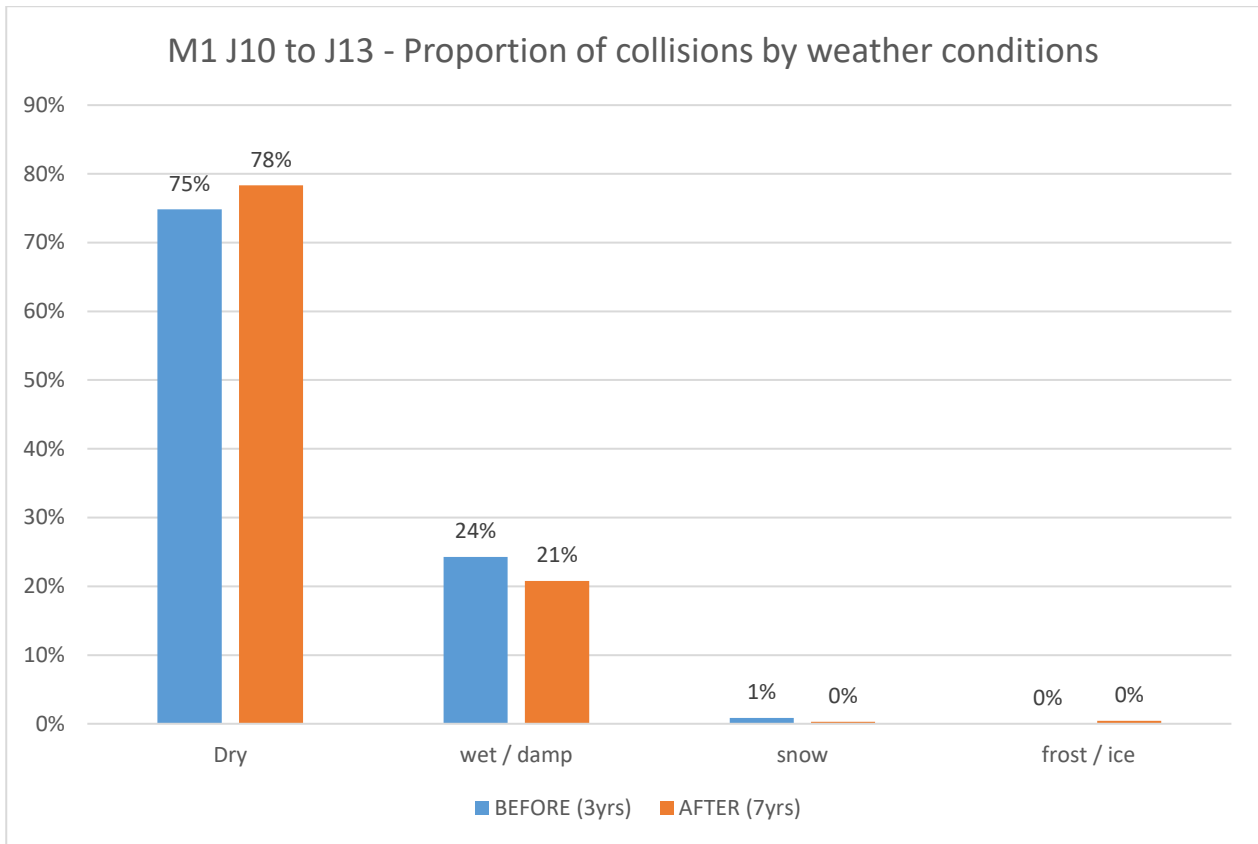
**Figure 4.3 Proportion of collisions by weather conditions for the before and after periods**

This section compares collisions before and after by the weather conditions. Figure 4.3 indicates a small decrease in the proportion of wet collisions of 3% identified from the before and after collision data.

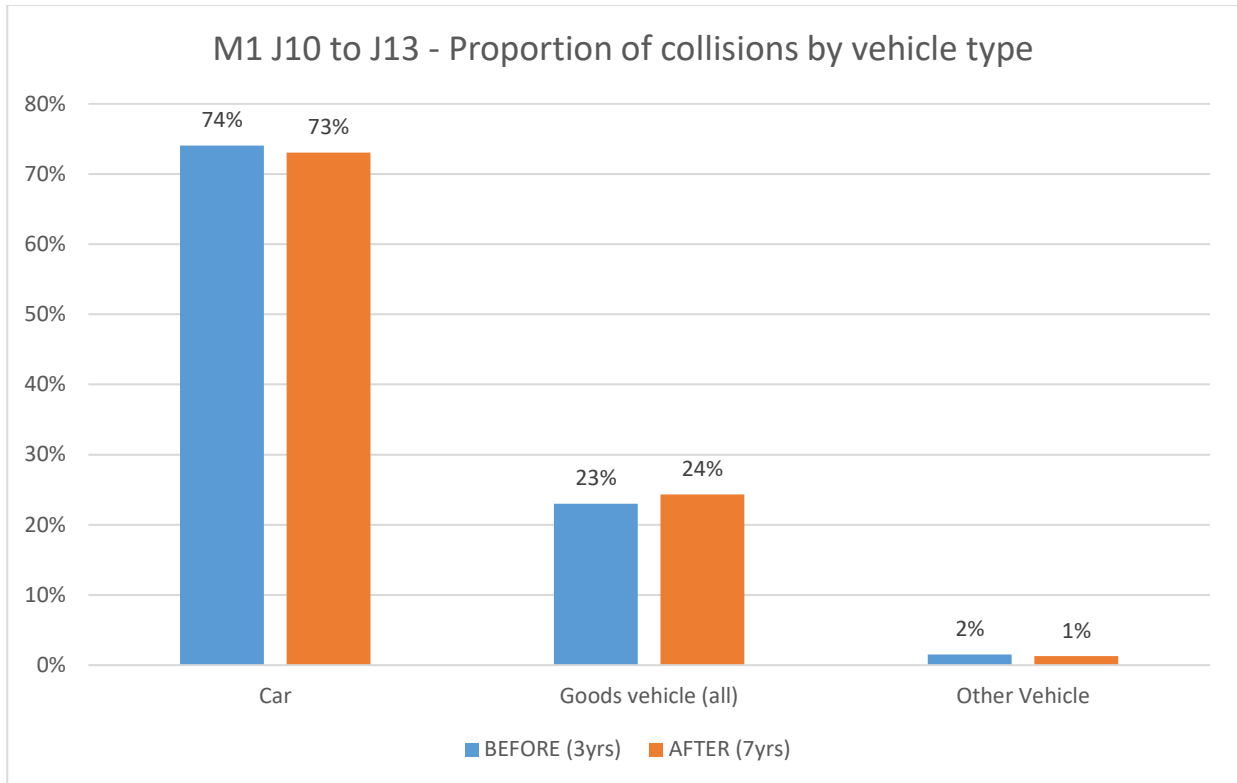
**Figure 4.4 Proportion of collisions by vehicle type for the before and after periods**

This section compares collisions before and after by type of vehicles involved, see Figure 4.4. There has been a 1% decrease in the proportion of cars involved in collisions and a 1% increase in all goods vehicles involved. In the after period the goods vehicle (unknown) category has been recorded for 10% of the goods vehicle collisions.

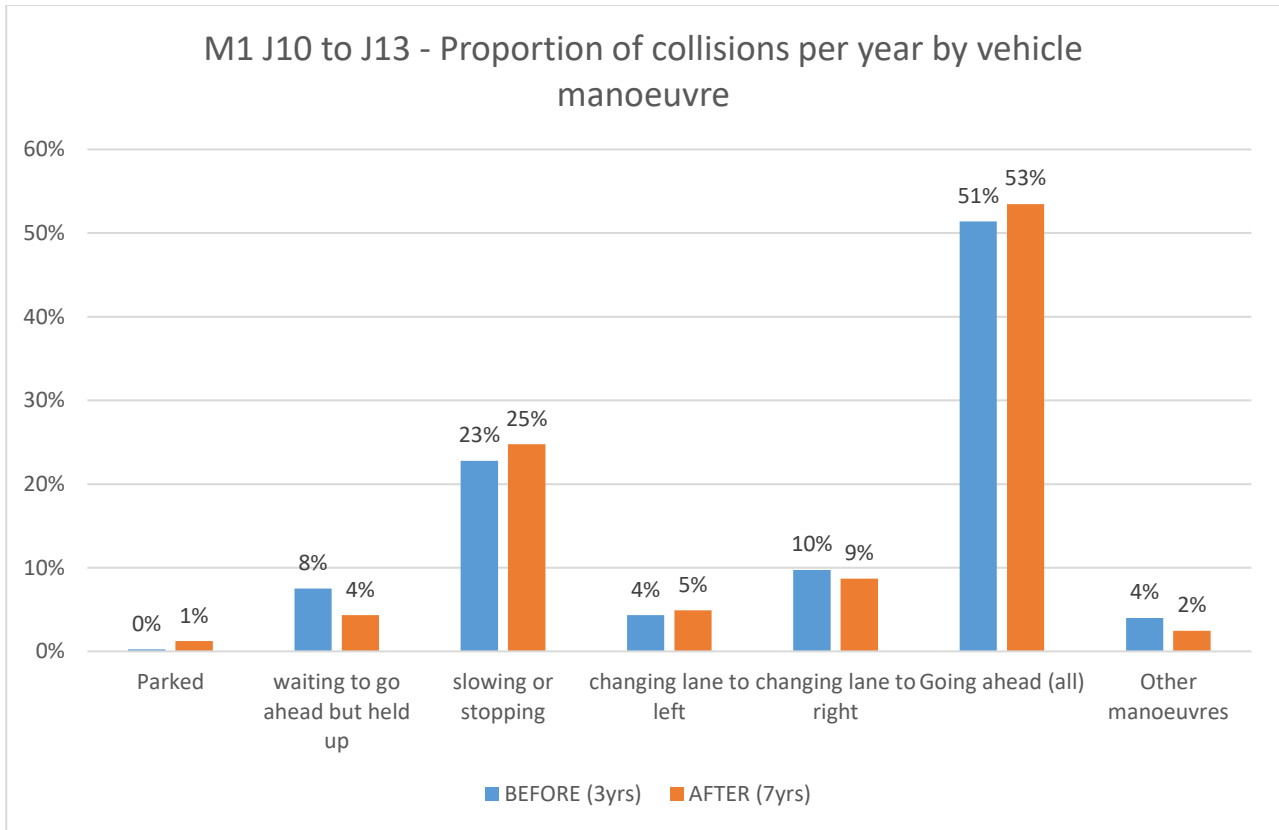
**Figure 4.5 Proportion of collisions by vehicle manoeuvre**

This section compares collisions before and after by vehicle movement and manoeuvre. Figure 4.5 indicates that there has been very little change in collisions by vehicle manoeuvre, the biggest difference is a 4% decrease in the proportion of collisions involving ‘vehicles waiting to go ahead but held up’ but this is partially negated by a 2% increase in the proportion of ‘slowing or stopping’ collisions. There has been a 1% shift in collisions involving vehicles ‘changing lane to the left’ and ‘changing lane to the right’.

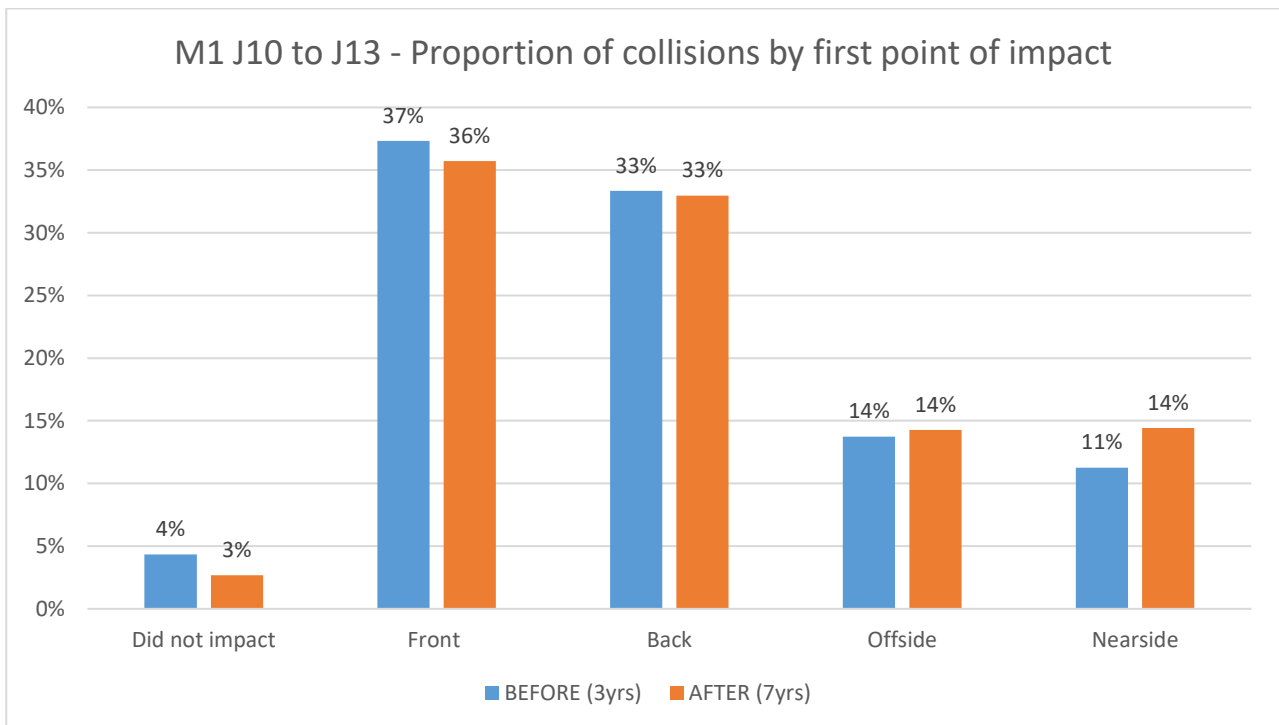
**Figure 4.6 Proportion of collisions by first point of contact**

In terms of points of impact (refer to Figure 4.6), this has shifted slightly in the after period with a greater proportion of nearside as first point of impact and a reduction in front, although front / back (implying a shunt collision) is still the most frequent.

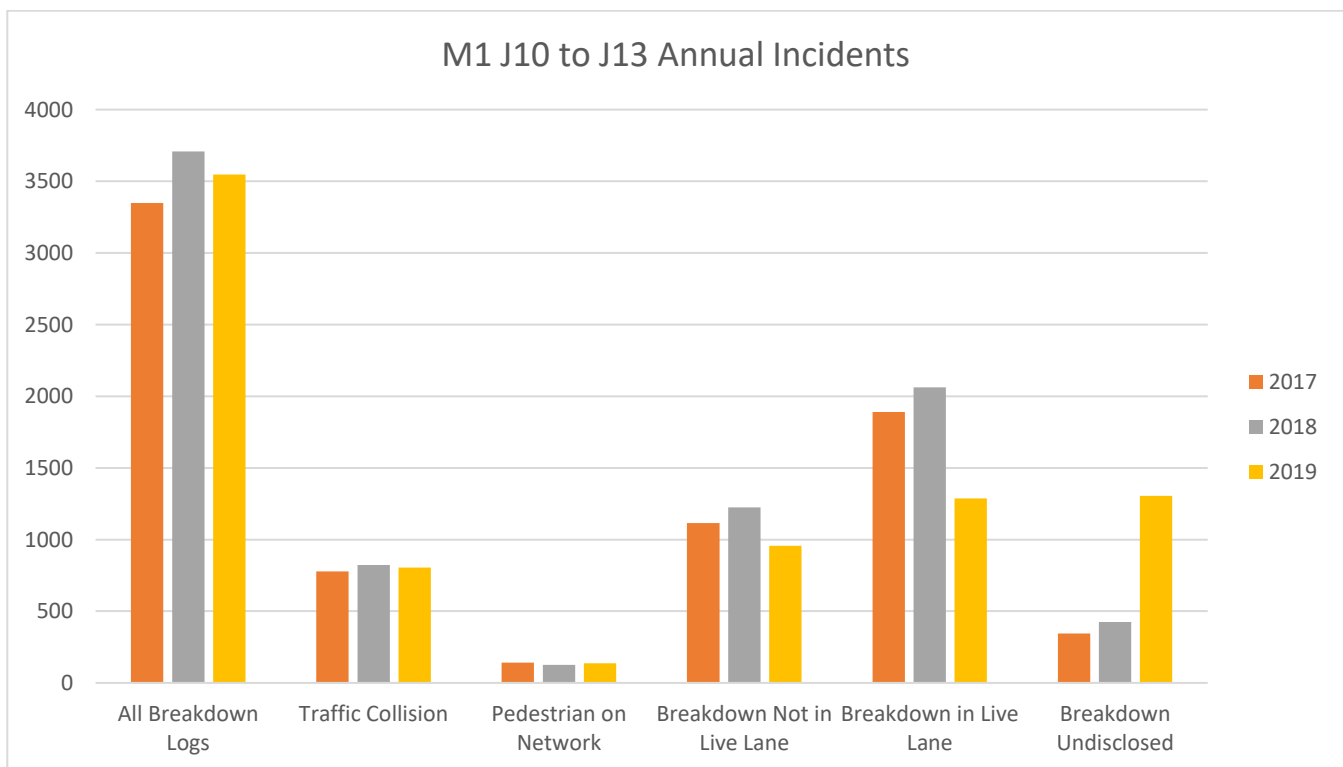
**Figure 4.7 Annual incidents by type**

Table 4.4 and Figure 4.7 indicates that the reported number of traffic collisions have changed little over the last three years (it is important to note that this will include *all* collisions of which the operations team are made aware, which will include damage-only collisions not captured elsewhere). The number of incidents recorded as a collision far exceeds those reported officially in injury collision records and suggests that there are a larger number of damage only collisions compared to injury collisions.

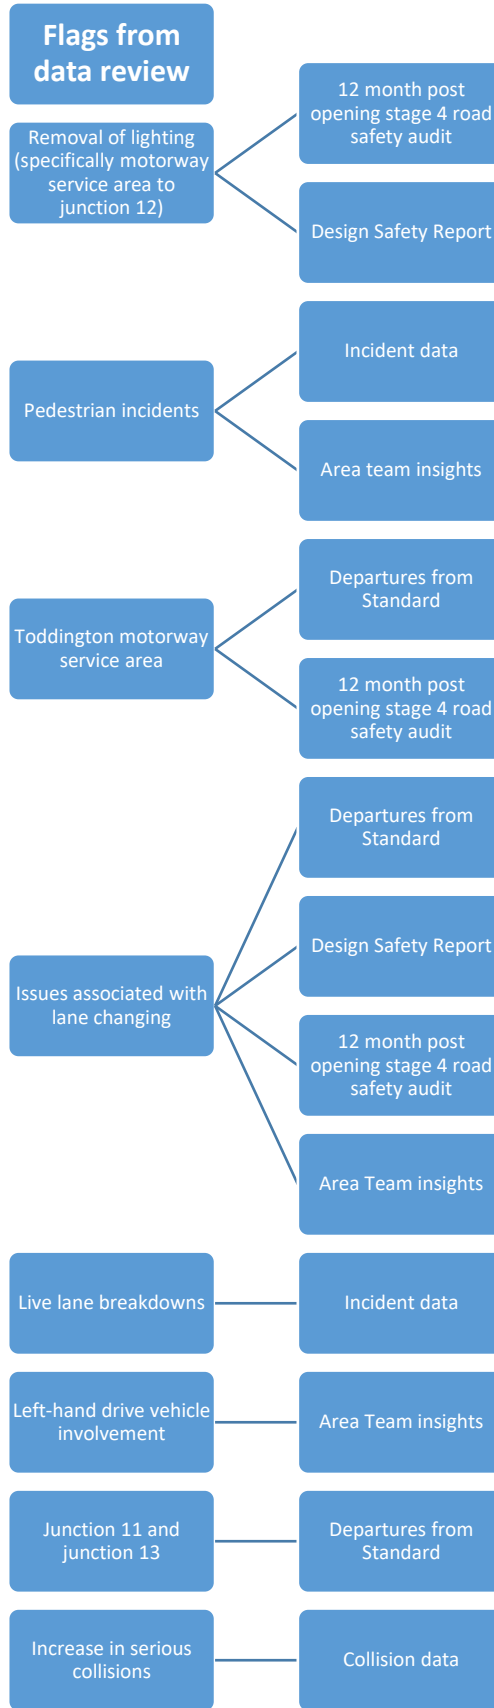
Figure 4.8 Factors to be considered in the focused investigation

- Collisions occurring in the vicinity of Toddington motorway service area.
- Collisions at junction 13 immediately south of the junction and at junction 11.
- Darkness collisions, specifically the impact of removing lighting through Toddington motorway service area to junction 12.
- Collisions involving live lane stops.
- Collisions resulting from lane changing.
- Pedestrian involvement in collisions and incidents.
- Left hand drive vehicle involvement in collisions.
