**Specialist Professional and Technical
Services (SPATS) Framework
Lot 1 & Lot 2**

**Task 1127
Smart Motorway Incident and Infrastructure
Investigation – M1 Junction 30 to 35**

July 2021

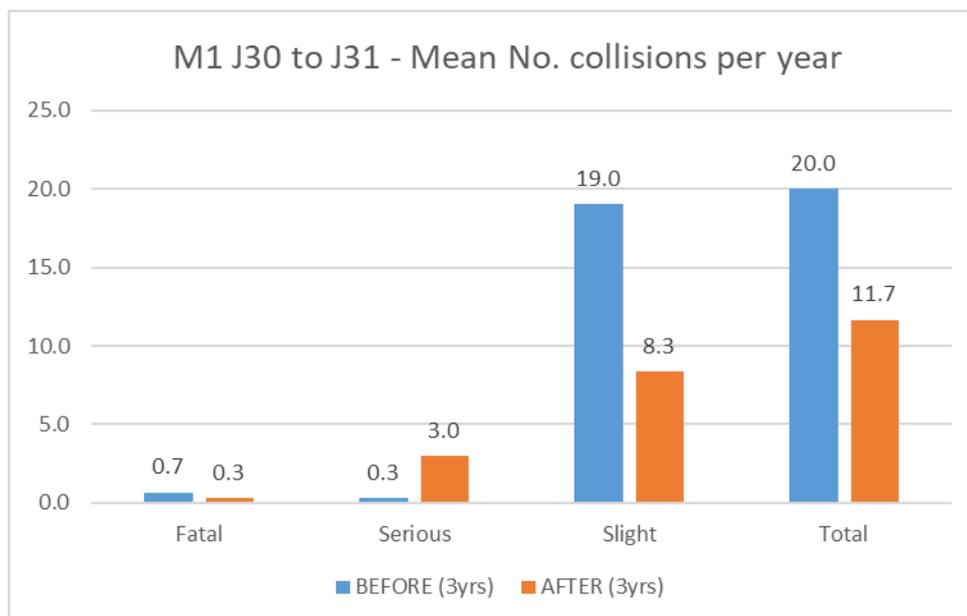
Figure 4.1 Junction 30 to 31 collision severity for the before and after data periods

Table 4.3 and Figure 4.1 show that overall the average number of collisions per year have reduced between Junction 30 to 31, however the number resulting in serious injuries has increased. The above shows a reduction in the number of collisions per year resulting in fatal injuries, however a fatal collision has occurred in year 4. Therefore inclusion of this year in the average data would present a smaller reduction as the rate would be 0.5 fatal collisions per year.

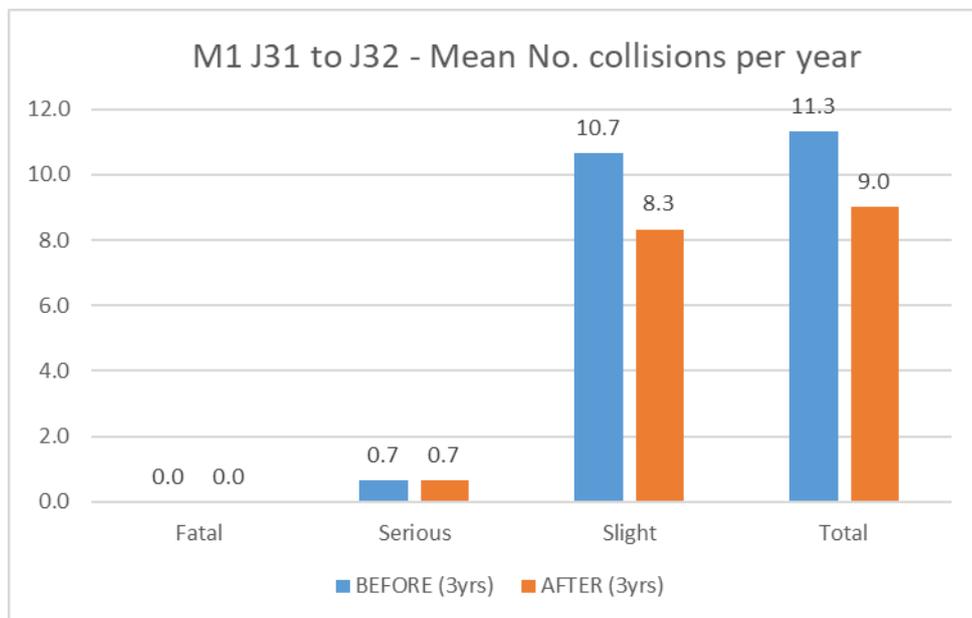
Figure 4.2 Junction 31 to 32 collision severity for the before and after data periods

Table 4.4 and Figure 4.2 show that overall the average number of collisions per year have reduced between Junction 31 to 32, and the number of collisions involving serious collisions has remained unchanged. No fatal collisions were recorded on this link.

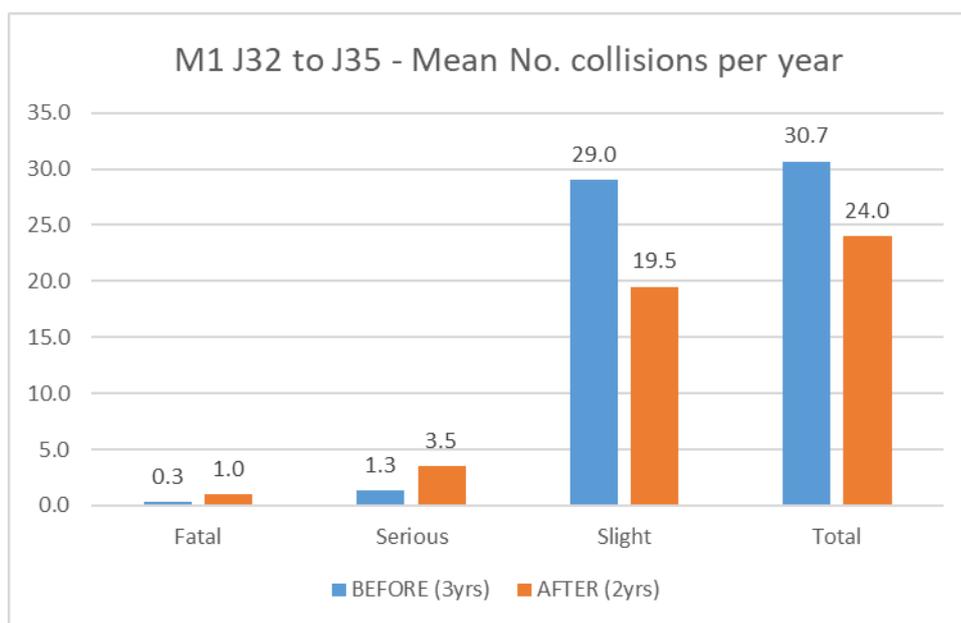
Figure 4.3 Junction 32 to 35 collision severity for the before and after data periods

Table 4.5 and Figure 4.3 show that overall the average number of collisions per year have reduced between Junction 32 to 35, however the number of collisions resulting in deaths or serious injuries has increased. During the partial year 3 data, one fatal collision has been reported and three serious collisions suggesting a consistent pattern.

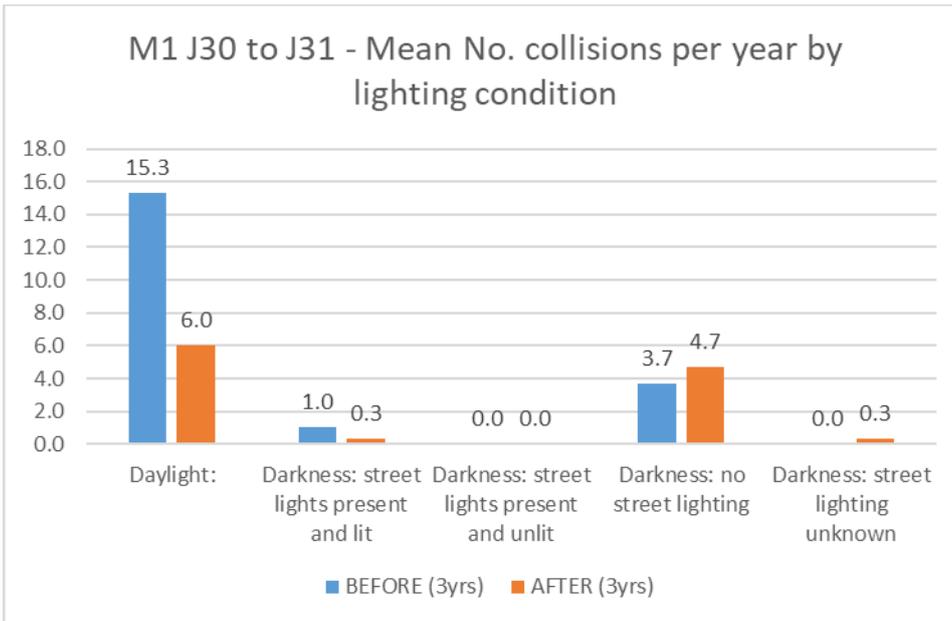
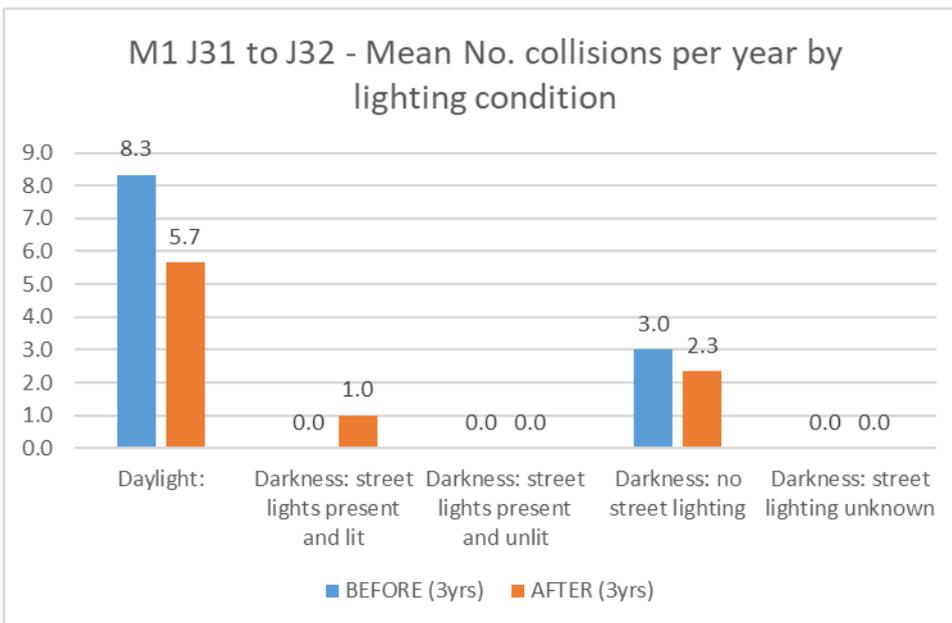
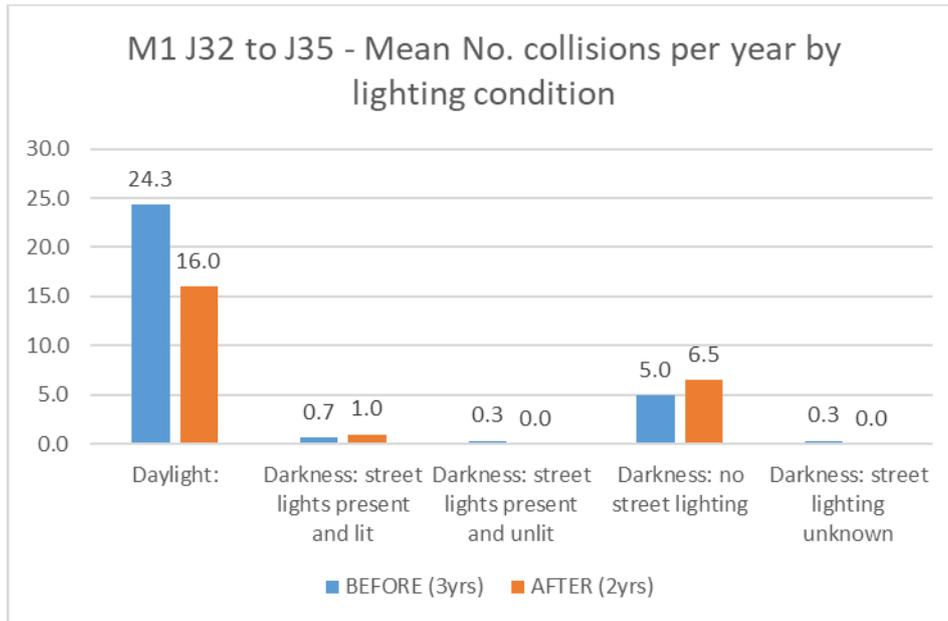
All the sections show a reduction in the number of collisions occurring during daylight with small increases in the collisions occurring in darkness, indicating that the overall reduction in collisions is occurring during the day. Whilst the Junction 32 to 35 section shows an increase of 1.5 collisions per year during darkness with no street lighting the before figure is influenced by year 3 during which only one collision of this type was reported, during the preceding two years seven of this collision type occurred. During the incomplete final year of after data only three collisions have been reported in darkness with no street lighting, however this is likely to be influenced by the missing months being winter.

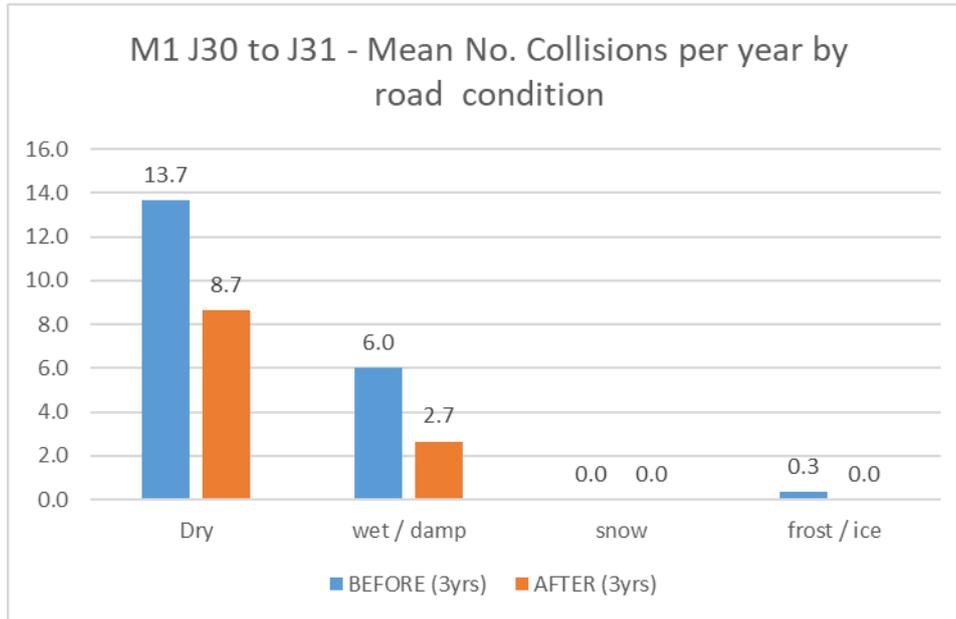
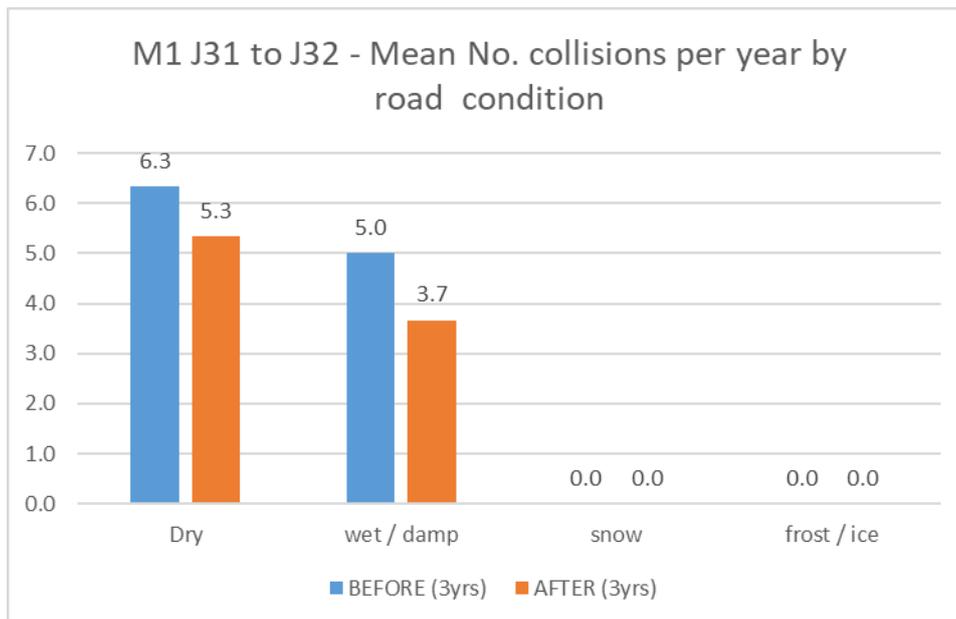
Figures 4.7 and 4.8 demonstrate a reduction in the number of collisions with a wet road surface for Junction 30 to 32. The proportion of collisions occurring on a wet road surface is 29% for Junction 30 to 31 and 39% for Junction 31 to 32 over the full period of after data including the partial year 4. Both of these are above the national average for motorways of 25%⁴. For Junction 30 to 31, given the overall reduction, this aspect is not considered for further detailed investigation. Junction 31 to 32 wet collisions are considered further in section 5.

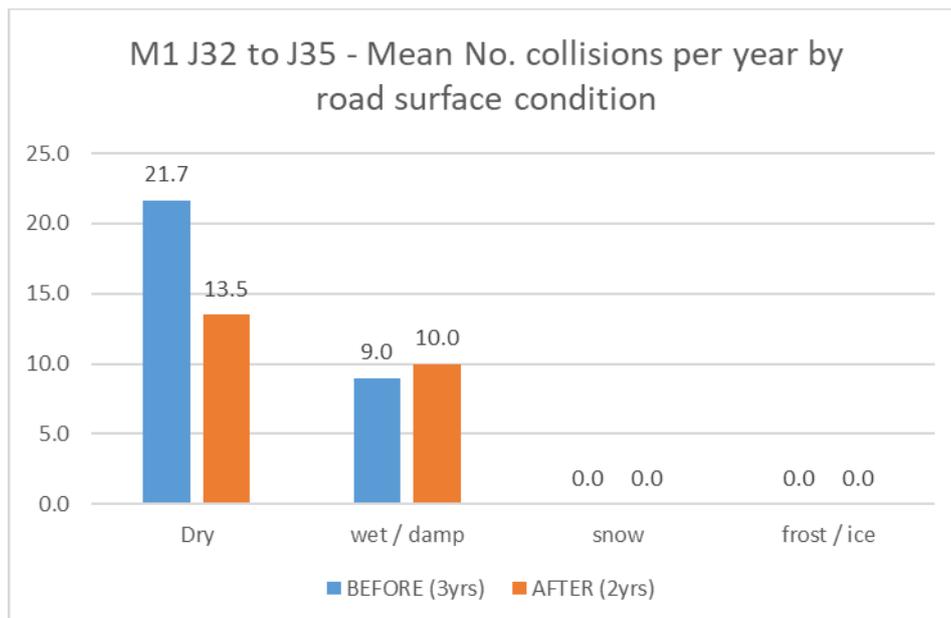
Figure 4.9 Junction 32 to 35 Collisions by road condition (weather related) for the before and after data periods

Figure 4.9 demonstrates for Junction 32 to 35 an increase in collisions with a wet road surface. Only four collisions on a wet road surface have been reported in the partial year 3 data, however this is likely to be influenced by the missing winter months. The proportion of collisions occurring on a wet road surface is 38% over the full period of after data including the partial year 3. This is above the national average for all motorways of 25%⁴. Given the increase of wet collisions, set against an overall reduction of collisions, this factor is investigated further in section 5.

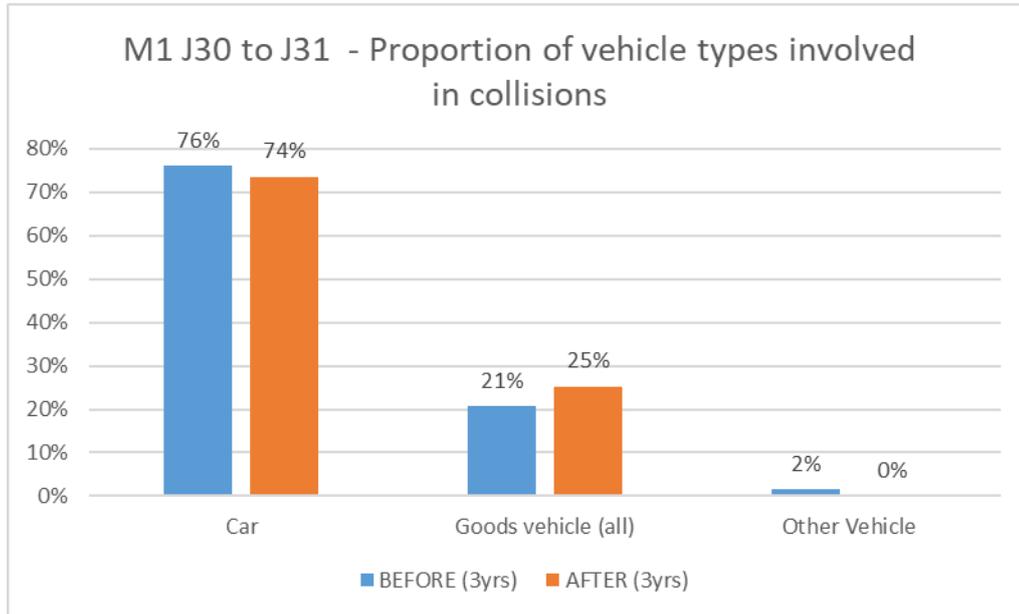
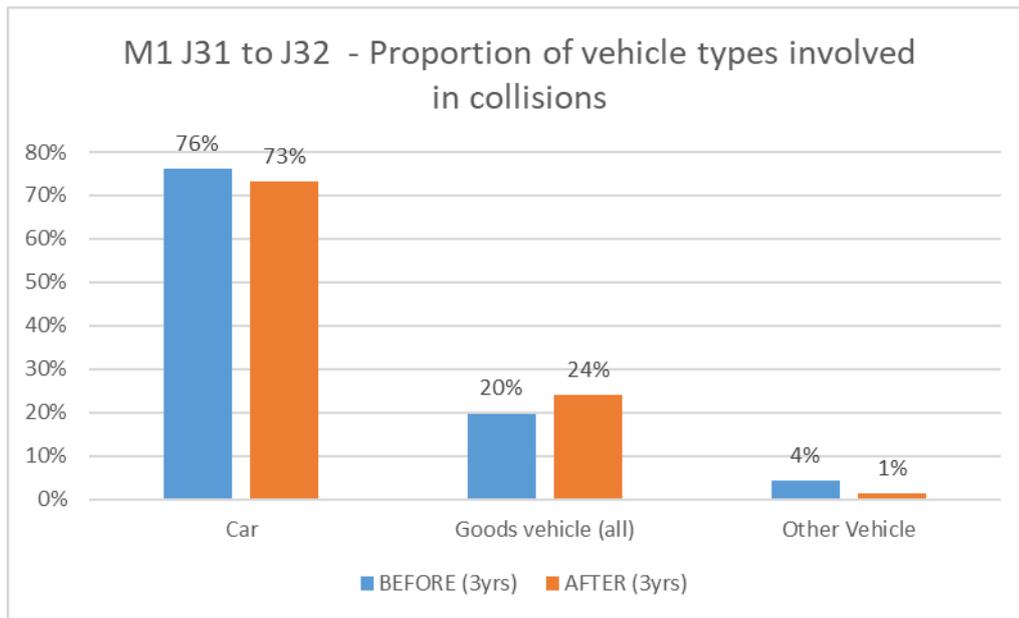
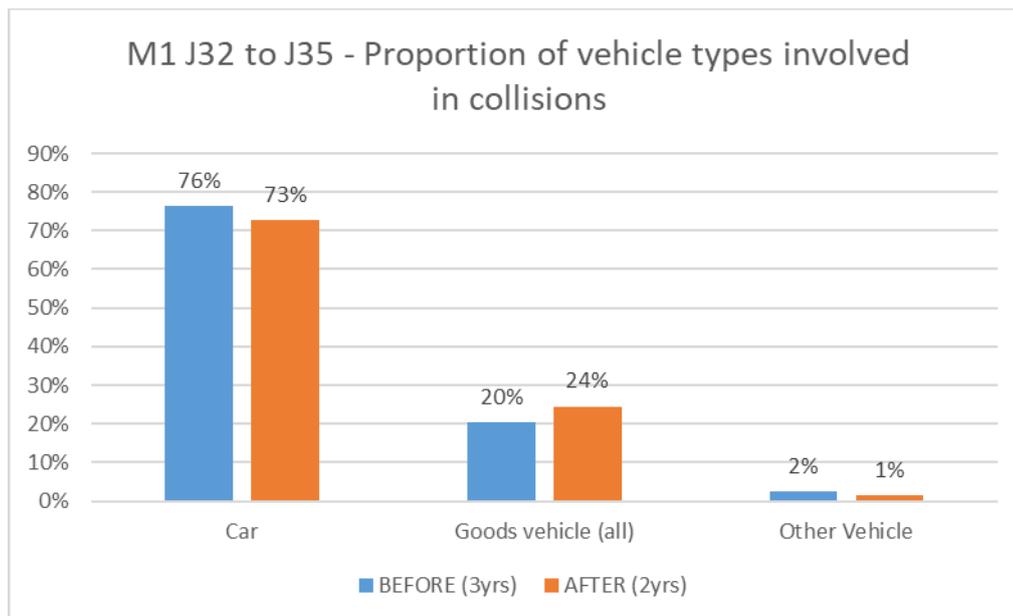
Figures 4.10, 4.11 and 4.12 demonstrate that the proportion of goods vehicles involved in collisions has increased by 4 percentage points for all sections.

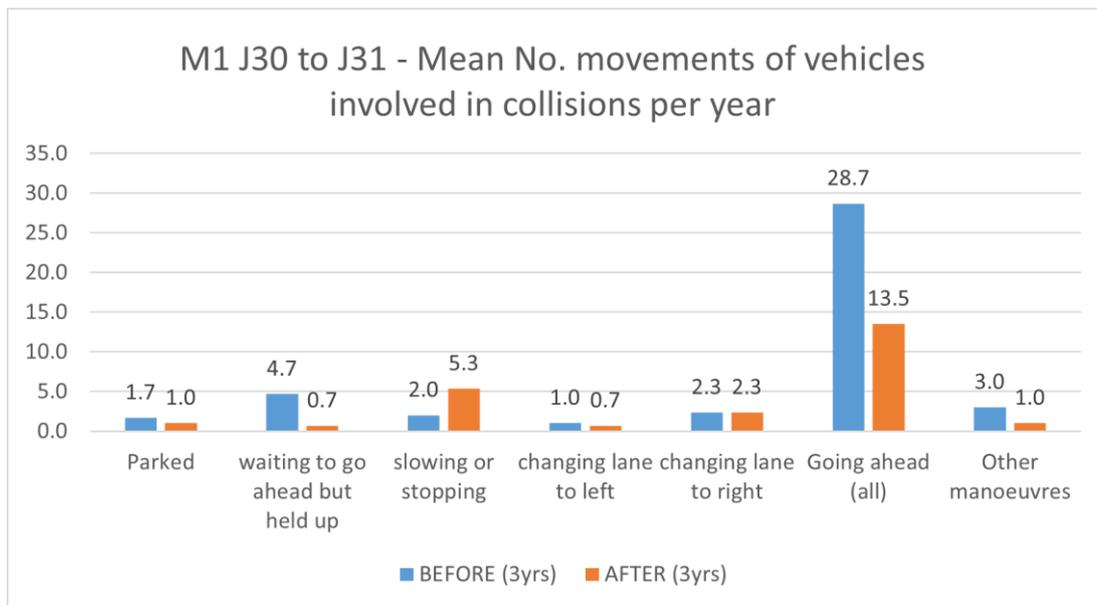
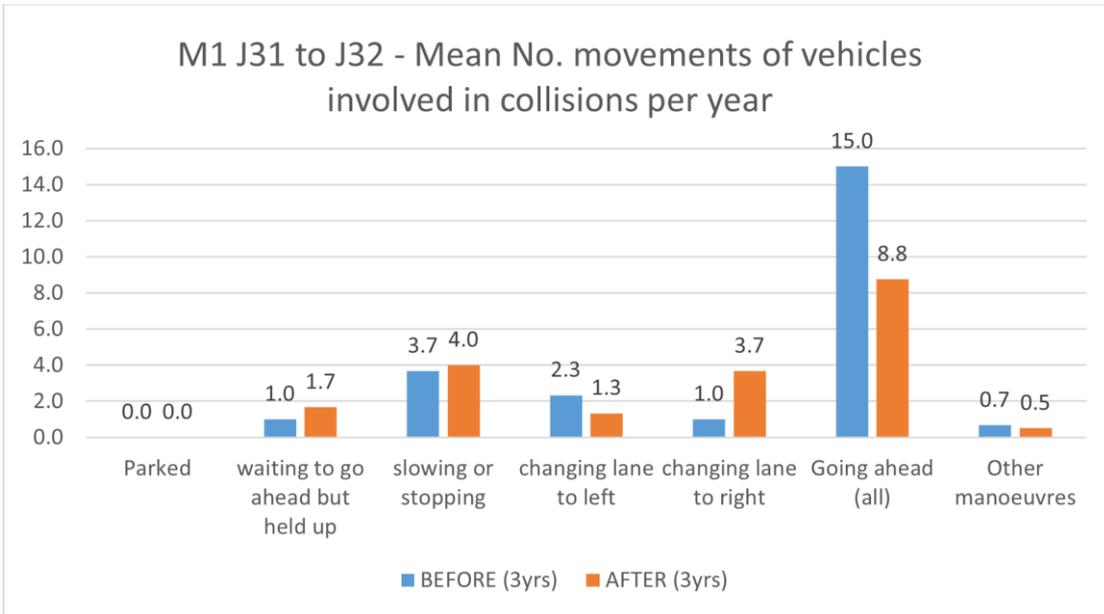
This section compares collisions before and after, by vehicle movement and manoeuvre (Figure 4.13 to Figure 4.15) and point of impact (Figure 4.16 to Figure 4.18). Figure 4.13 and Figure 4.14 show that vehicles involved in a collision either waiting to go ahead but held up, or slowing and stopping, has broadly stayed the same, with the number of collisions waiting to go ahead and held up reducing and the number of collisions involving slowing or stopping increasing by a similar amount. The collision movements are both indicative of congestion, and the change would suggest this has reduced but is still an issue between Junction 30 and 32. Given the combined number of collisions involving either of these movement has remained broadly comparable is not considered a concern for further detailed investigation.

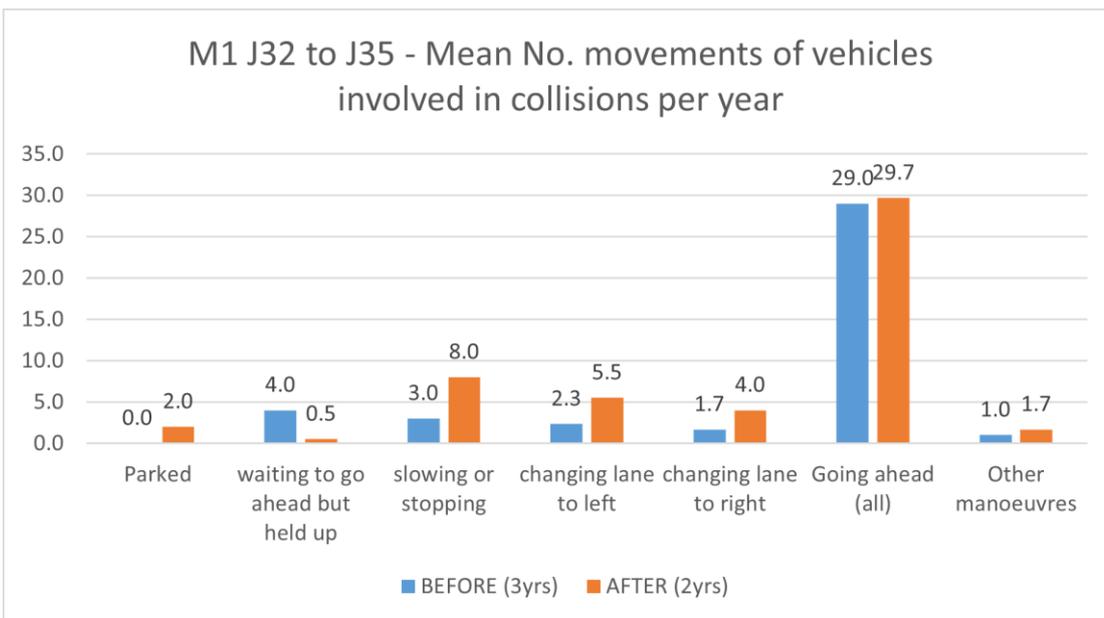
Figure 4.15 J32 to 35 Movements of vehicles involved in collisions for the before and after data periods

Overall, vehicles involved in a collision either waiting to go ahead but held up, or slowing and stopping, has increased in the Junction 32 to 35 section (Figure 4.15). Local effects are considered further in section 5.5.

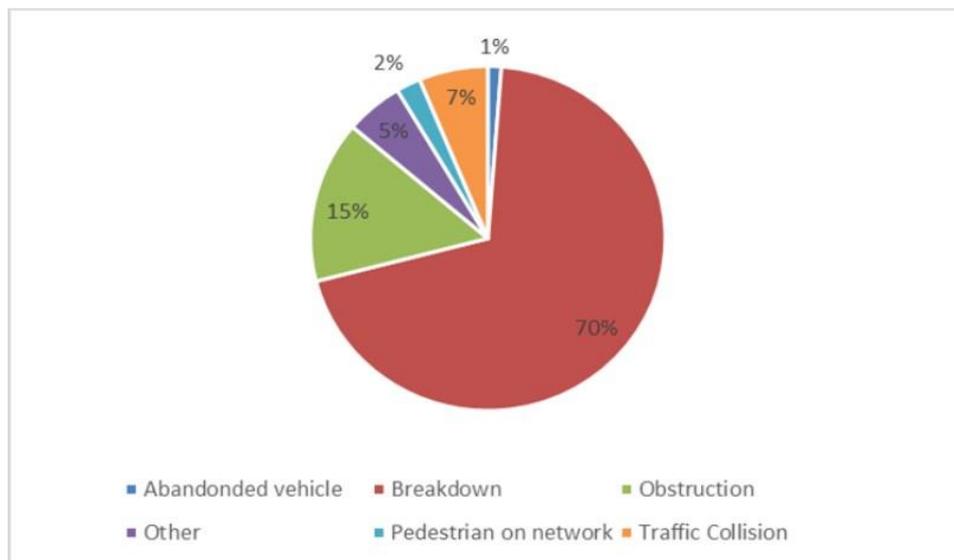
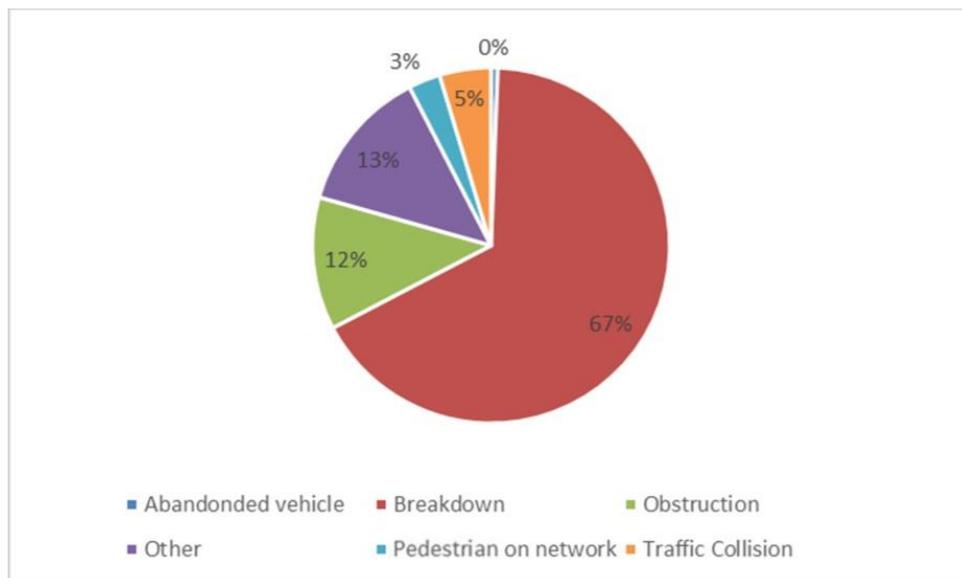
Figure 4.19 shows that breakdowns make up 70% of incidents on the controlled motorway link with Figure 4.20 showing 67% of incidents on the all lane running section are classified as breakdowns.

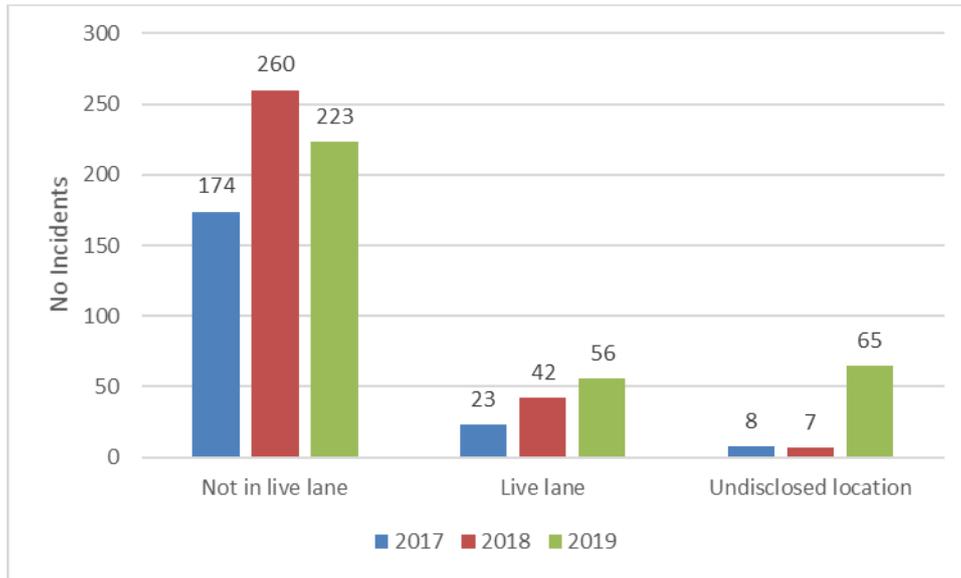
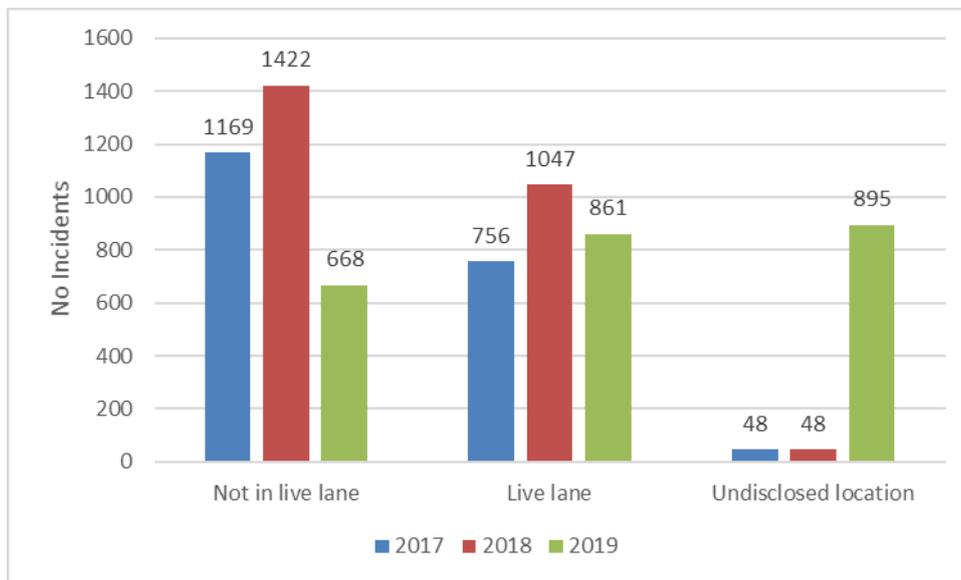
The number of breakdowns logged as live lane and as non-live lane across all three years are shown in Figure 4.21 & 4.22⁸. In 2017 and 2018 on the all lane running sections there were between 1.3 and 1.4 non-live lane breakdown incidents for every live lane incident. On the controlled motorway section there are far fewer live lane stops, again indicating that road users make use of the hard shoulder in around 86-89% of reported breakdown incidents. It should be noted that non-live lane incidents may go unrecorded.

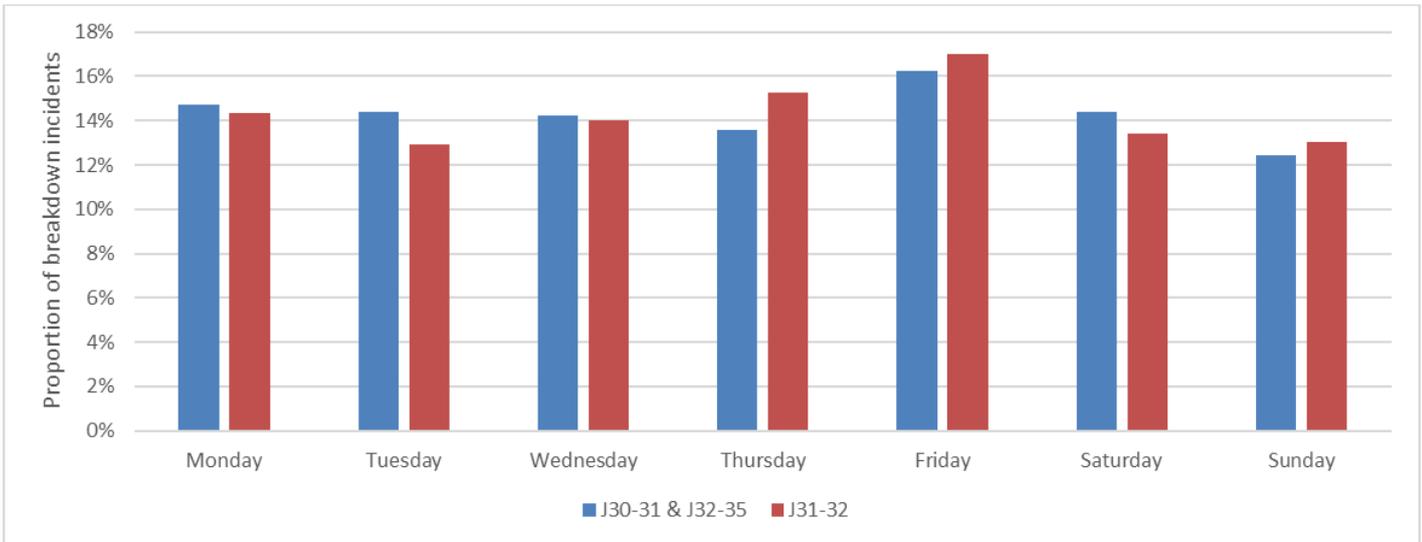
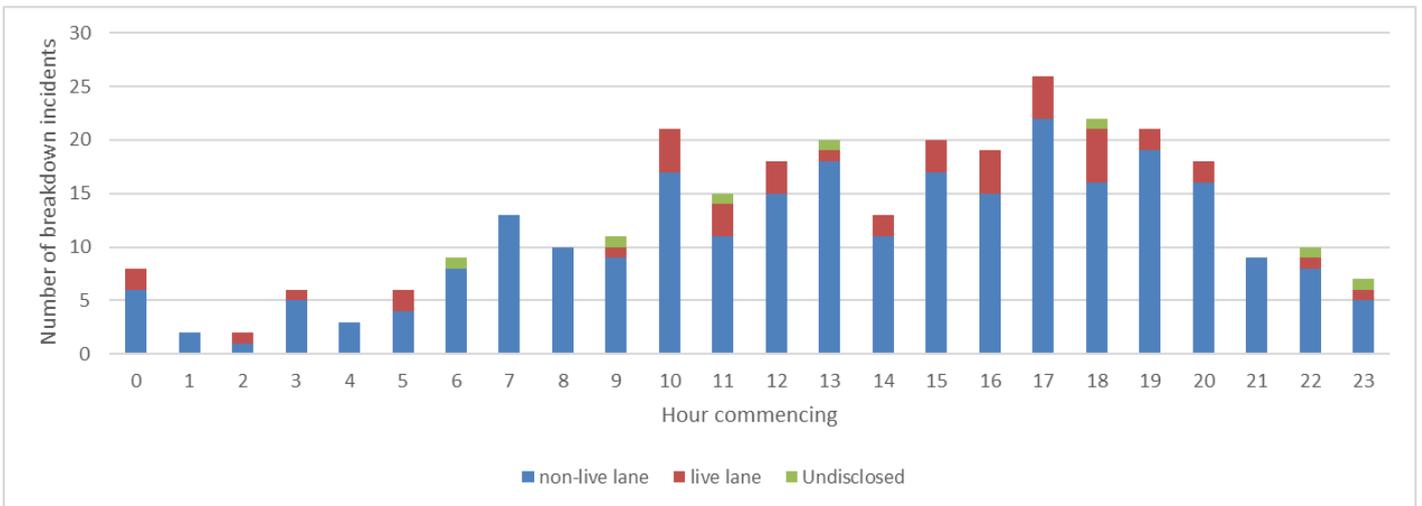
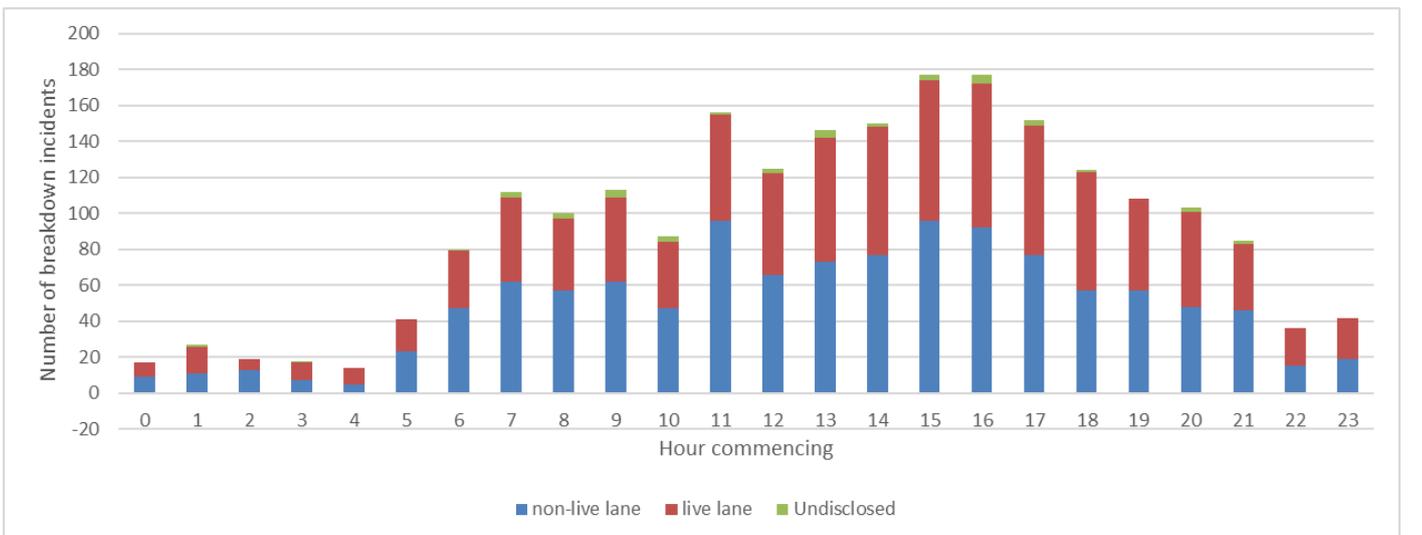
These reported breakdowns have been further analysed by day of the week and time of day; the results are shown in Figures 4.23 - 4.25. The day of week analysis shows that the proportion of breakdowns that occur on Saturday and Sunday is marginally less than the Monday-Friday average. The hour of day analysis on the all lane running sections shows that the number of breakdowns seems to peak later in the afternoon and early evening. The busiest three hours for breakdowns are 15:00 to 18:00, however there is a less noticeable pattern in the morning peak between 7:00 to 8:00.

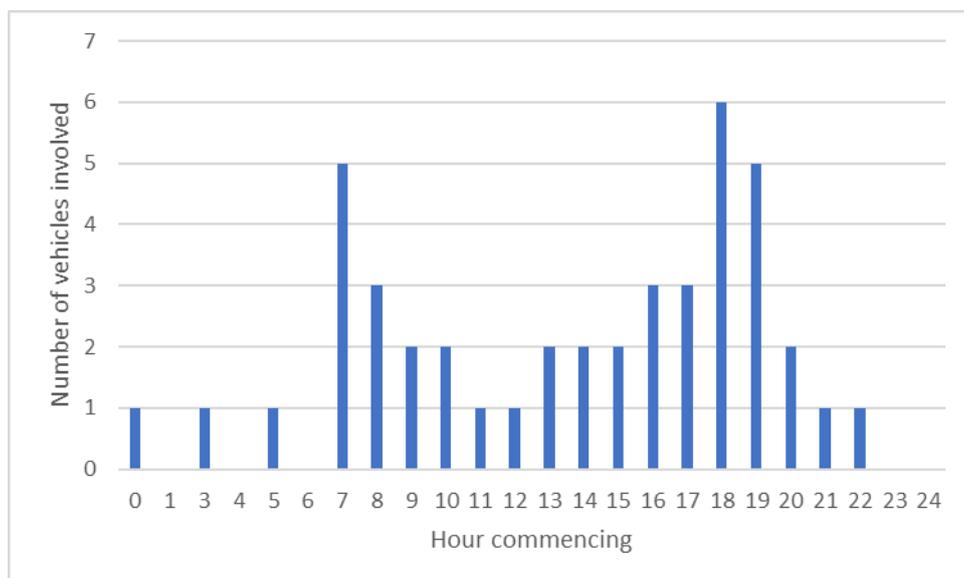
Figure 5.9 Time of occurrence of lane changing collisions between Junctions 32 to 35

Figure 5.9 shows the split of collisions by the hour in which they occur. Lane changing collision occurrence appears to align with peak periods on the M1, i.e. there are more collisions at peak times. There are slightly more collisions in the evening peak, which is similar to the findings for HGV collisions.

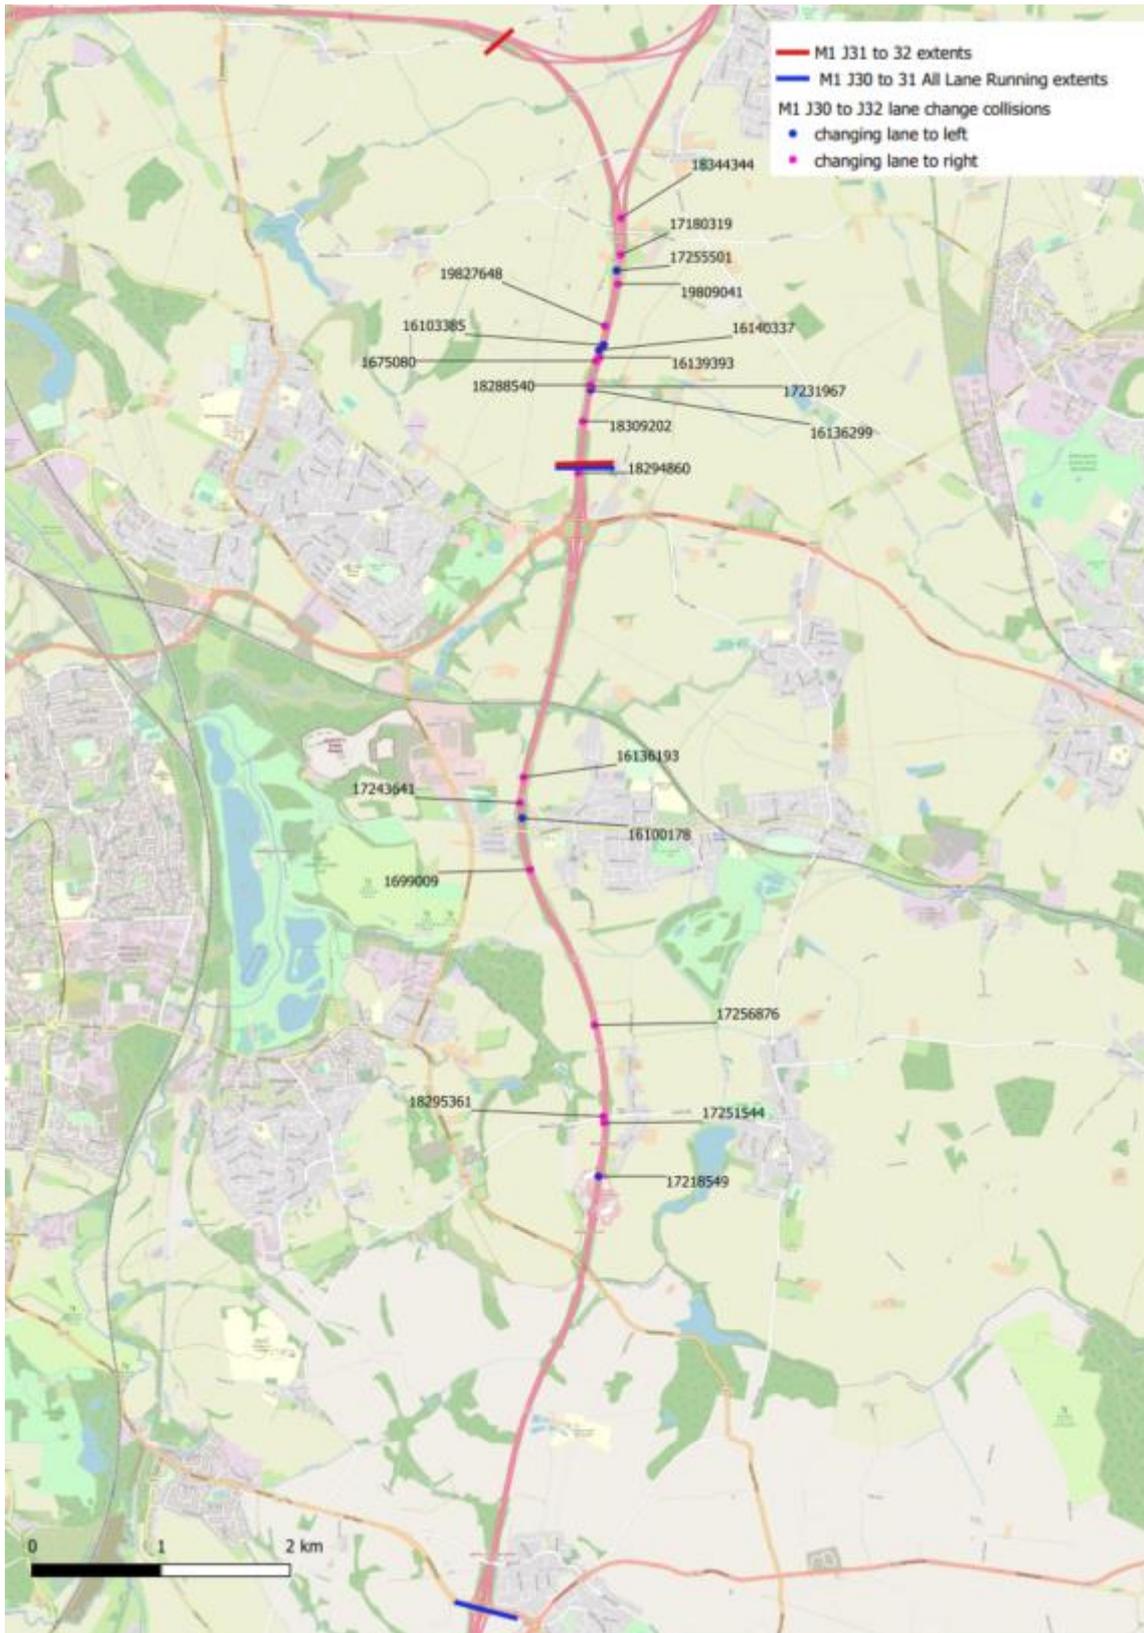
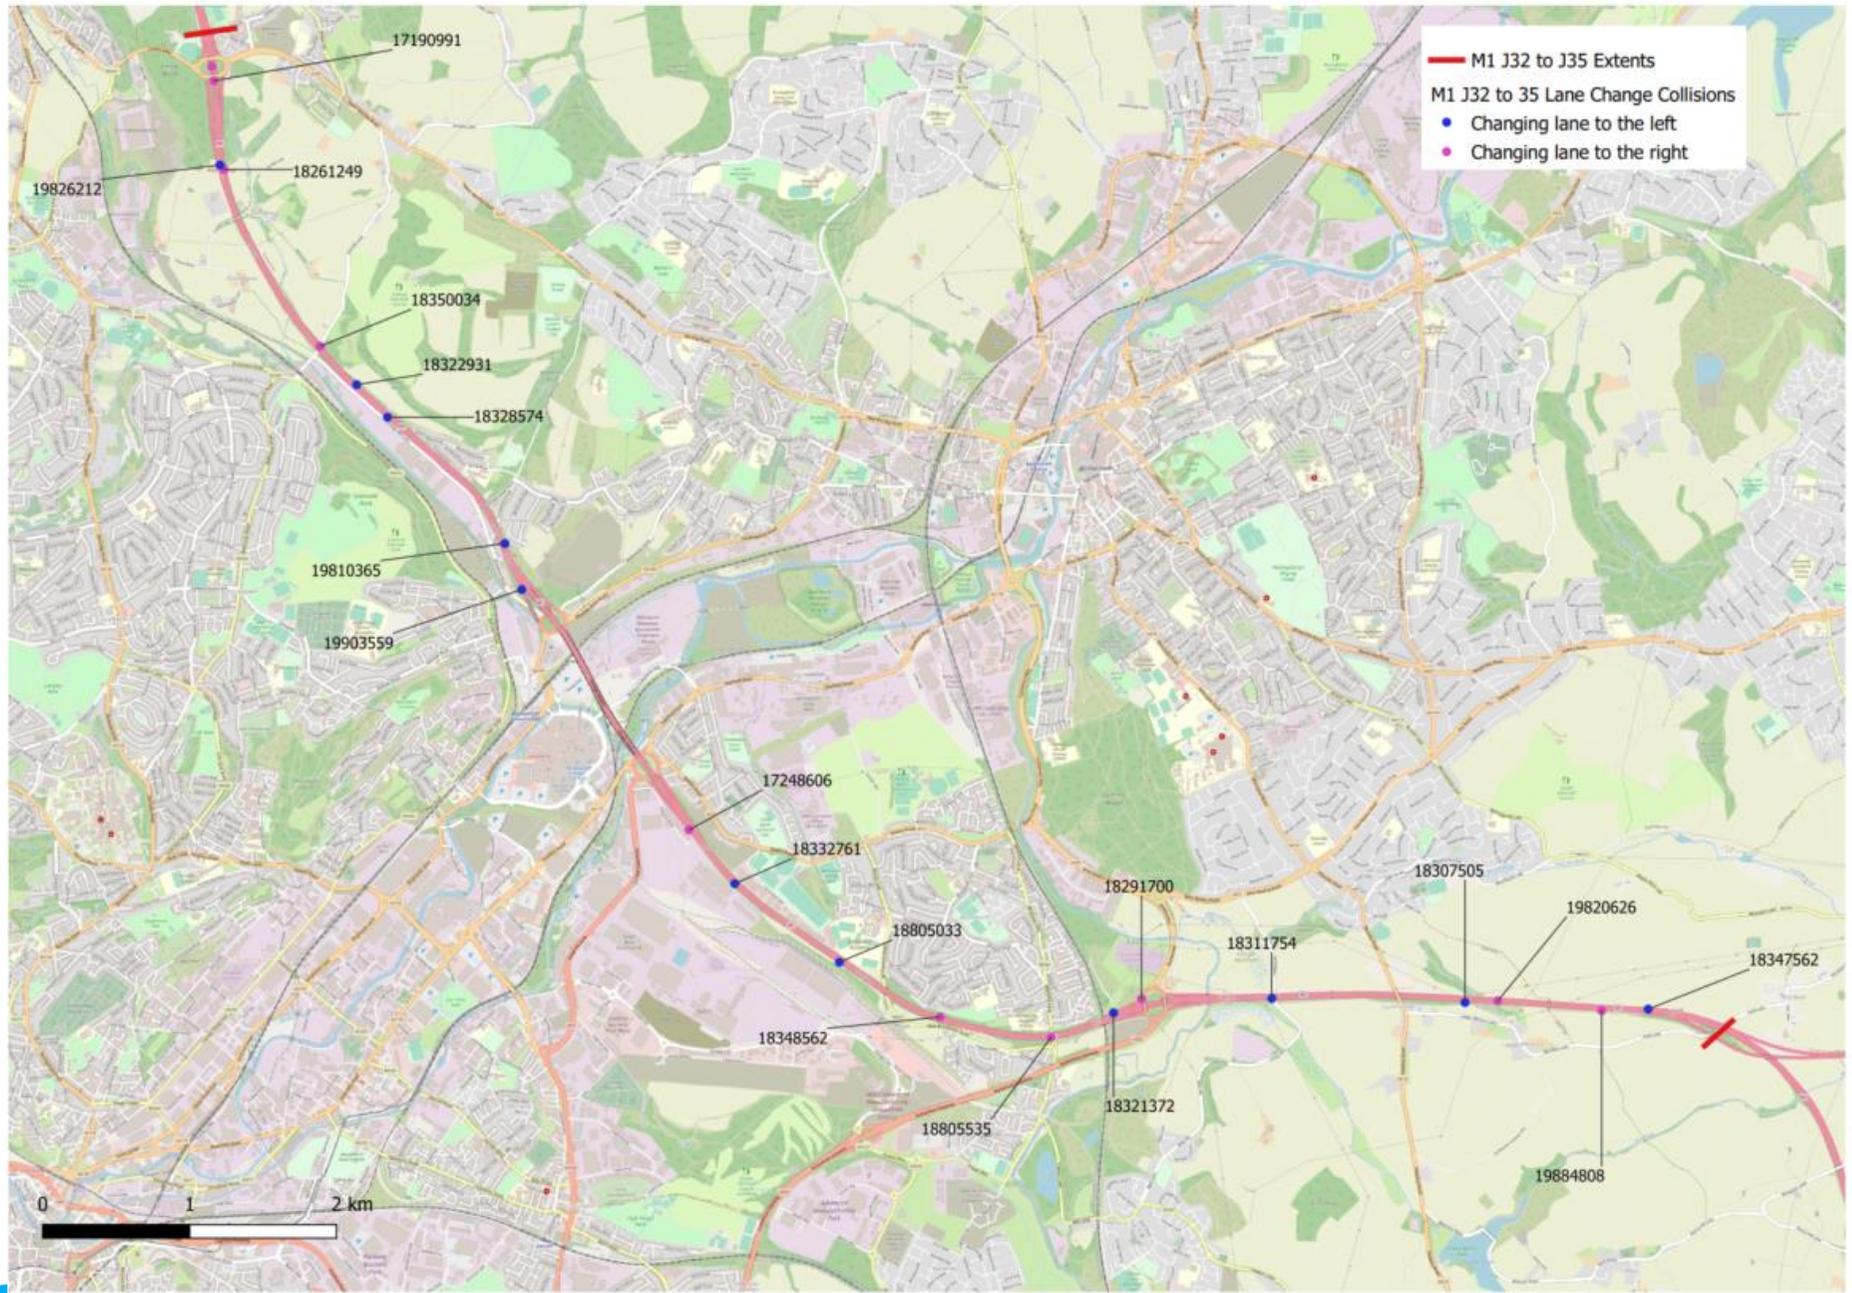
Appendix F. Lane change collisions (after)

The data collation and review exercise suggested that the number of lane changing collisions had increased in the after period, and further analysis of the after-collision data has been undertaken. A location plan of all lane changing collisions can be found in Appendix F. In total there were 38 collisions in the after period with 18 on the Junction 30 to 32 section and 20 on the Junction 32 to 35 section, see Table 5.9. The majority of the lane change collisions between Junction 30 to 32 occurred on the Junction 31 to 32 link and have been considered above in section 5.6. Collisions are fairly evenly split between the northbound and southbound on both sections; see Table 5.10.

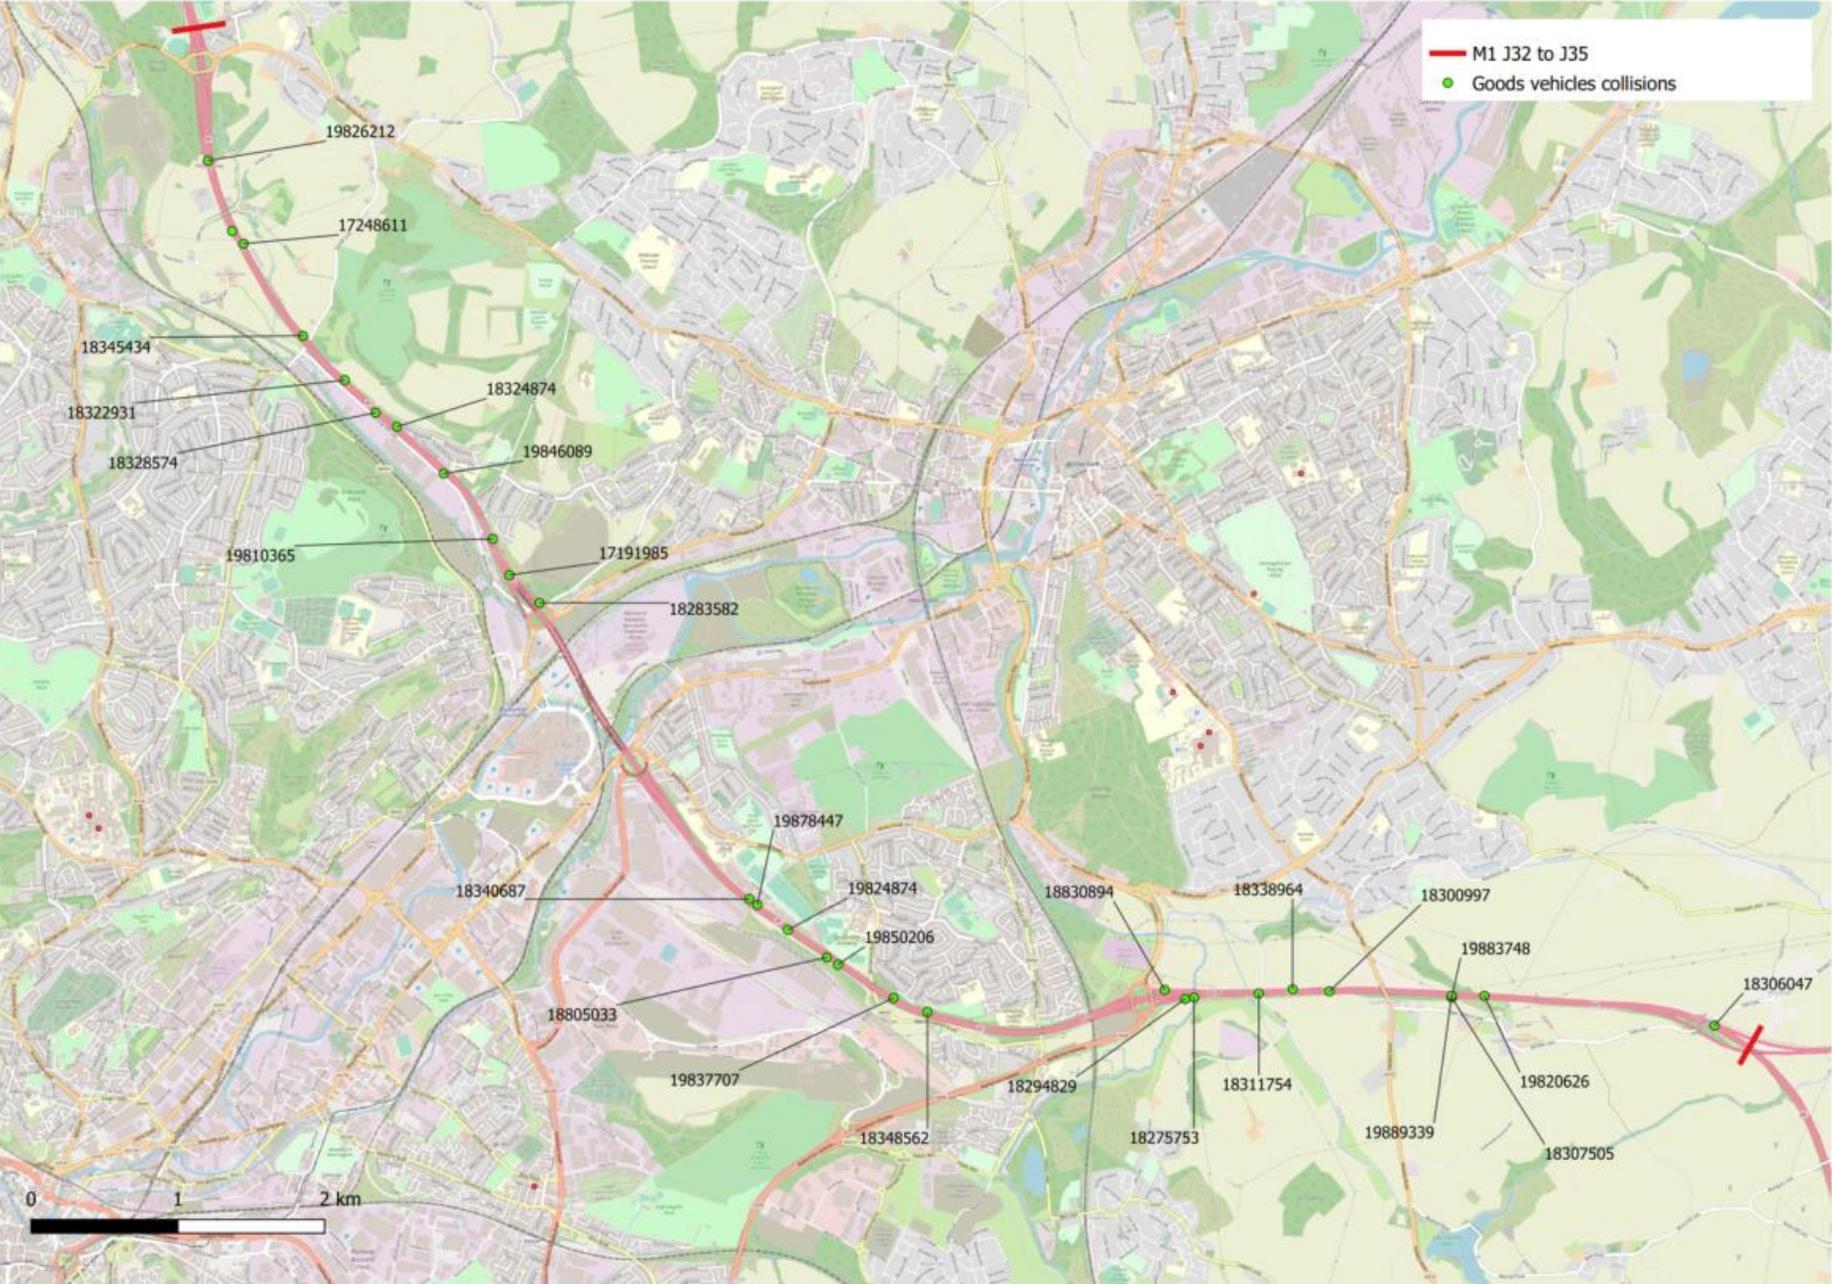
Appendix G. Goods vehicle collisions between J32-35 (after)

Although an overall increase in goods vehicle collisions has been identified in this section, no clear treatable issue is apparent. A location plan of all goods vehicle collisions can be found in Appendix G.
