**Specialist Professional and Technical
Services (SPATS) Framework
Lot 1 & Lot 2**

**Task 1127
Smart Motorway Incident and Infrastructure
Investigation – M1 Junction 30 to 35**

July 2021

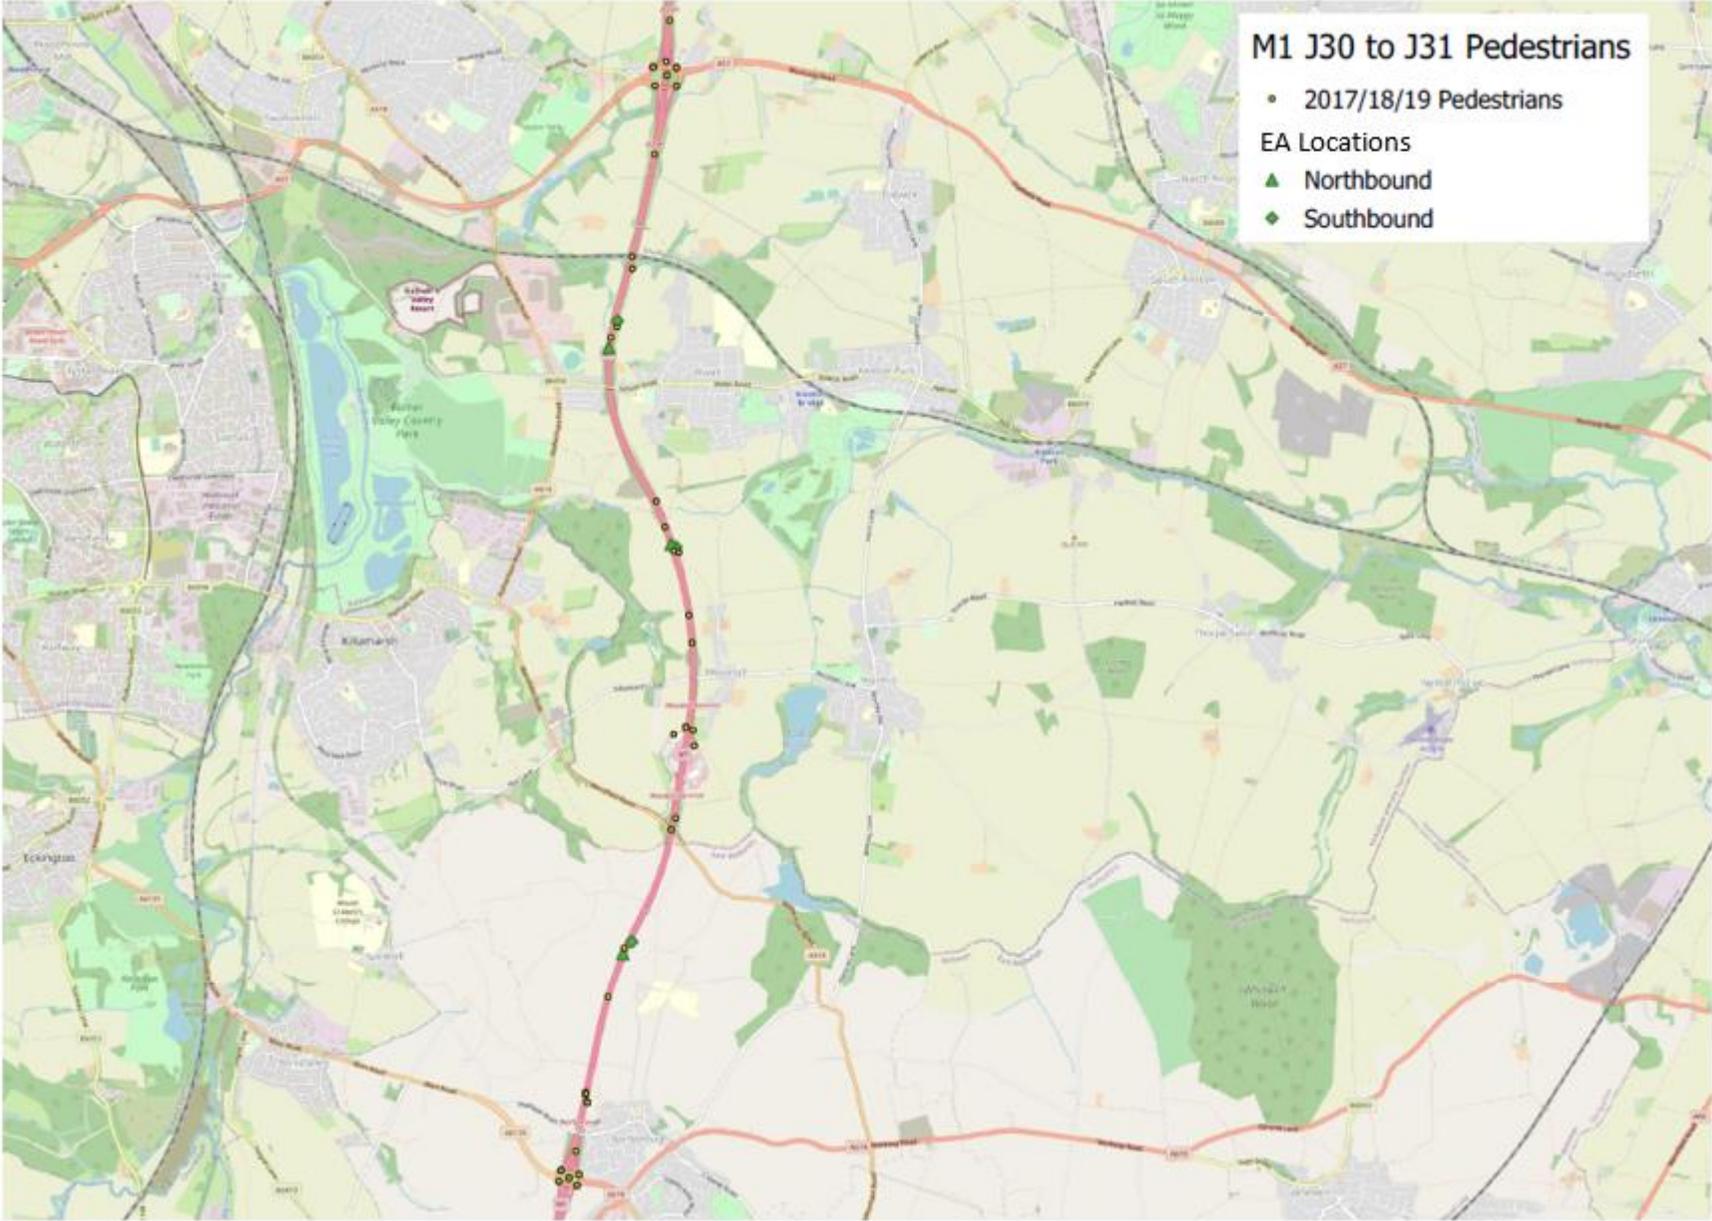
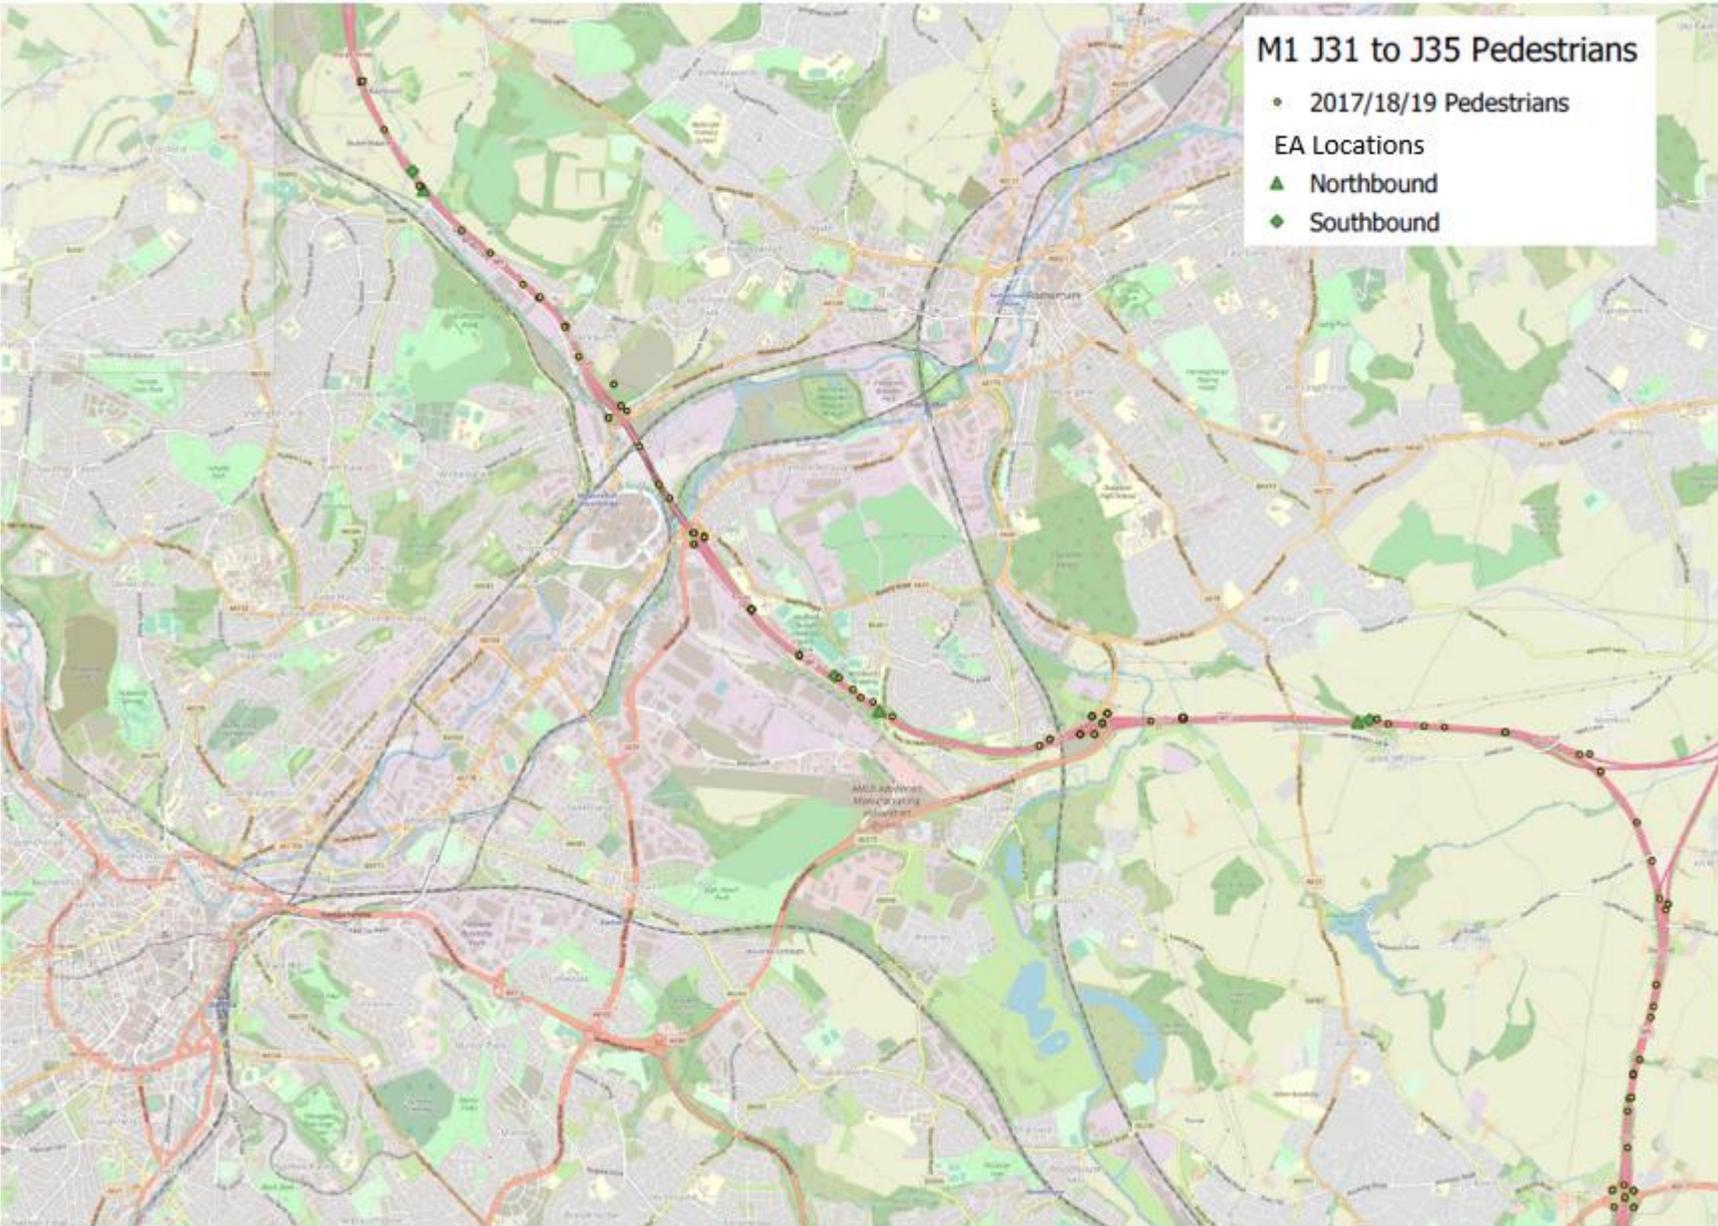
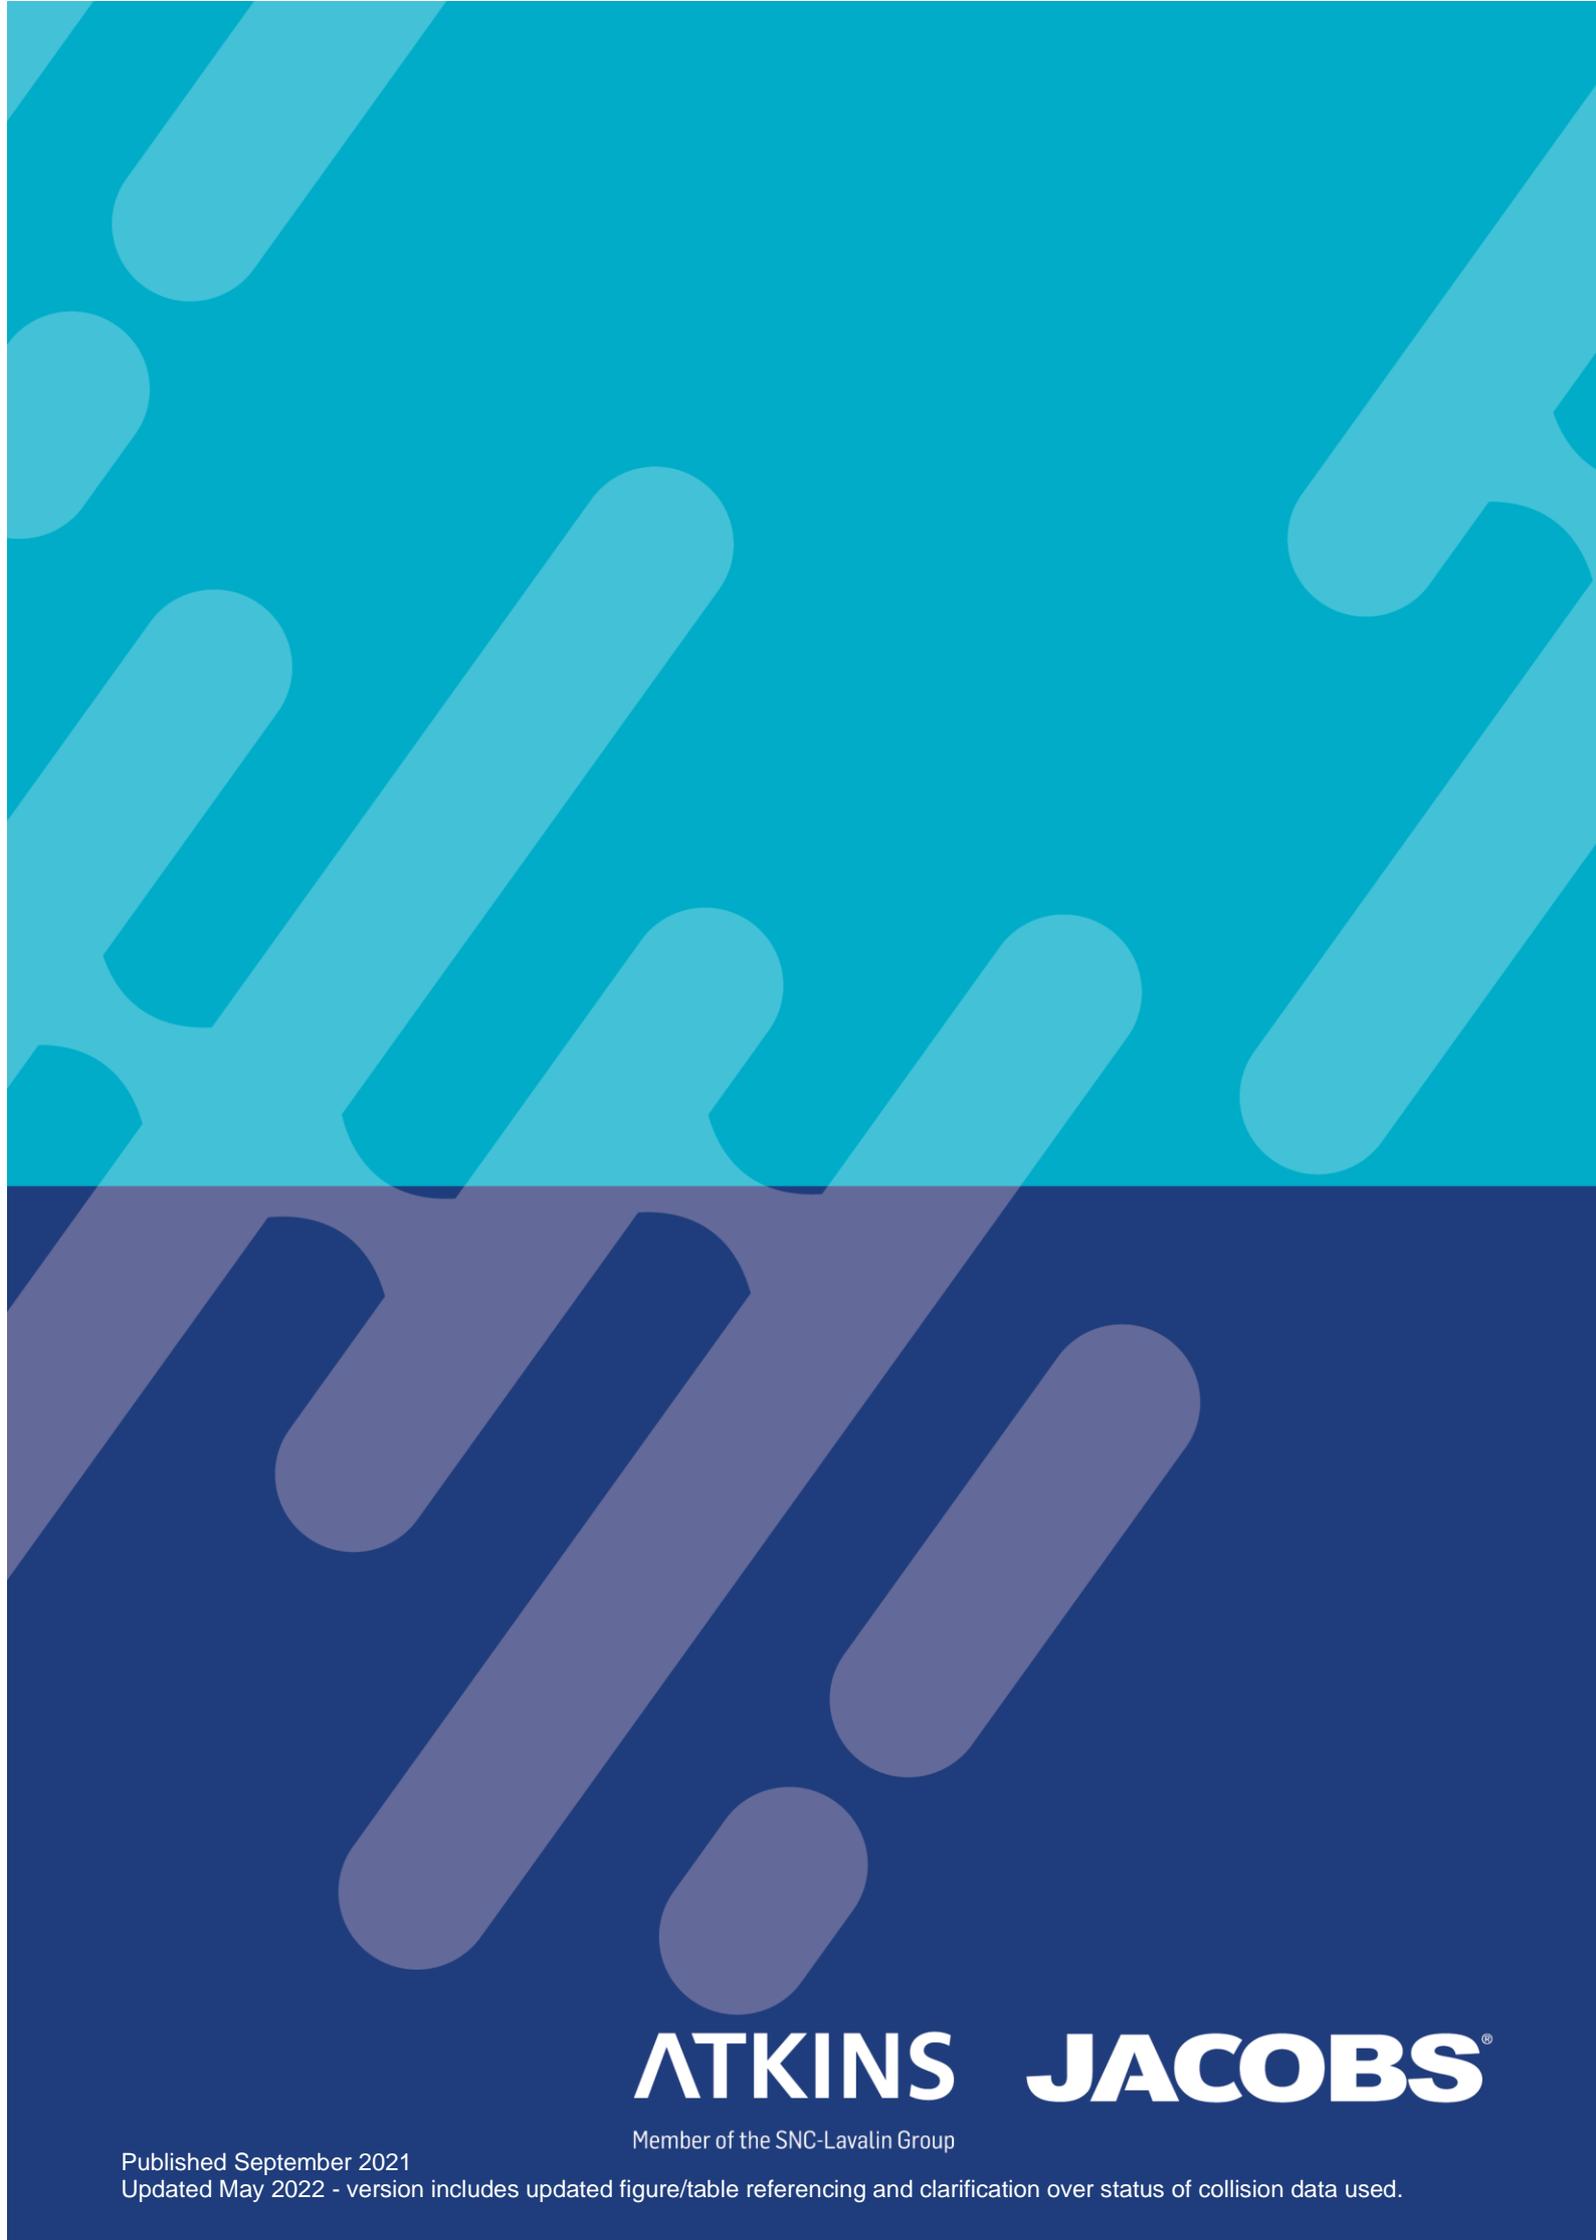
Appendix H. Pedestrians on network recorded incidents (2017 to 2019)

Pedestrian collisions and incidents have been reviewed and the range of crossing and potential access points (i.e. via slip roads close to urban areas) is a risk factor. Measures to prevent pedestrian incursion at slip roads are recommended.

To identify detailed intervention measures it is recommended to review the pedestrian provision, fencing and other deterrents. The large scheme process set out in GG 142 *Walking cycling and horse-riding assessment and review* would be a suitable structure for this exercise.
