**Specialist Professional and Technical  
Services (SPATS) Framework  
Lot 1 & Lot 2**

**Task 1127  
Smart Motorway Incident and Infrastructure  
Investigation – M1 Junction 39 to 42**

July 2021

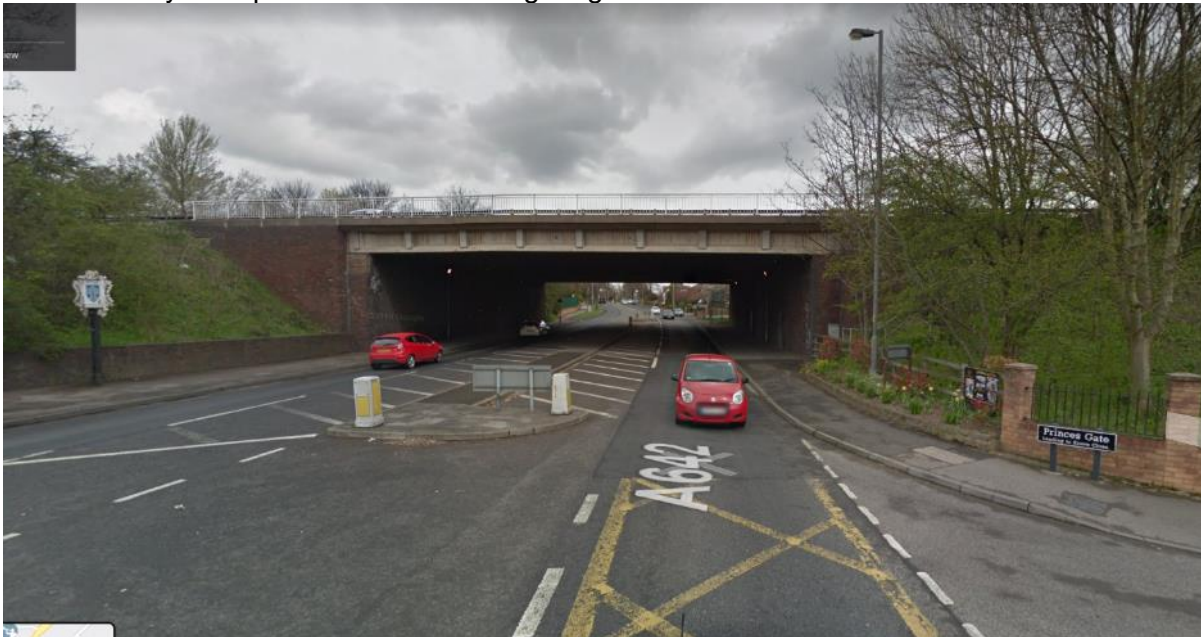
Figure 5.8 Horbury Road Bridge viewed from the west (source: Google Streetview, August 2020)

Wide footways are provided and some lighting is evident.

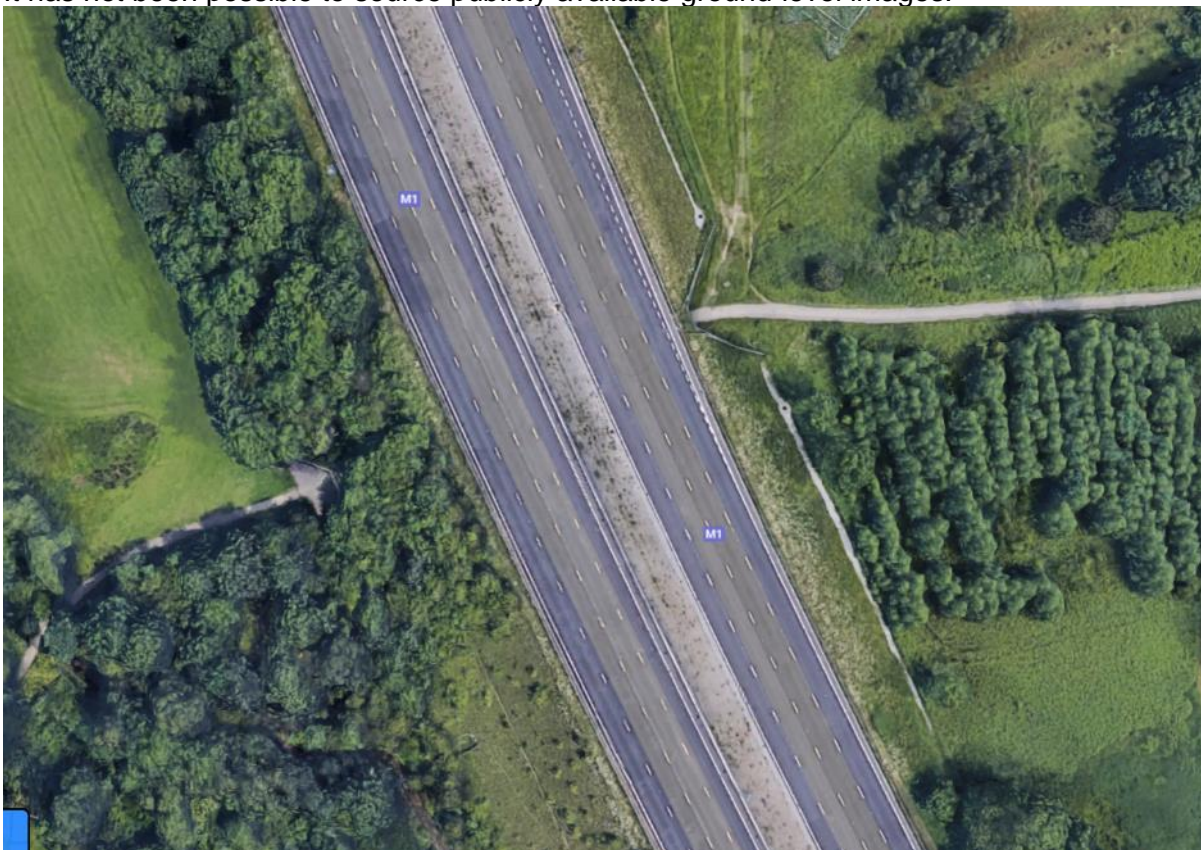
Figure 5.11 Baptist Lane Pedestrian Subway (source: Google Maps, August 2020)

It has not been possible to source publicly available ground-level images.

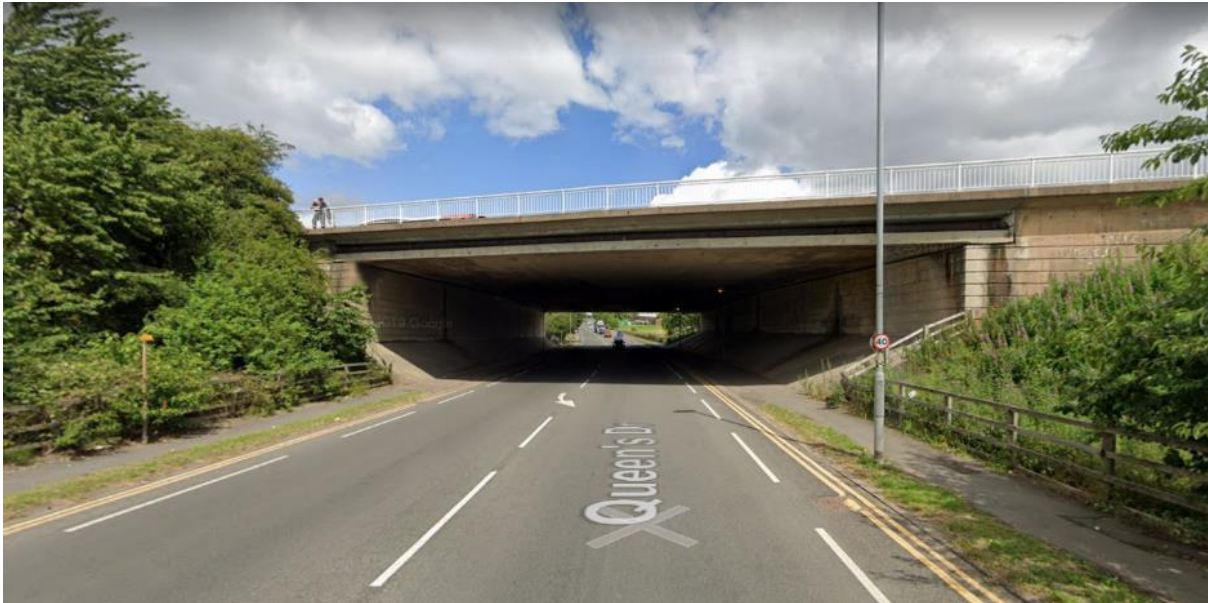
Figure 5.12 Queens Drive Bridge viewed from the west (source: Google Streetview, August 2020)

In Figure 5.12, note coincidence of pedestrian visible on carriageway in this image, apparently next to a stopped vehicle (most likely ex-vehicle pedestrian).

Footways are provided and some lighting evident.
