## STRUCTURES MOONSHOT

# Delivering the Moonshot Ambition

# Huntingdon Viaduct – History

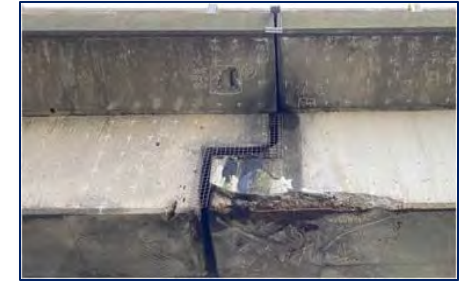
## Half-joint Bridges:

# Priority Risk Structures

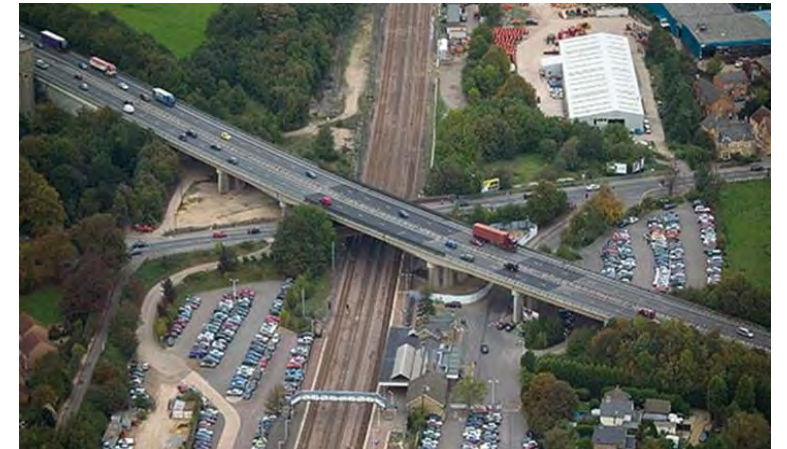
## The Huntingdon Railway Viaduct Trials present two opportunities:

- The ability to verify the conclusions drawn from 20 years of monitoring (e.g. Have wire breaks occurred in the post-tensioning system, and have they occurred where the acoustic emission system indicated?)
- A test bed for established and emerging technologies/methods (relatively high TRL technologies), with direct verification of results possible through careful hydro-demolition.

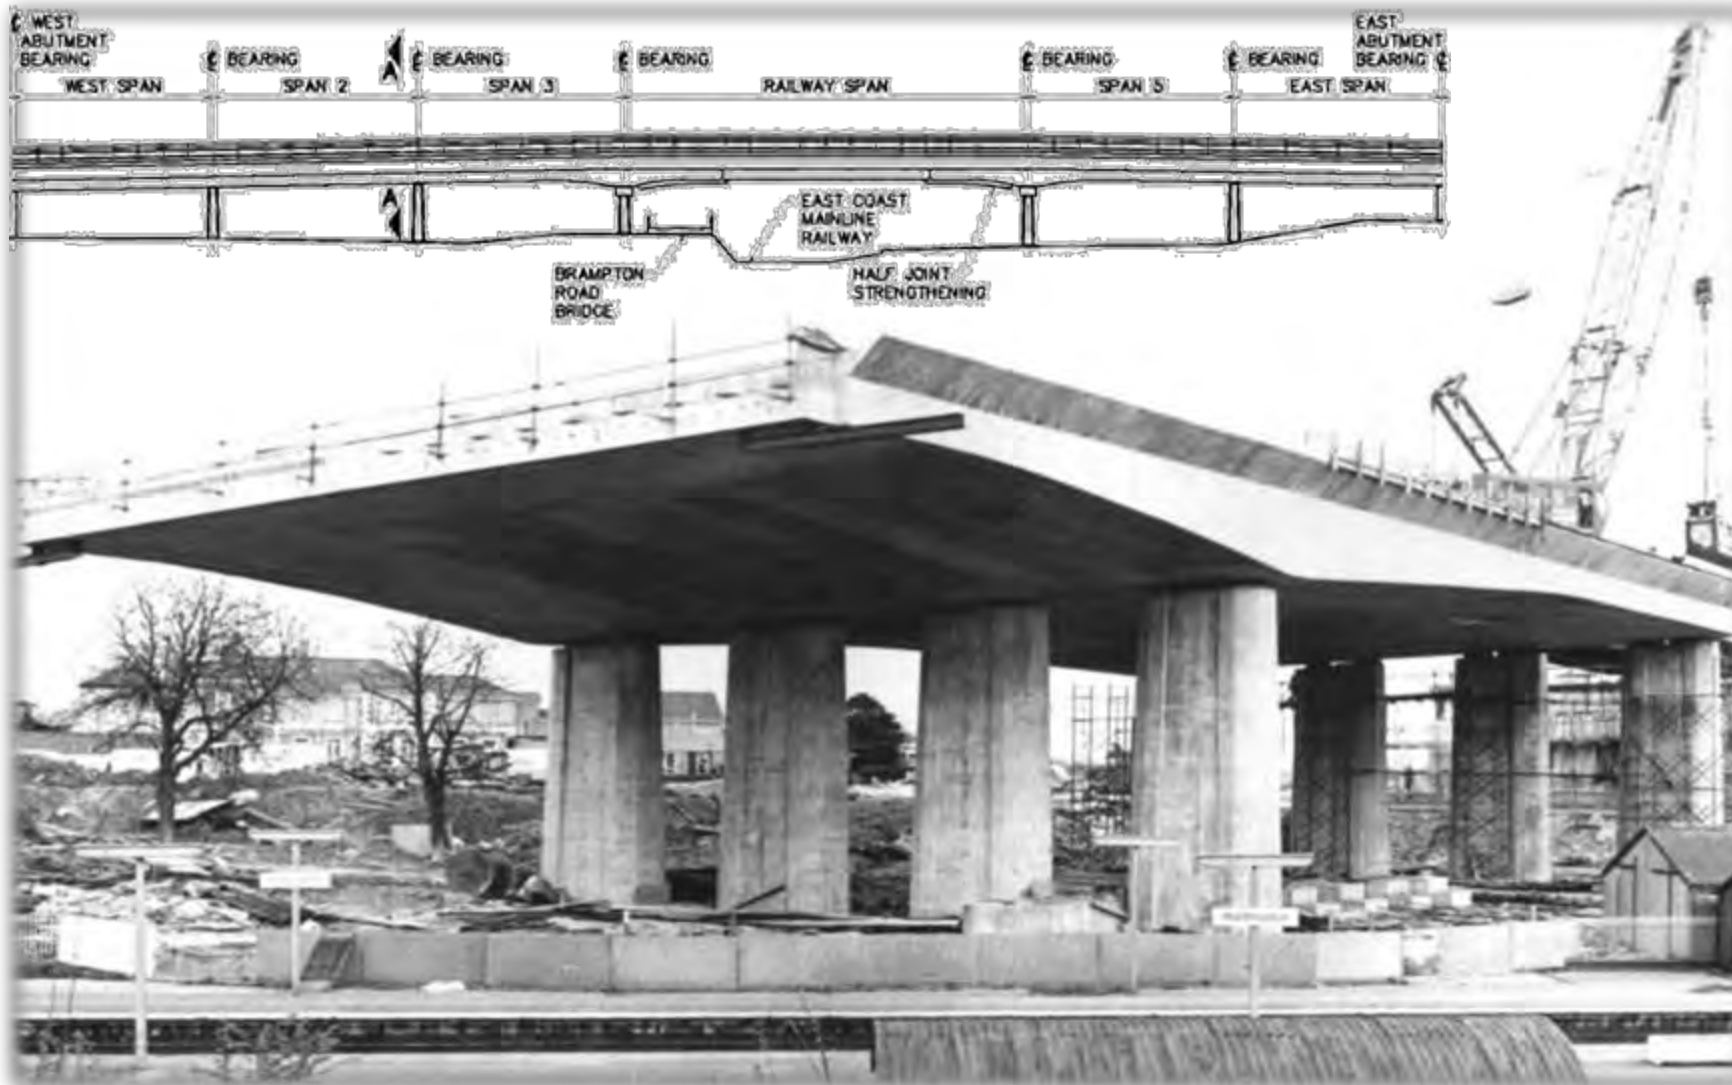
Construction Date – 1975

Total Length – 225.8m (6 spans)

Carried – A14 (4 lanes)

Crosses – East Coast Main Line  
& Brampton Road

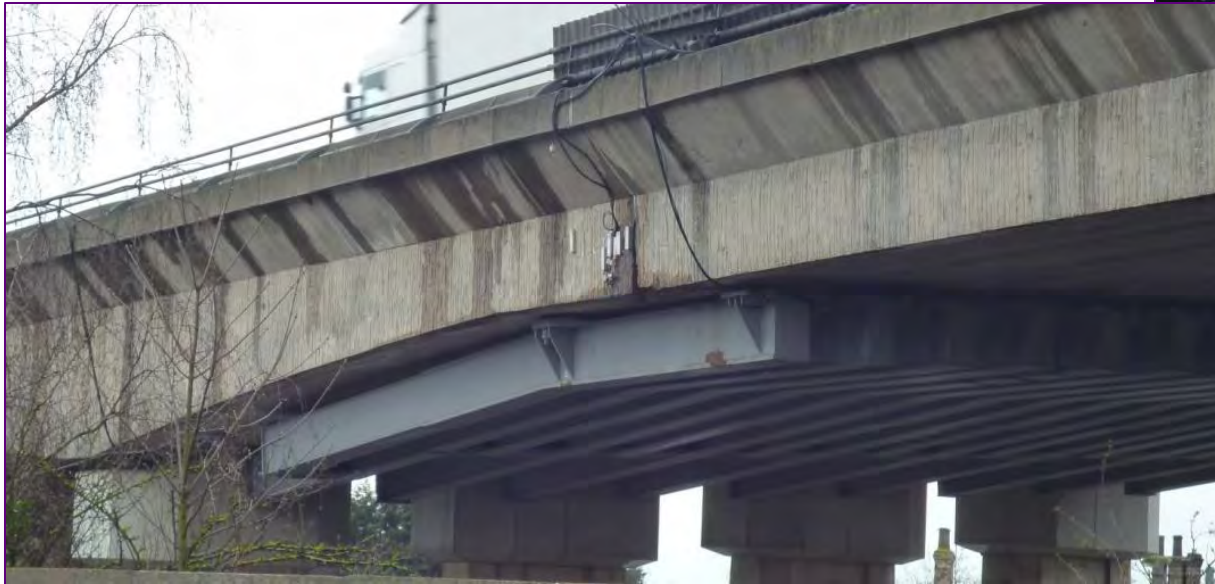
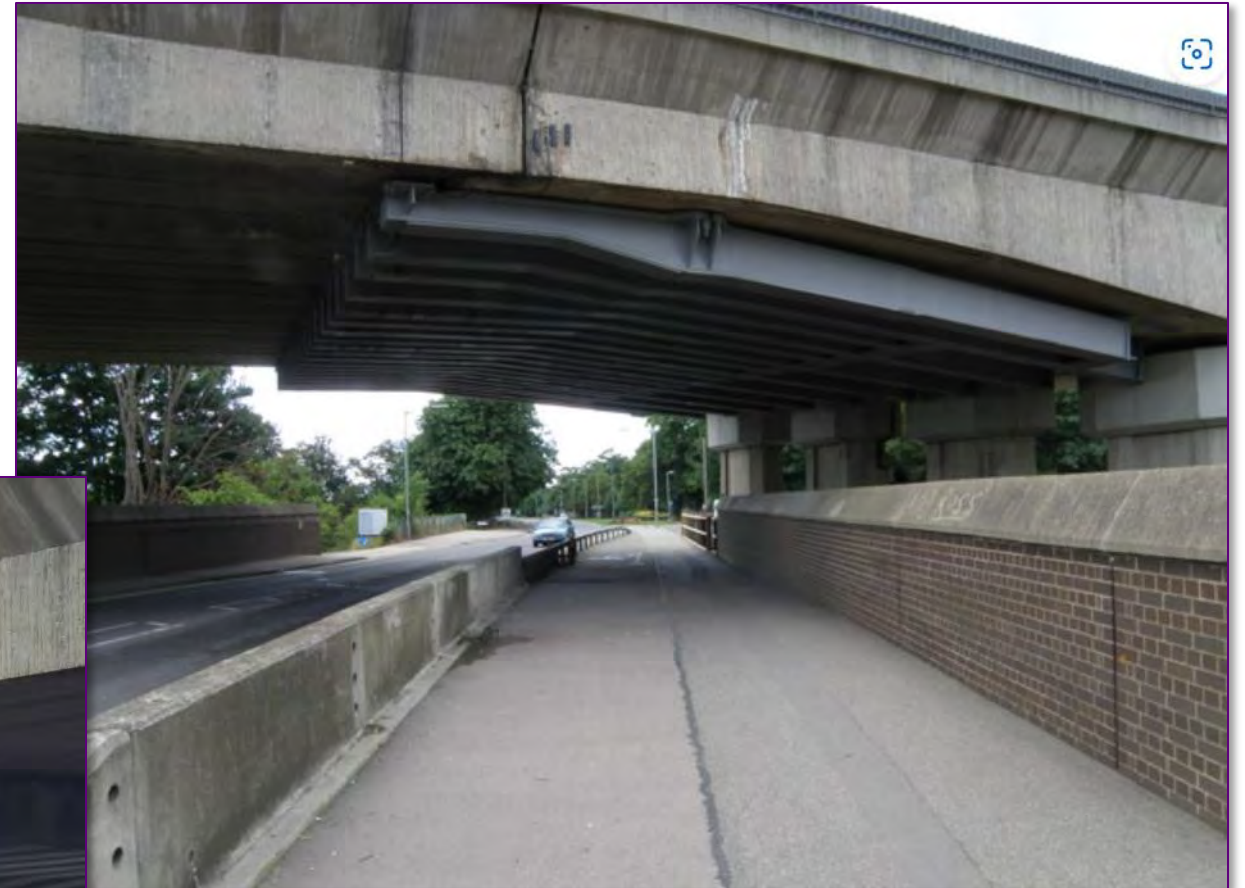
# Huntingdon Viaduct – History

- Temporary strengthening carried out in 2003
- Concerns of the condition of the main cantilever half joints
- Beams increased from 750mm to 1775mm
- £11m scheme completed in August 2013

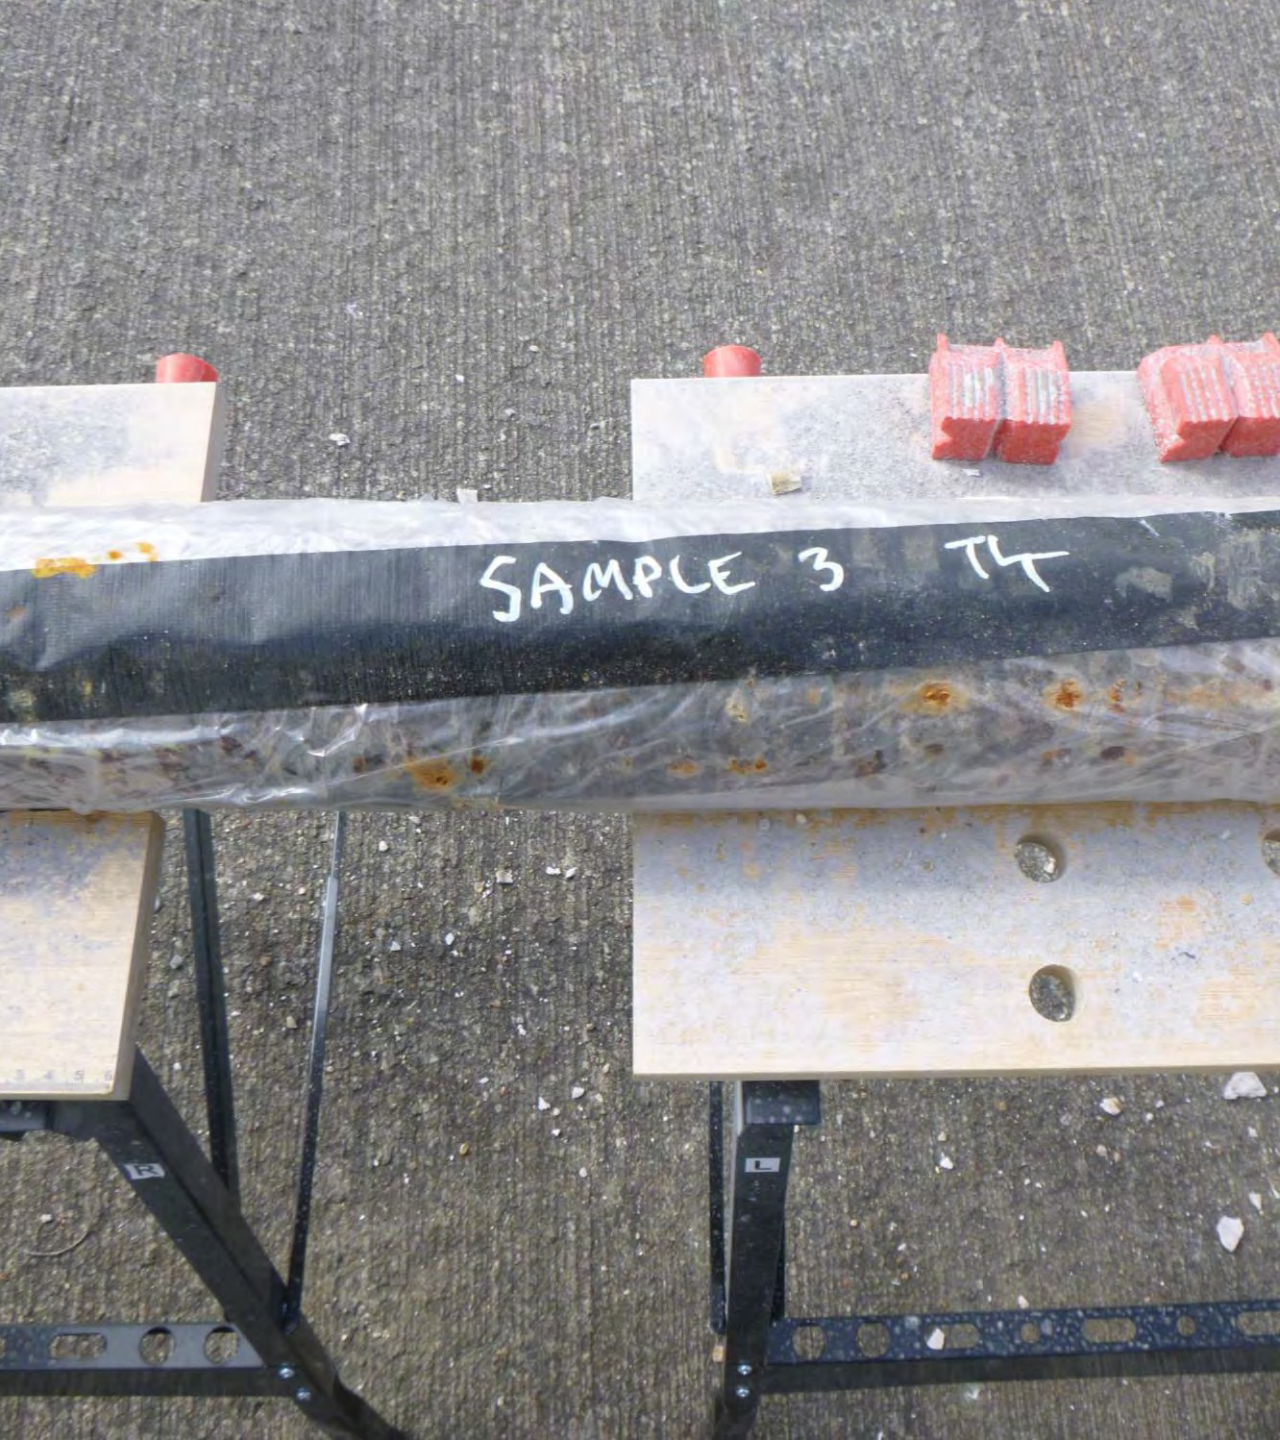
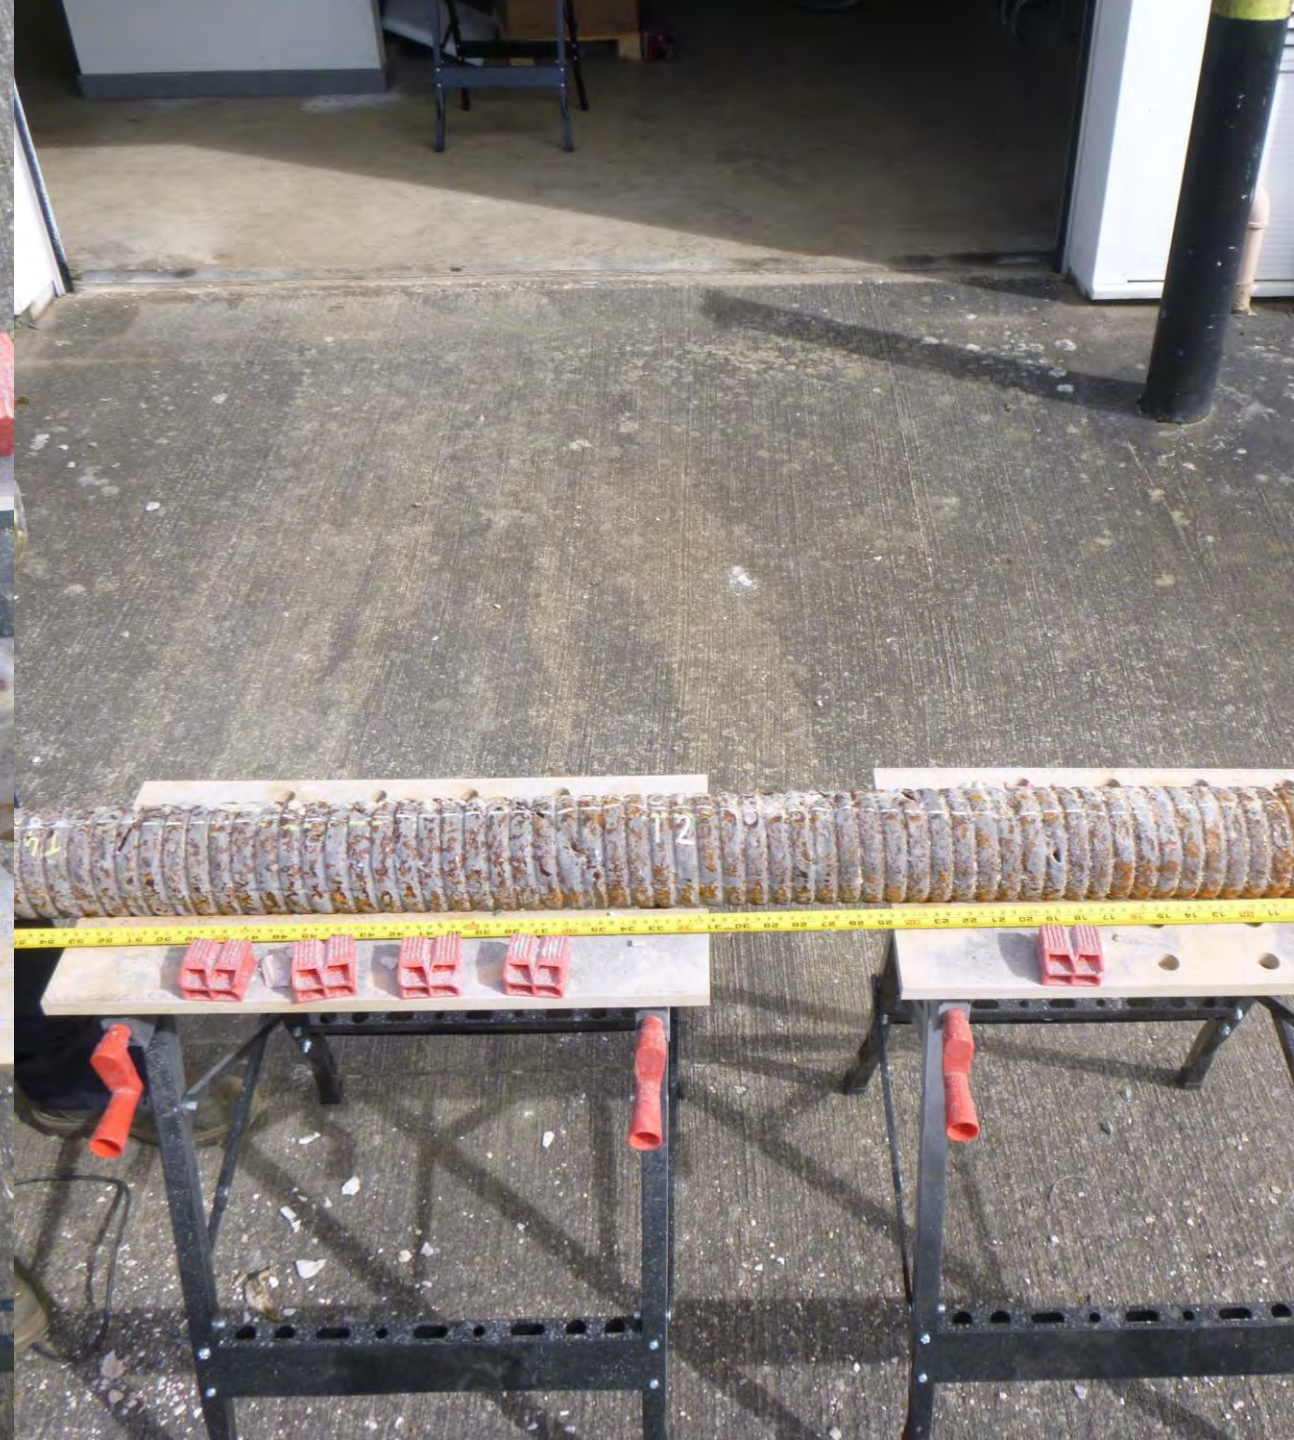
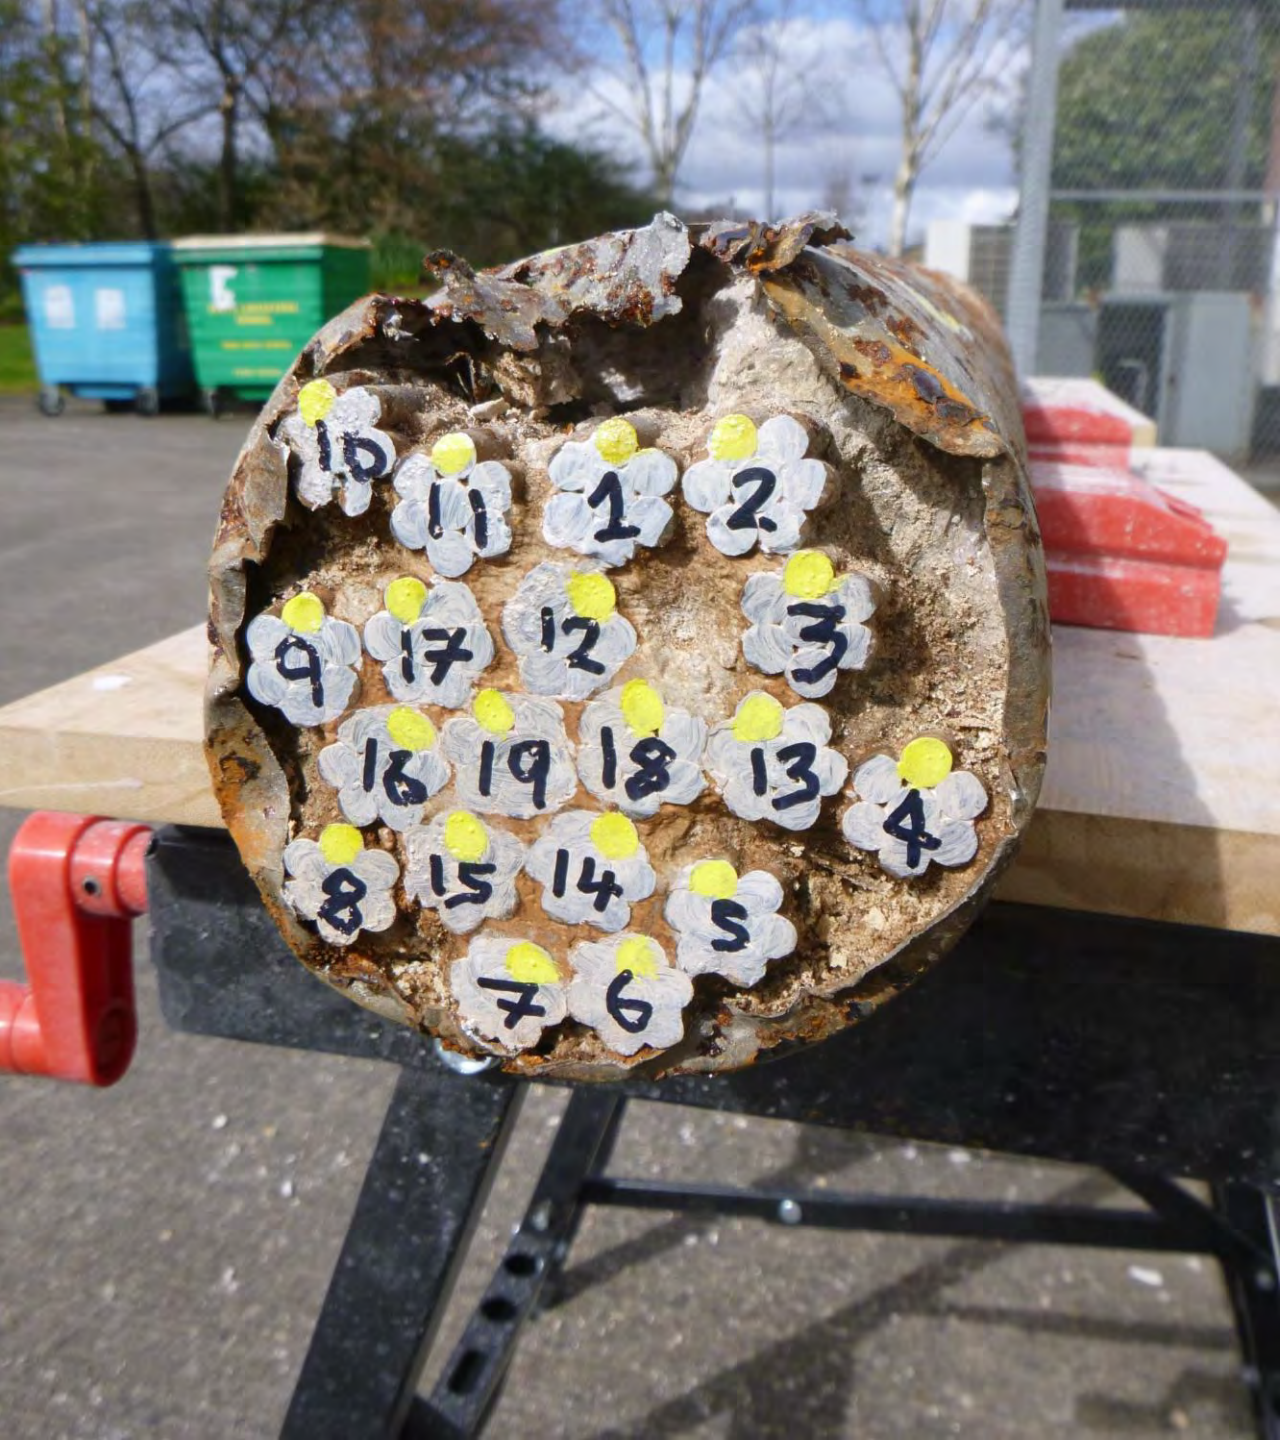
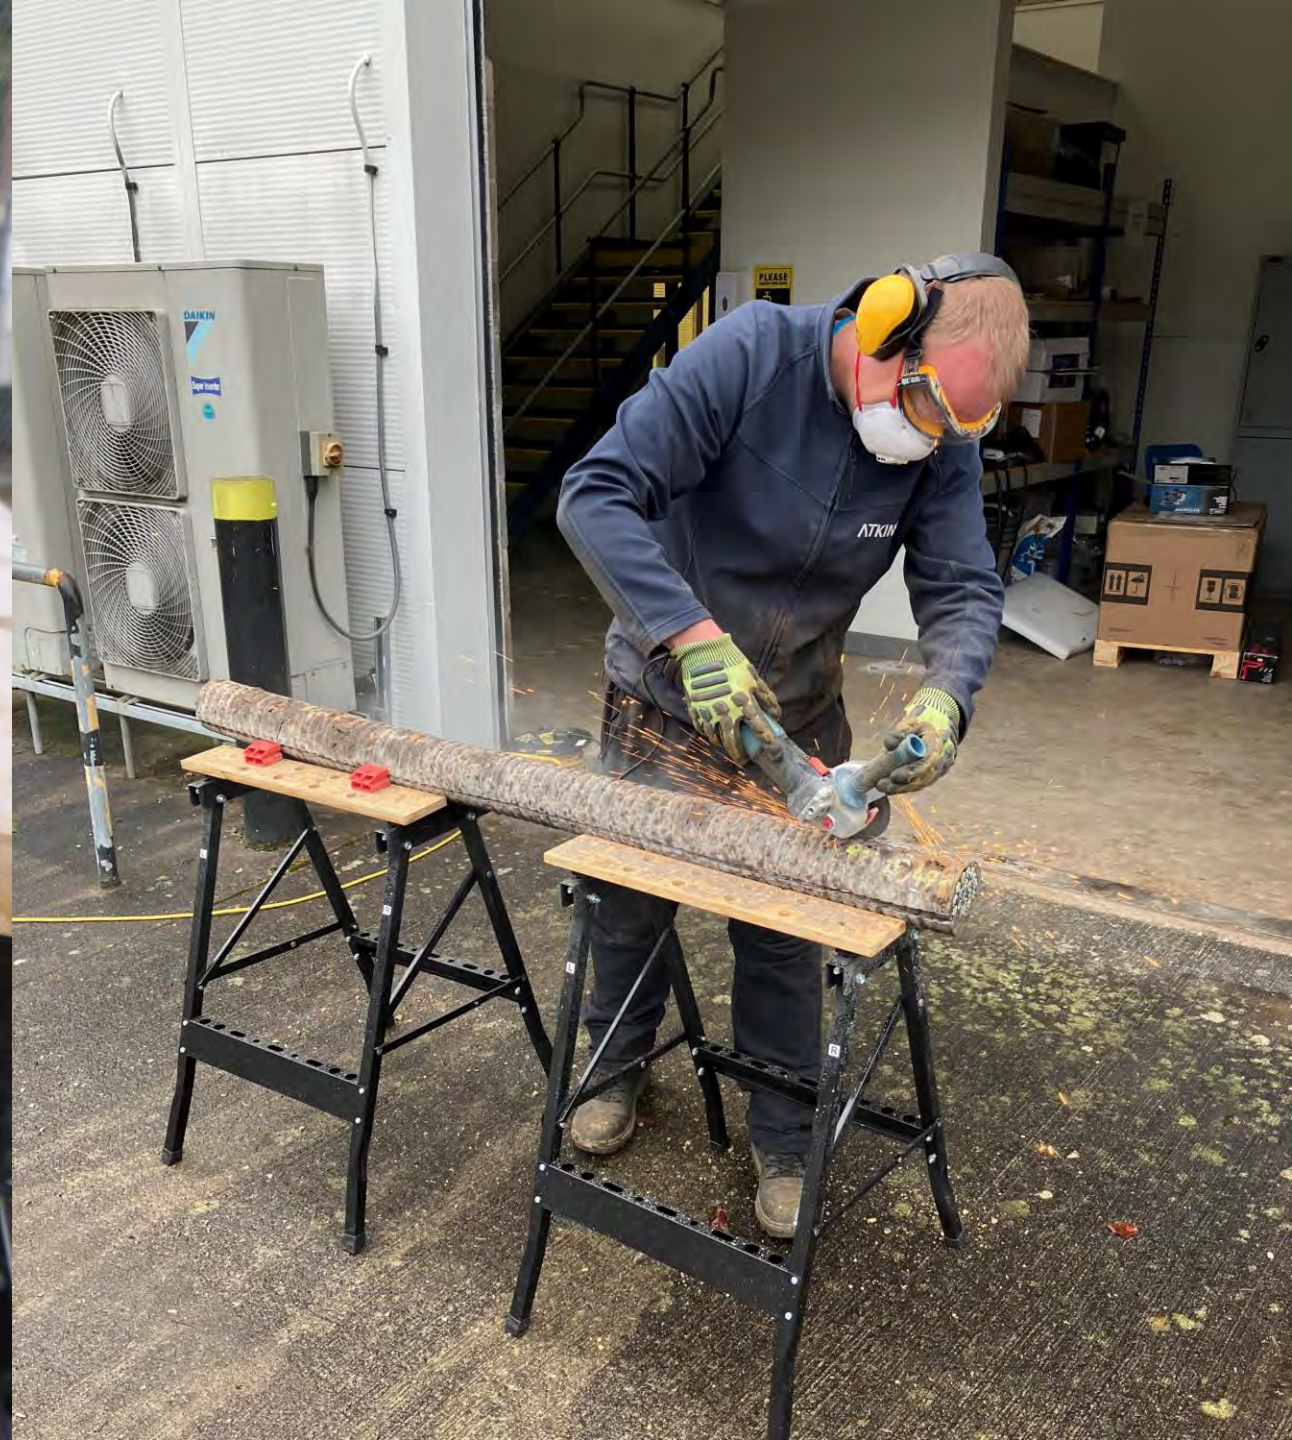
| All strands removed and subject to powered wire brushing operation to remove corrosion / adherent grout. Overview images of intact / cleaned strands displayed. Each strand subject to unwinding operation. Light corrosion product evident on strand / wire interiors and king wire. No measurable loss of section noted at any location on any wire / strand. | | | | | | | | | | | |

All strands subject to full unwinding operation. Defective regions itemised as follow:

| Reference Figure | Strand Number | Chainage (mm) | Approx % Loss of Section | Description |
|---|---|---|---|---|
| 1 | 1 | 270 - 400 | N/A | 0 - 270mm wires missing due to tensile fracture of all wires in strand. Fractures appeared brittle and not attributable to section loss – no additional broken wires in evidence. |
| 3 | 3 | 600 | 50 - 75 | Strand exterior in heavily corroded condition. Significant / major section loss on outermost wires at 600mm chainage. |
| 14 | 14 | 460 | 0 - 25 | Break in king wire 460mm chainage. Fracture appeared brittle in nature, not attributable to sectional loss. Surrounding wires in corroded condition but not deformed / stretched and displayed typical sectional loss. |

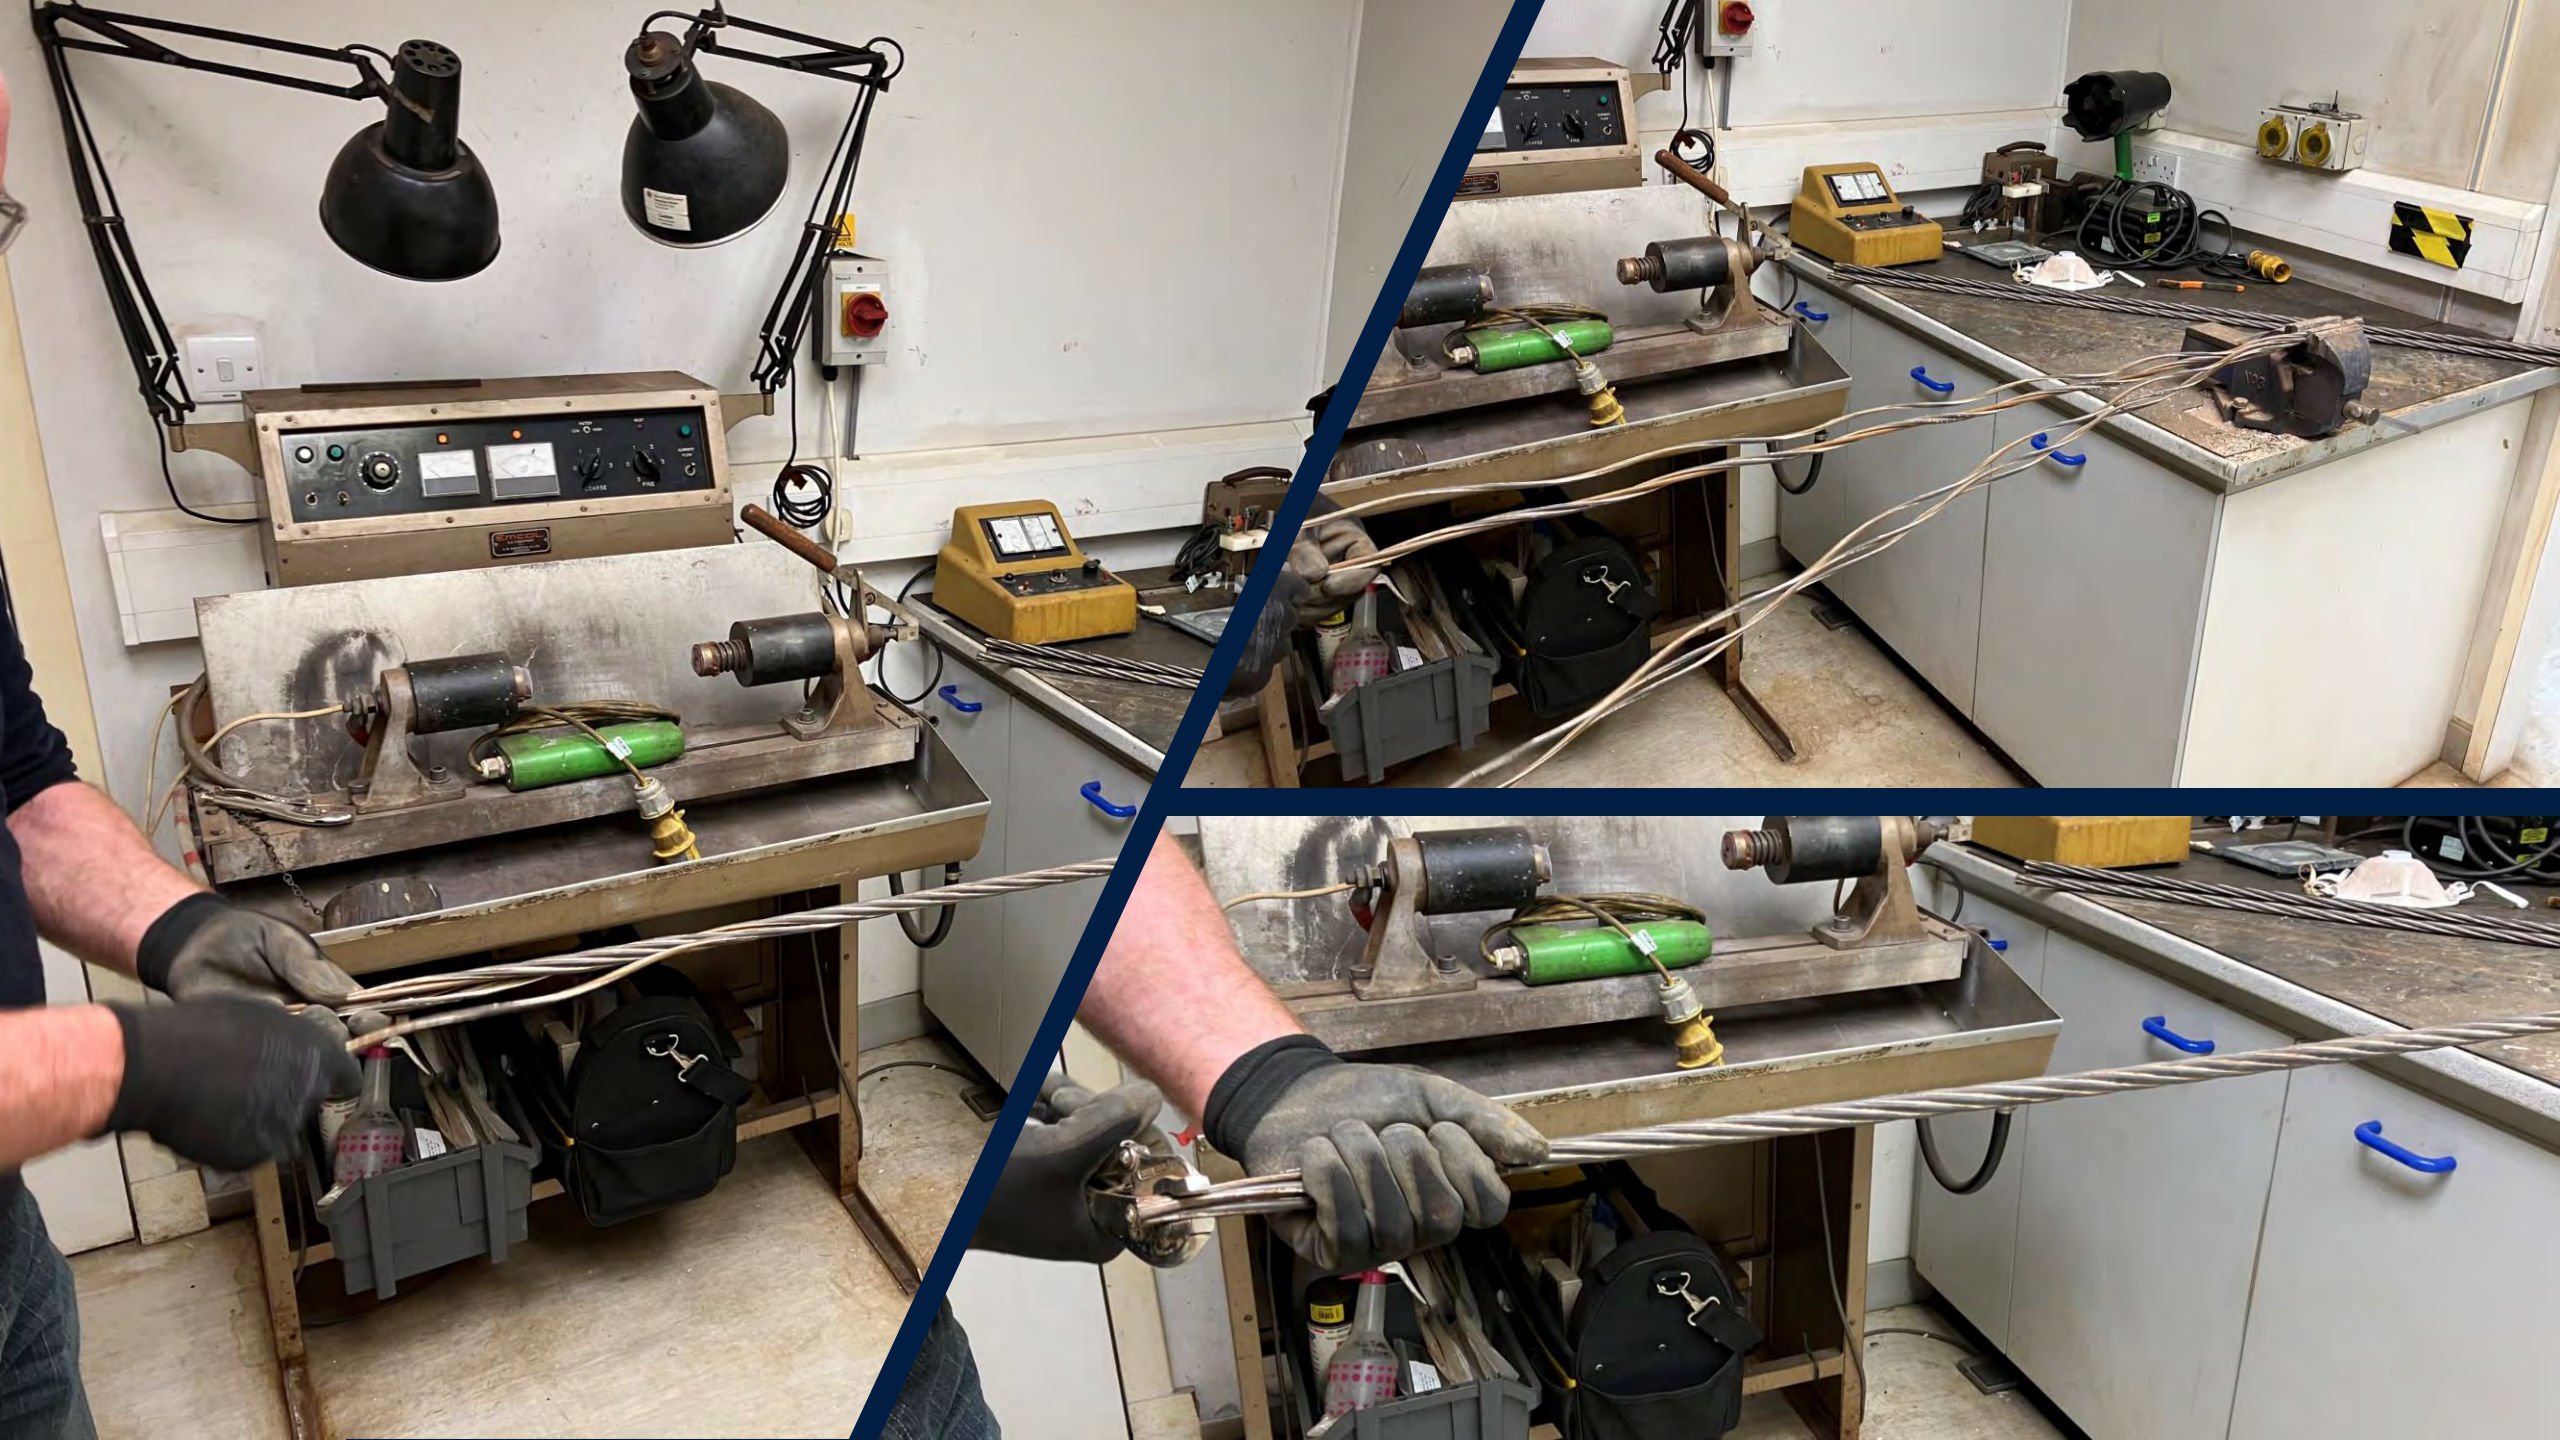
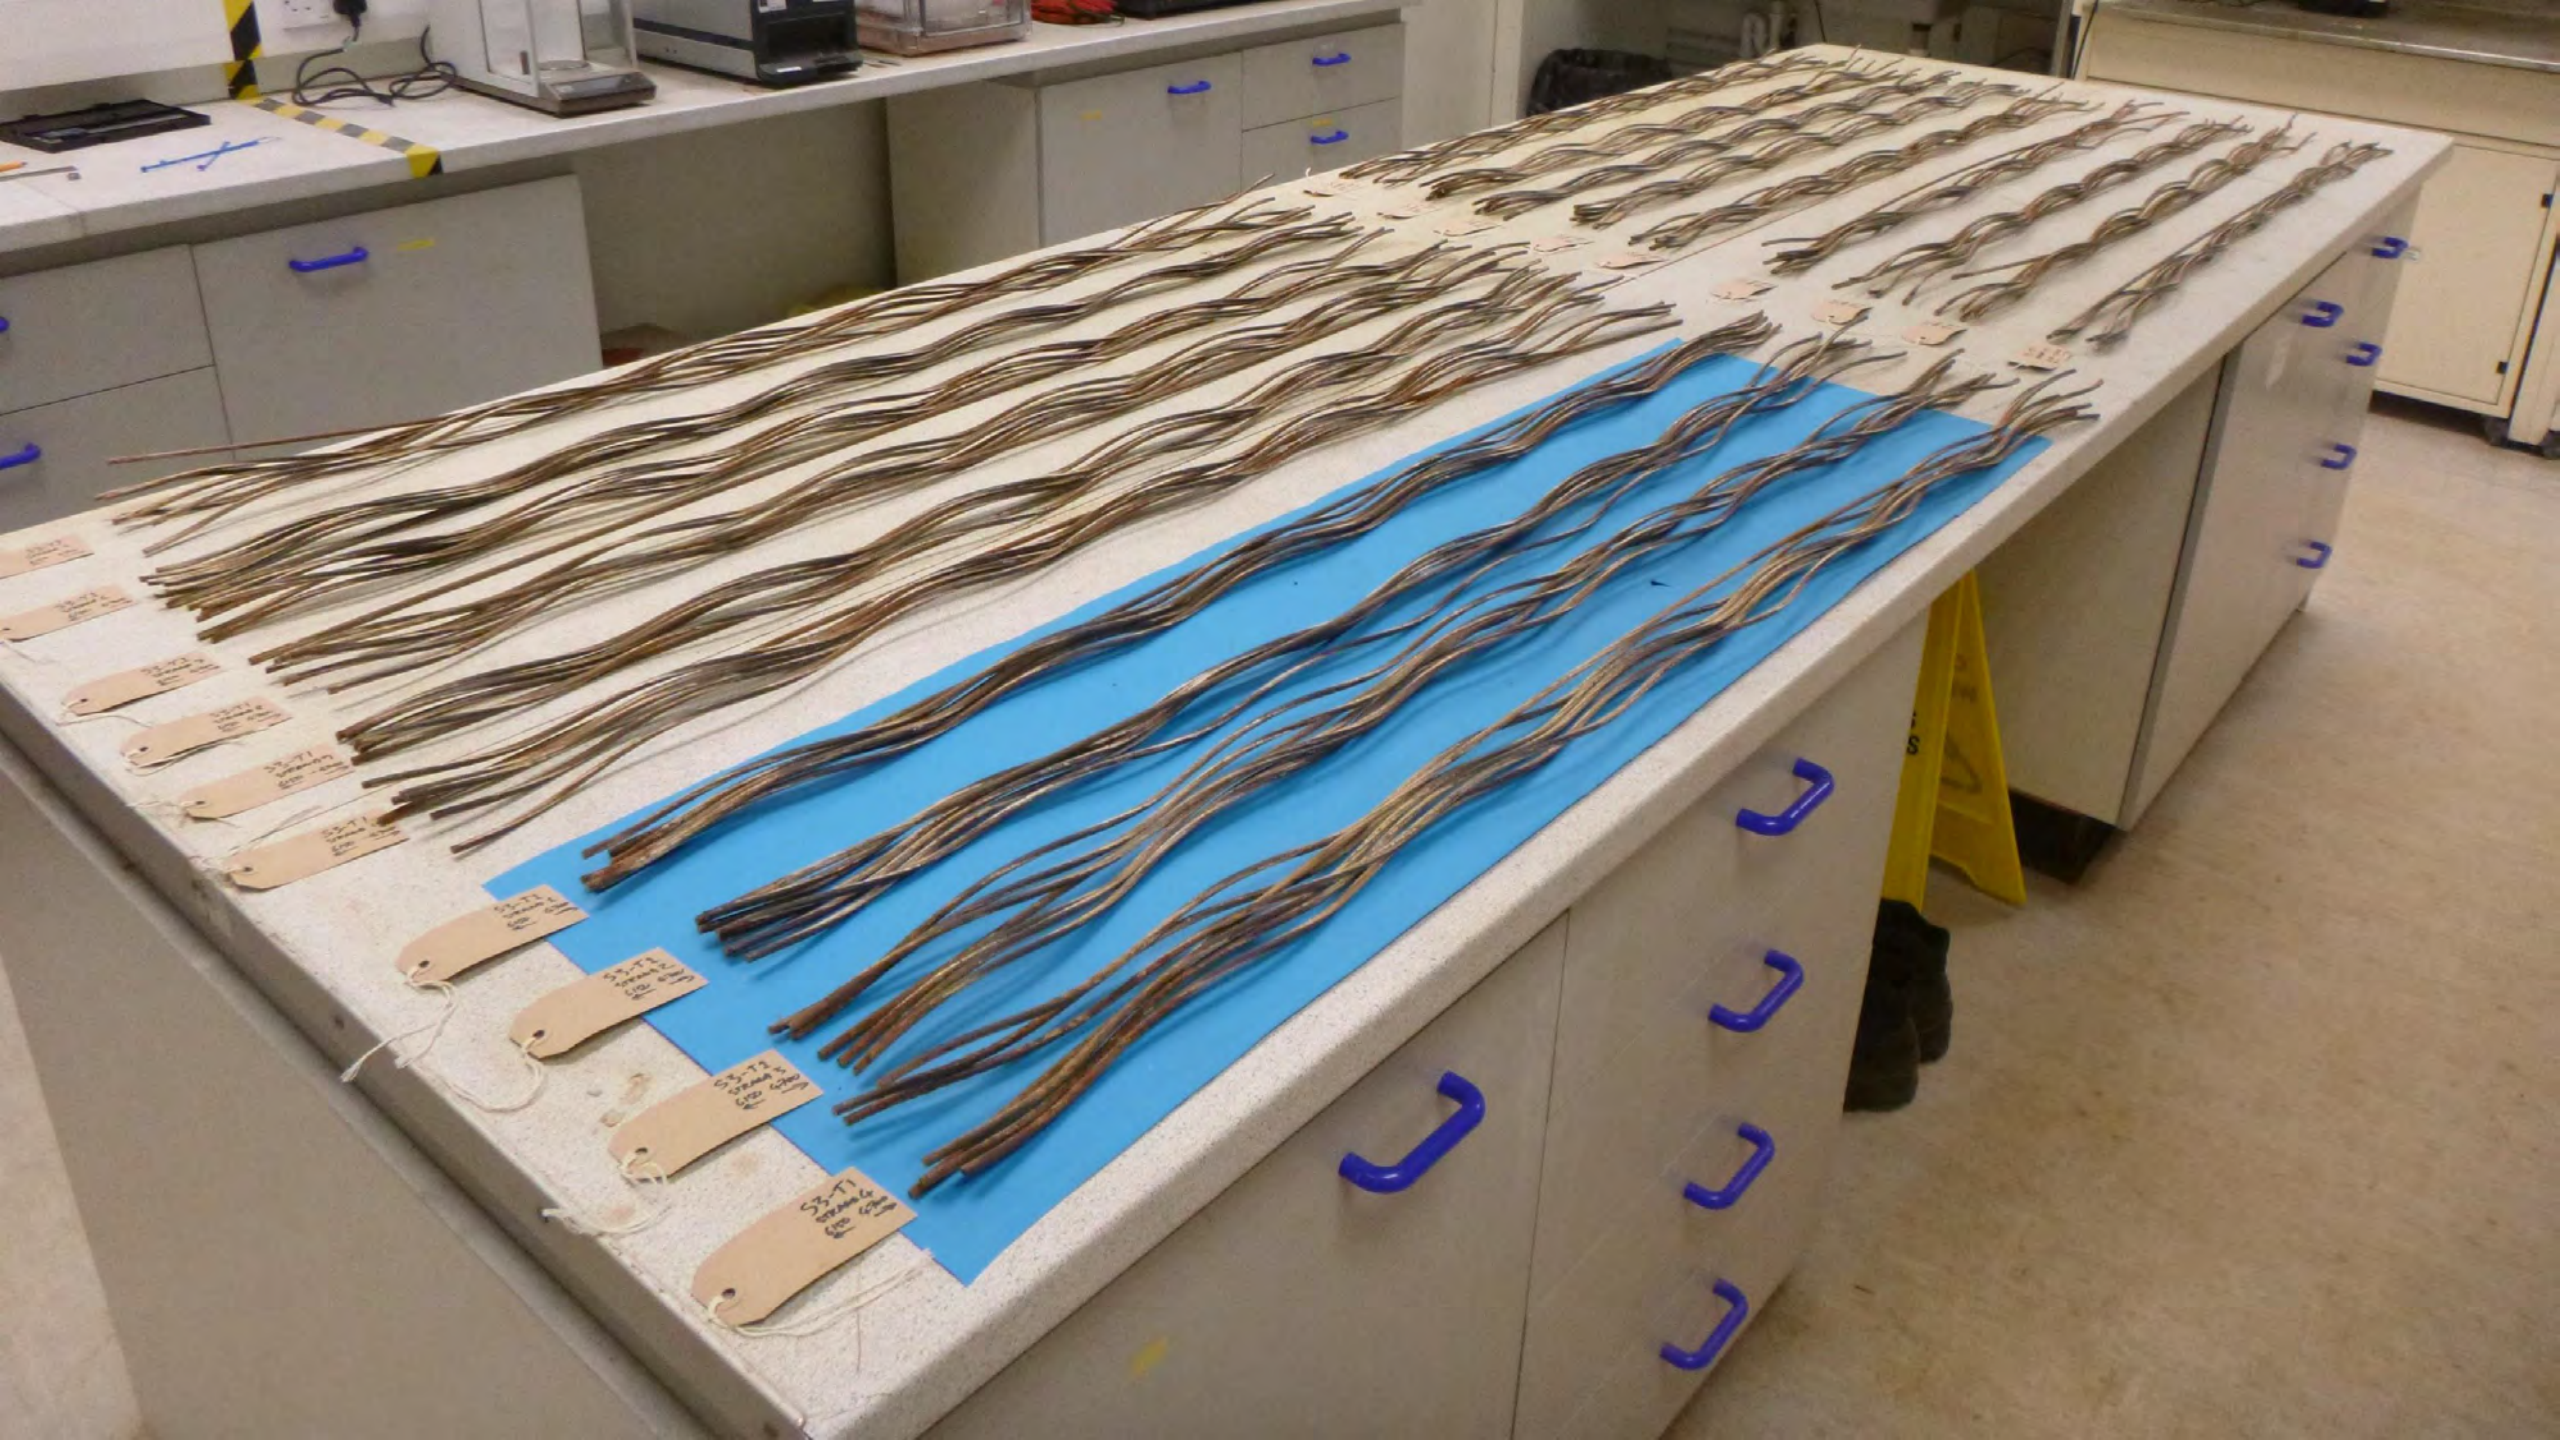
TA  
- 6.2  
STRAND 11

TA  
- 6.2  
STRAND 4

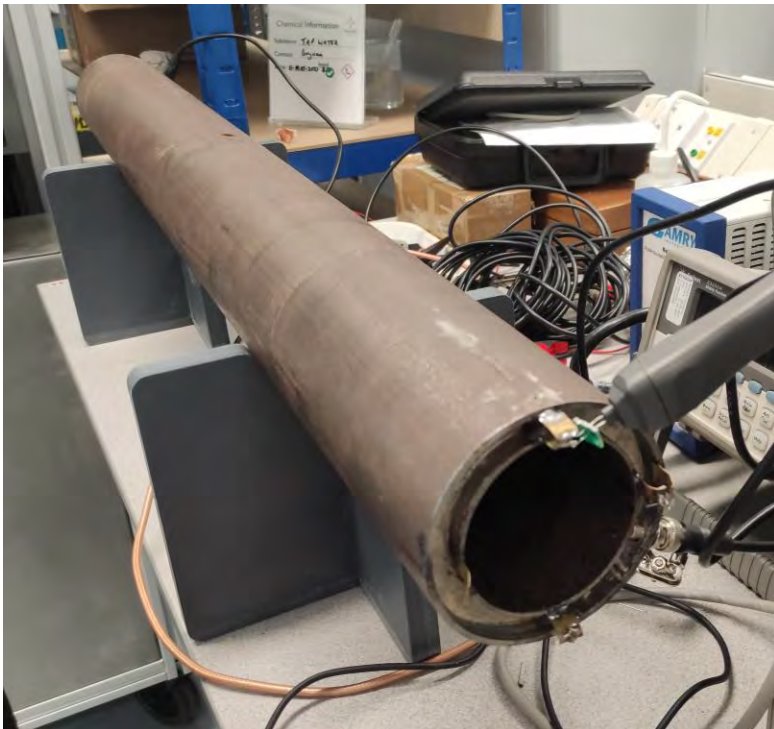
# Proof of principle – Impact of grout on electrical impedance

Grout is a lossy, low-impedance dielectric:  
Dampens changes in impedance caused by  
water ingress vs. initial assessment

- Grout properties limit signal bandwidth to ~10 MHz – limits defect location to ~1 m
- Fault detection and location relies on having a clear baseline for comparison

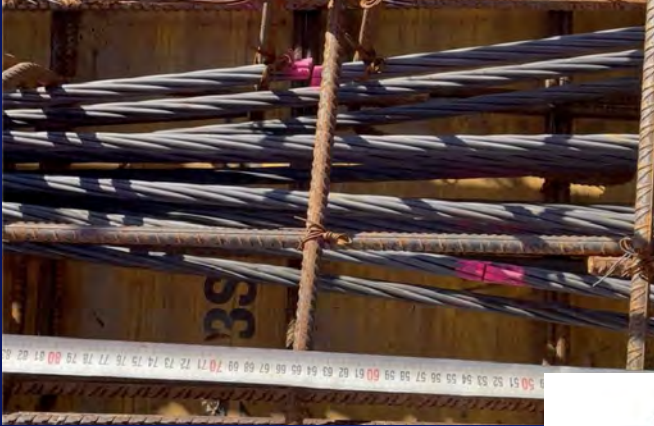
# Results in June 2025 – cuts

GSCAN

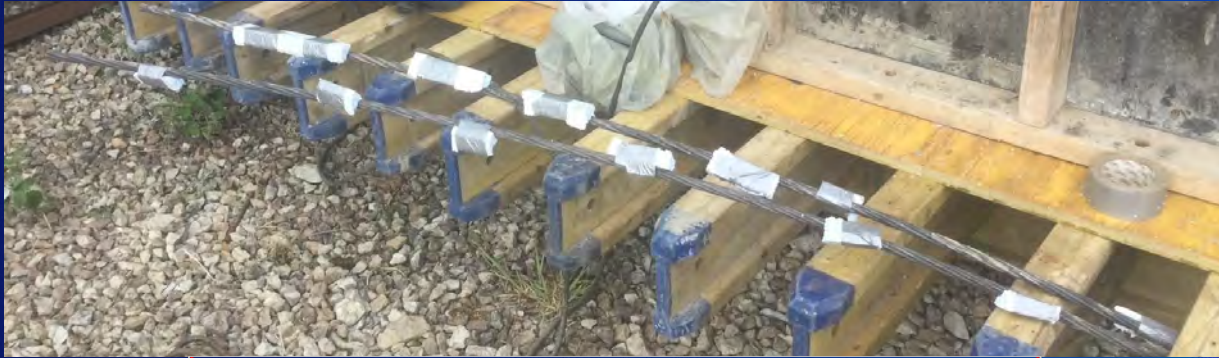
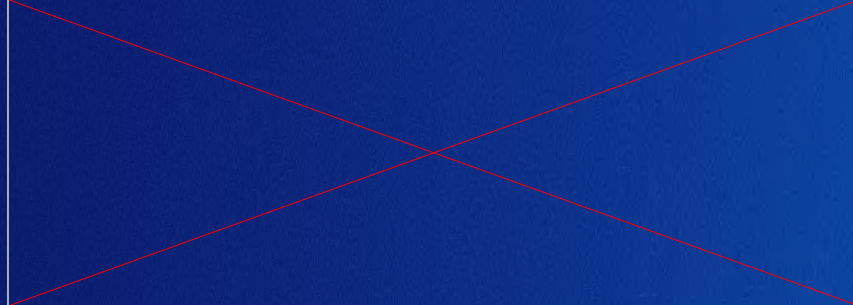
# Results in June 2025 – missing grouting

GSCAN

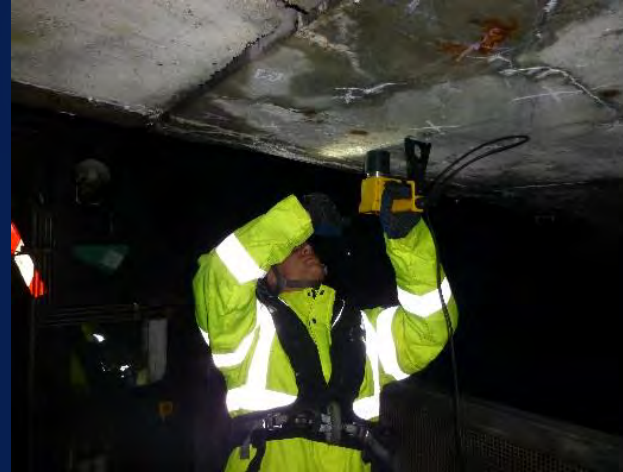
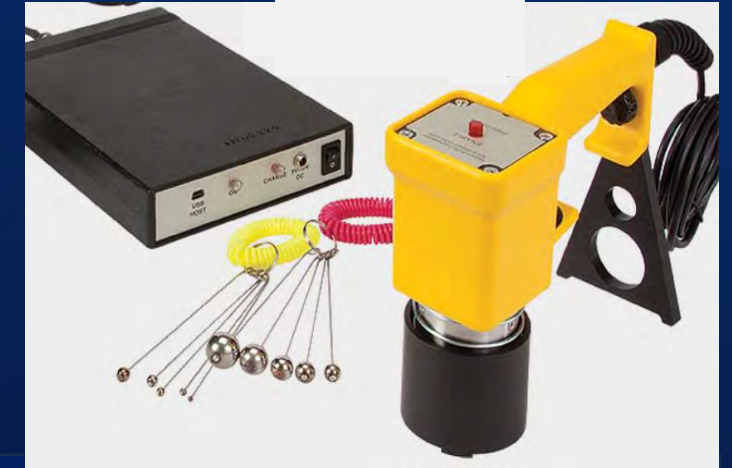
# 1 - Impact Echo – Technology Overview

- The Impact Echo (IE) test uses an impact generated stress waves propagating through concrete and being reflected by internal flaws and external surfaces.
- Stress wave generated through impact of a small steel ball (4-10mm diameter) on the concrete surface.
- Transducer placed adjacent to the impact site records the surface vibrations.
- Displacement v time waveform is converted to plots of amplitude vs frequency.
- These are evaluated to establish the presence and depth of the reflective indication.
- The technique is used across the world to detect voids in concrete and PT ducts.

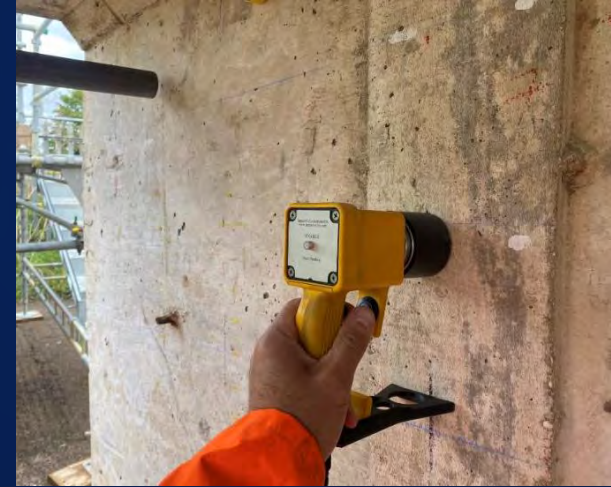
# 1 - Impact Echo – Trials and Testing

- GPR used to detect and mark out the duct location.
- IE is easy and quick to operate, ~40m of duct tested in ~4hrs.
- Point measurement every 200mm along the duct.
- Simple data with minimal processing.
- Written procedures for manual signal analysis.

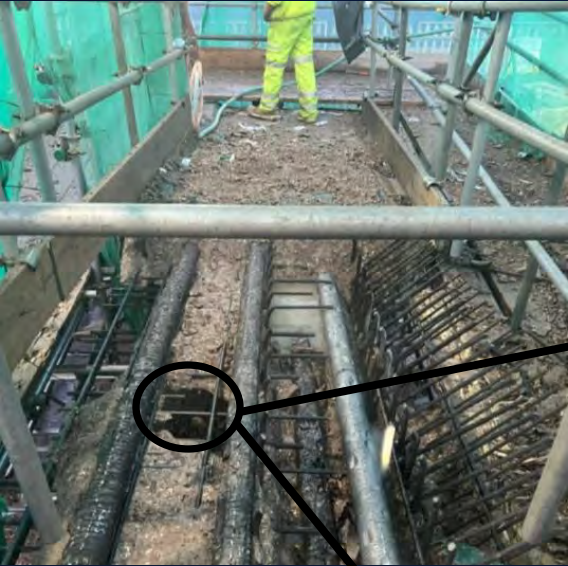
# 1 - Impact Echo – Comparison of Results Against Actuals

Image from AtkinsRéalis-Jacobs JV

Note – tendon position shown is slightly elevated vs reality.

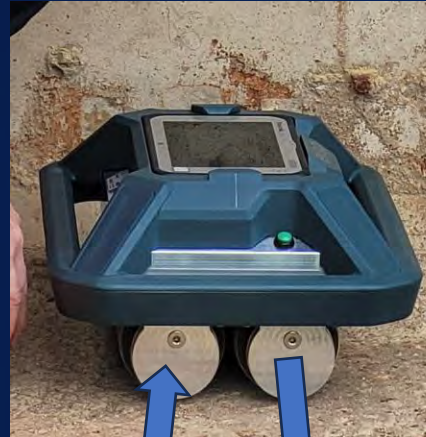
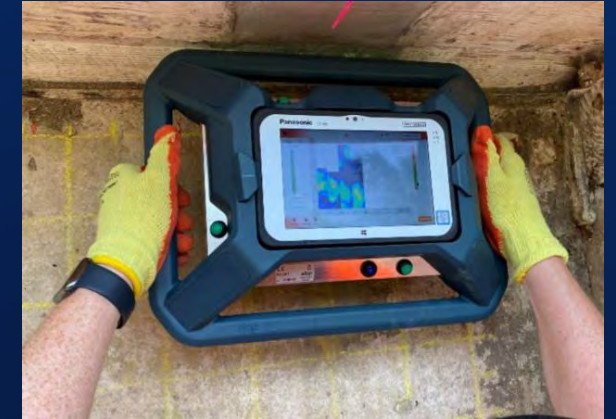
## 2 – Rolling Ultrasonic Tomography – Technology Overview

- Insight system, by Elop Technology.
- Dry-coupling rolling ultrasound using low frequency pressure wave signals with pulse-echo transducers.
- Comprised of tablet and scanner.
- Records and displays 2D & 3D data in real time.
- Cover large areas quickly, from 20cm to 100cm per second, depending on speed mode.
- Concrete and structural application areas include measurement of thickness, detects voids, delamination, debonding, tendon ducts, honeycombing etc.
