## STRUCTURES MOONSHOT

# Delivering the Moonshot Ambition

# Huntingdon Viaduct – History

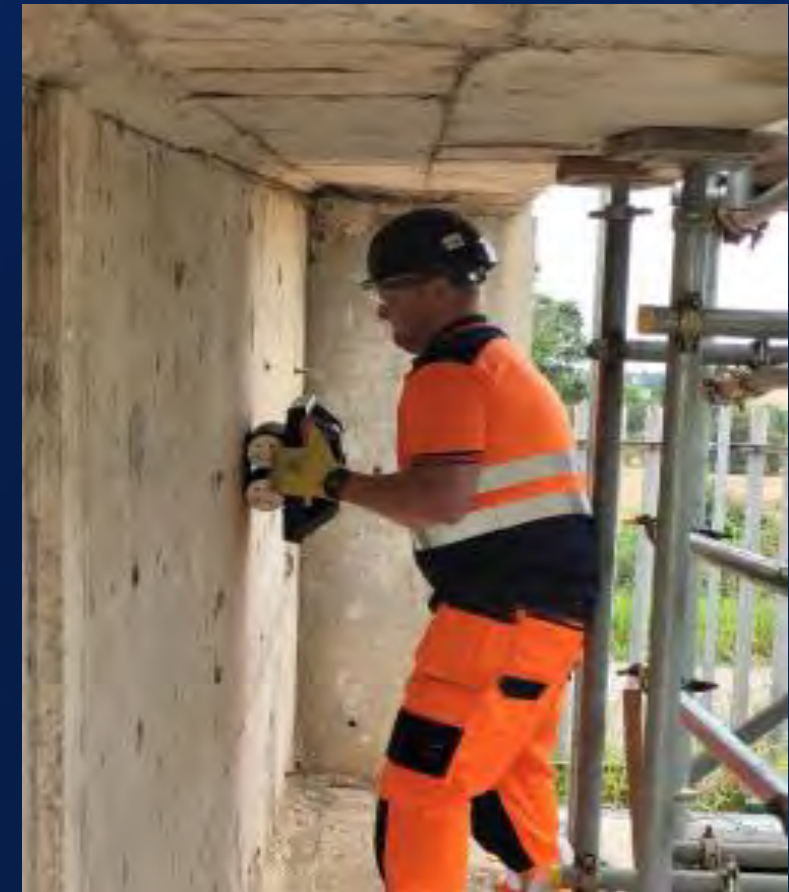
## 2 – Rolling Ultrasonic Tomography – Trials and Testing

- Duct locations are found with GPR and marked out.
- A linear scan was carried in vertical strips (500m wide), then stitched together to form an image of the ducts in the web.

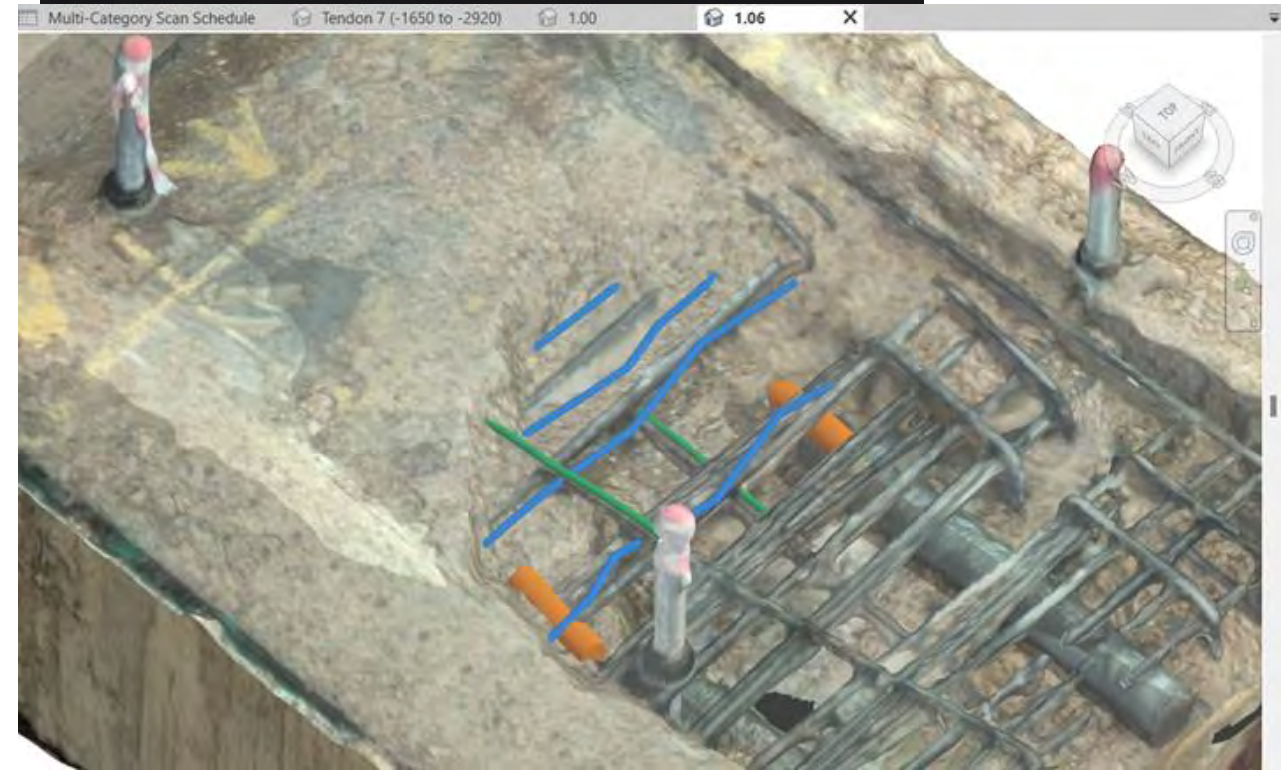
## Sample 1 Top GPR Findings

Rebar placement defect

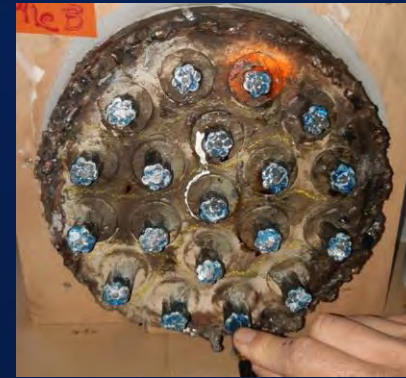
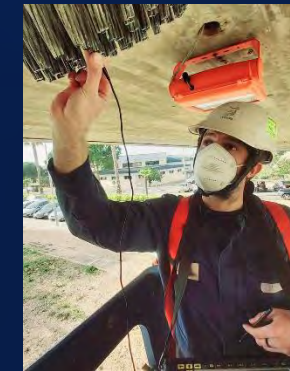
### Principle of Ultrasonic Measurement on Wires

- The test technique uses a probe mounted to the exposed end of a wire which pulses a special signal generated by an Ultrasonic system (Pulse Echo).
- Inspects from 0.0m < ~1m length of a wire (variable) for wire breaks.
- Trial for quantification and validation is important.
- The ultrasonic signal travels down the wire to ~1m from the probe and any signals that are reflected from strand/wire defects or material interfaces are captured and recorded by the same probe and system.
- Software and analyses procedure is used to evaluate the received data for evidence of indications.

Example of testing on anchorage wires

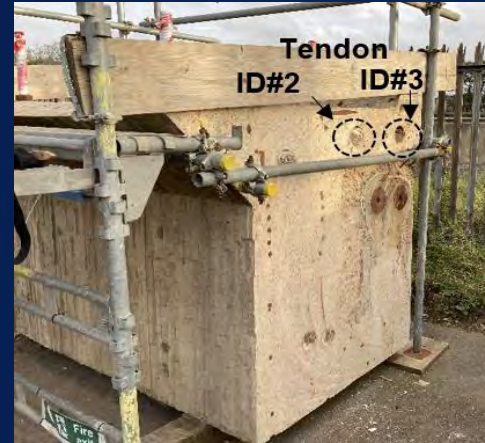
## 5 – Ultrasonics of Wires – Trials and Testing

- Testing carried out on Sample 1.
- Wires are sanded flat.
- Wires tested 1 by 1, with 5mm diameter probe.

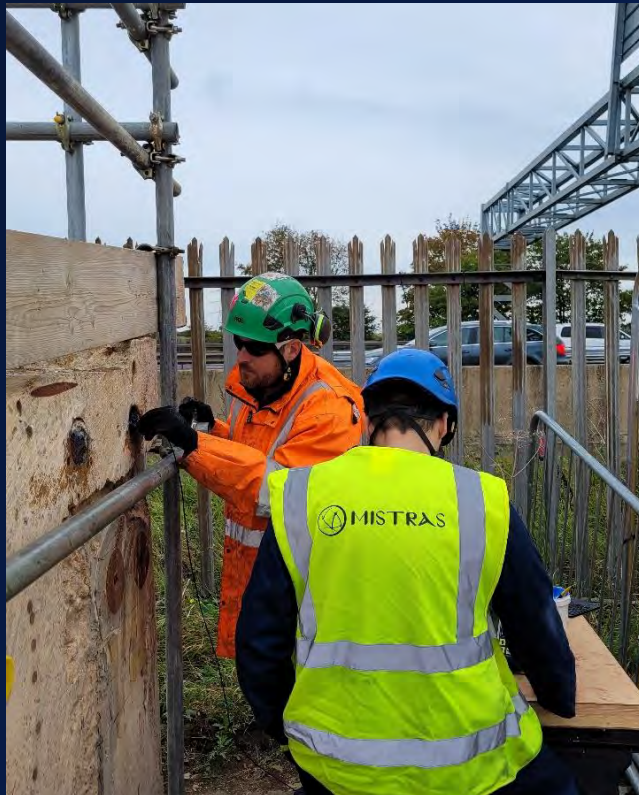
Sample ID 1 and tendon ID's

Ultrasonic testing

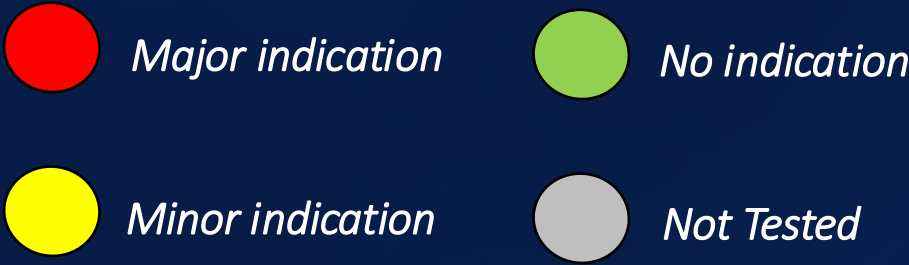
## Comparison of UT Results vs Investigation

- Poor correlation!

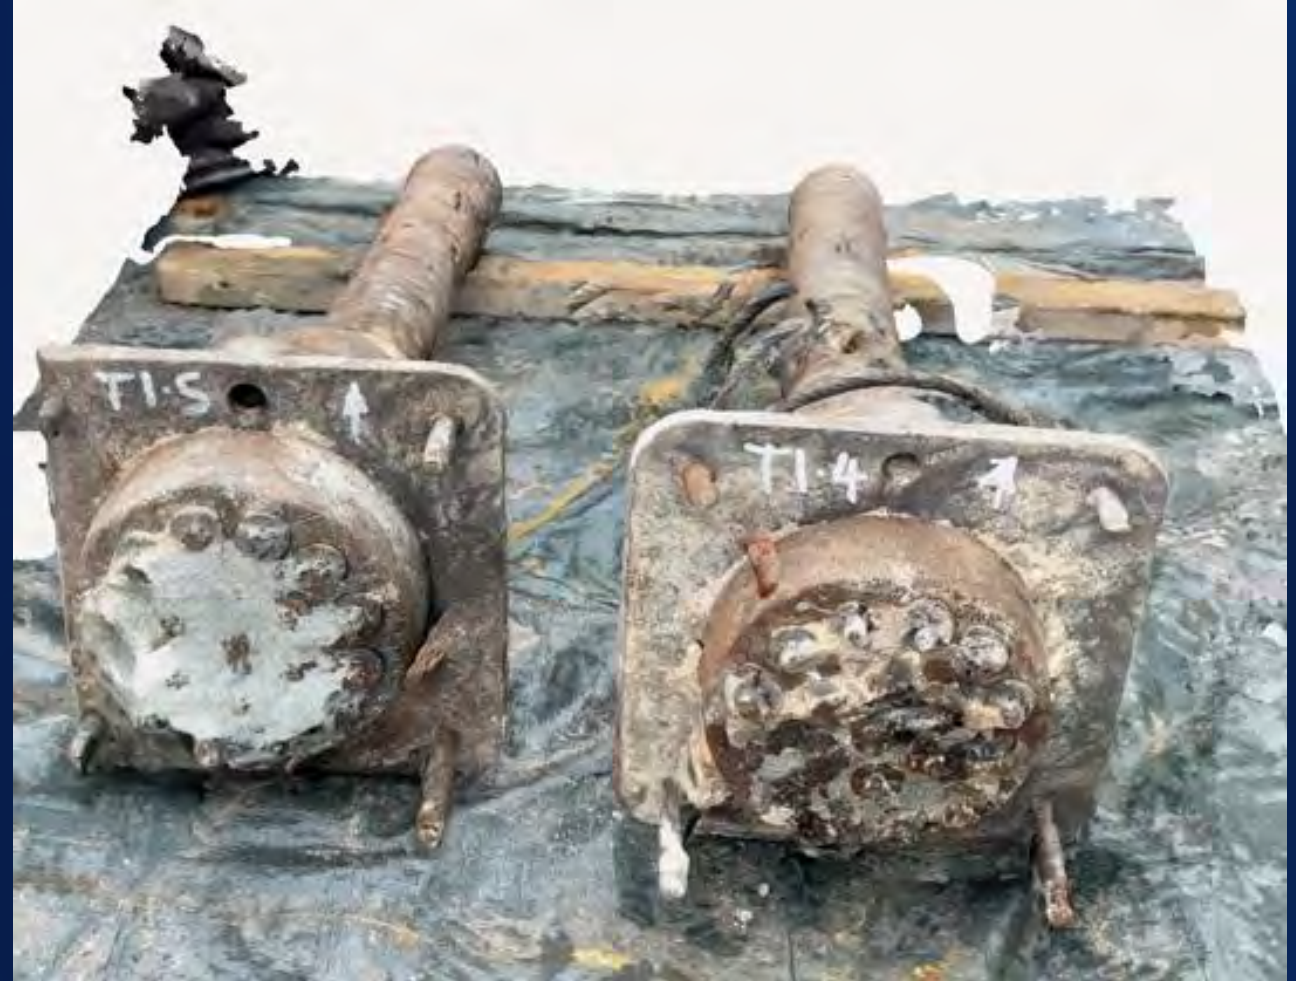
- Wire testing of removed anchorages taken from HRV sample 1
  - with grout
  - without grout
- Improve the procedure for ultrasonic testing for future works.

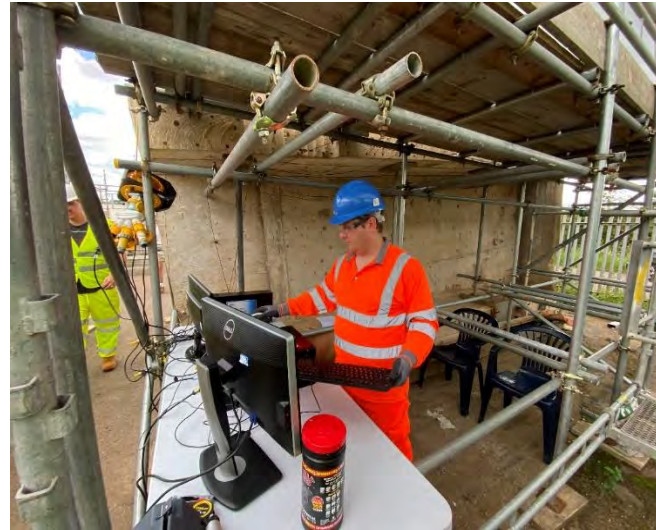
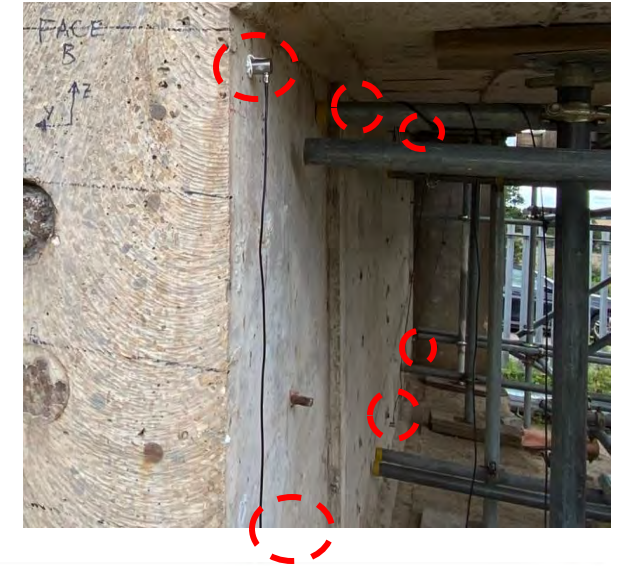
- AE monitoring is passive – so testing used simulated wire break source – spring loaded impactor.
- AE sensors are mounted on concrete surface and cabled to a MISTRAS Express-8 AE system for measurement.
- Simulated wire breaks made on concrete surface and exposed (de-tensioned) cable ends.
- AE source location and signal characterisation carried out the specimen (using simulated wire break source).

- Tendon duct end (surface B)
- Position of tendon duct inside sample 3 concrete
- ✱ Centre punch on concrete surface E

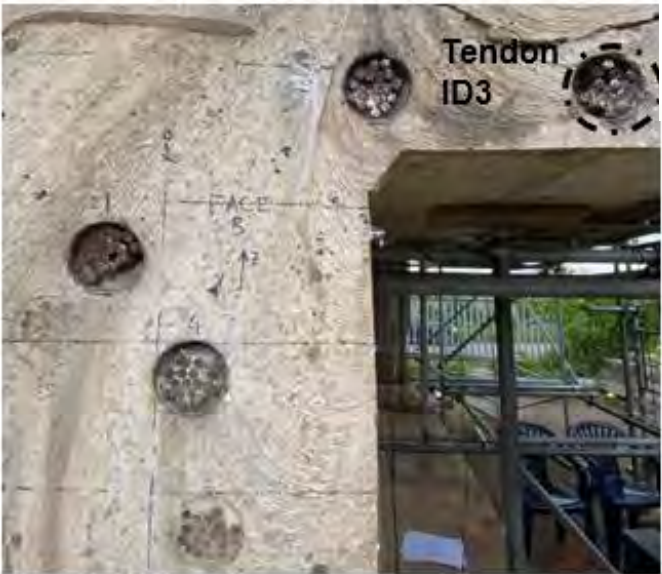
Tendon ID 3 on Surface B

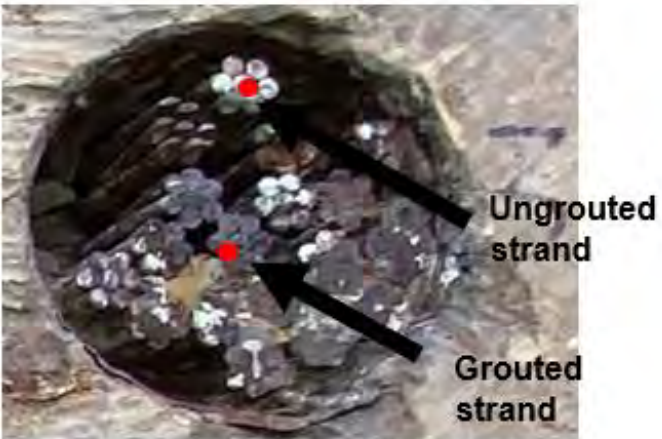
Centre punch source

Duct ID#3 found to be part (1/2) grouted along whole length.

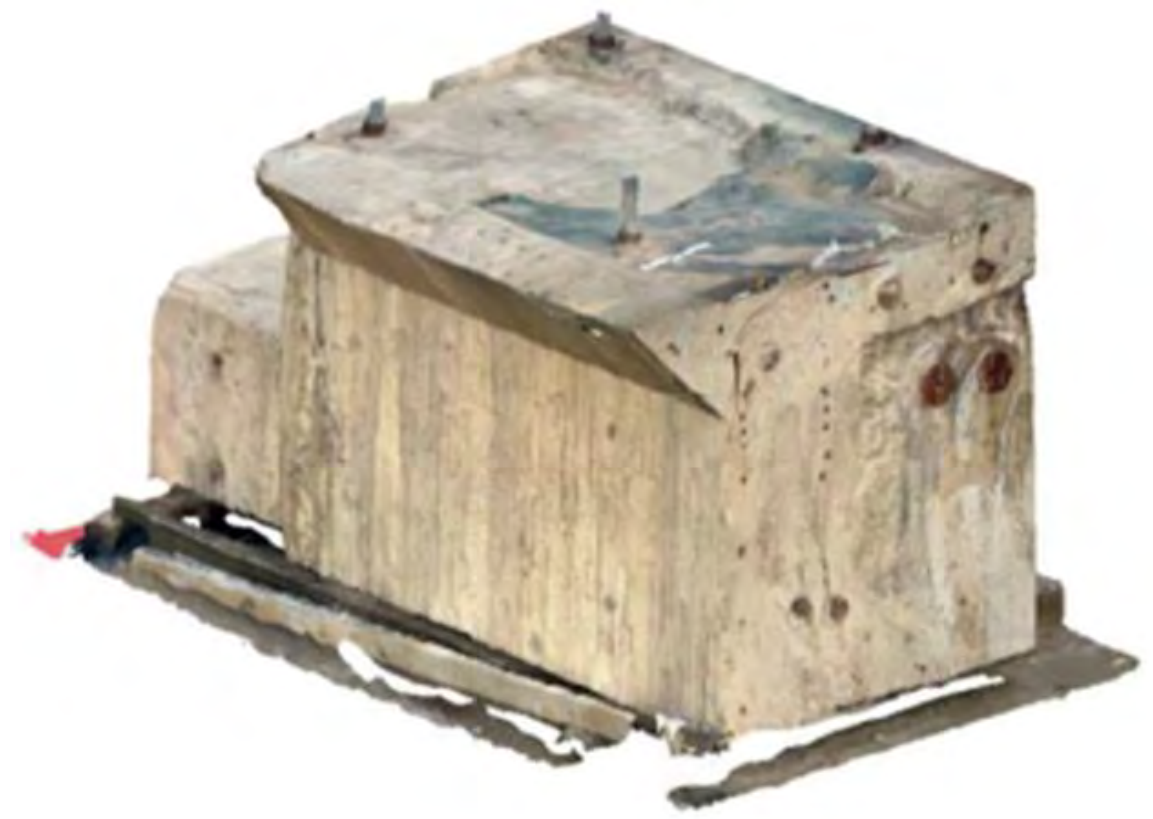
# Sample 1 – Face

Elements

Contamination

Concrete cover

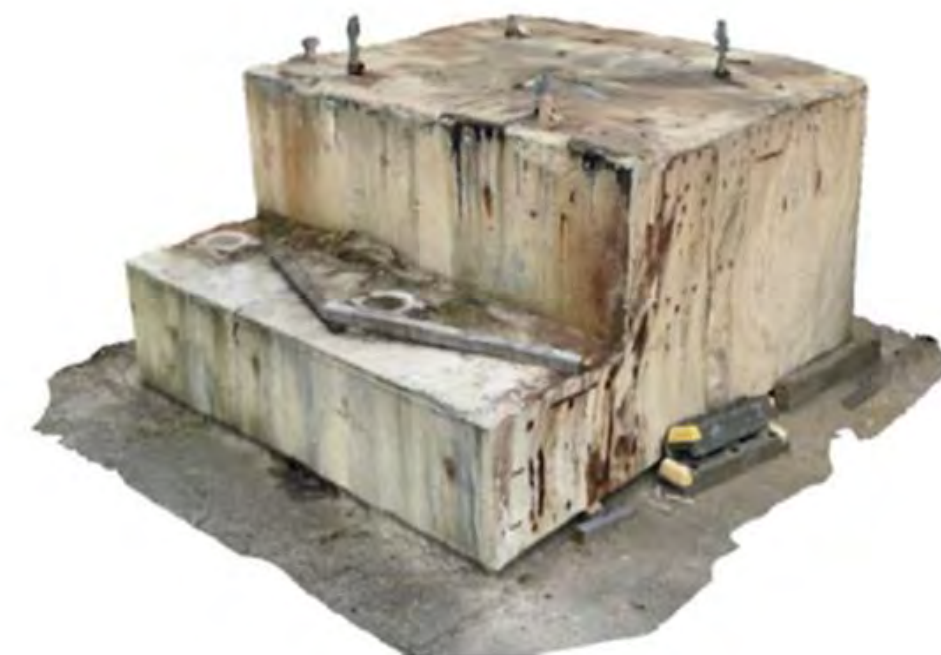
# Sample 2 – Face

Elements

Position of the scan

Contamination

Concrete cover

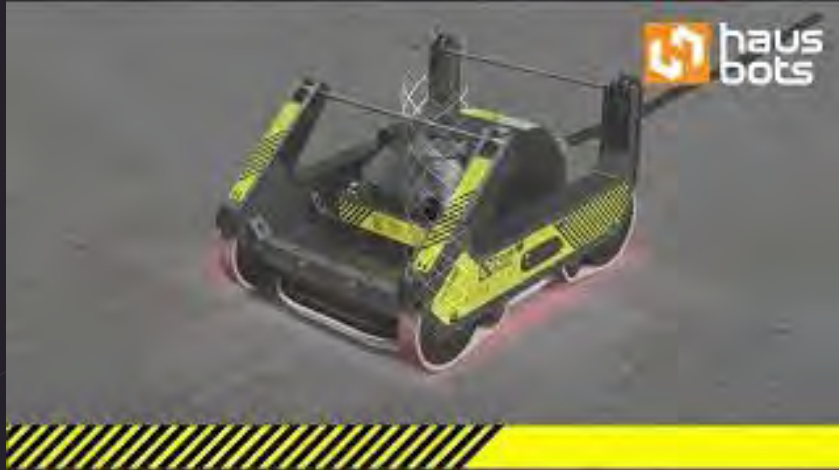
# What is AEROGRIP™

- **Hybrid airflow and suction**

High airflow, with the downforce benefits of low pressure designed and built to drone standards with redundancy, back-up and flight control systems

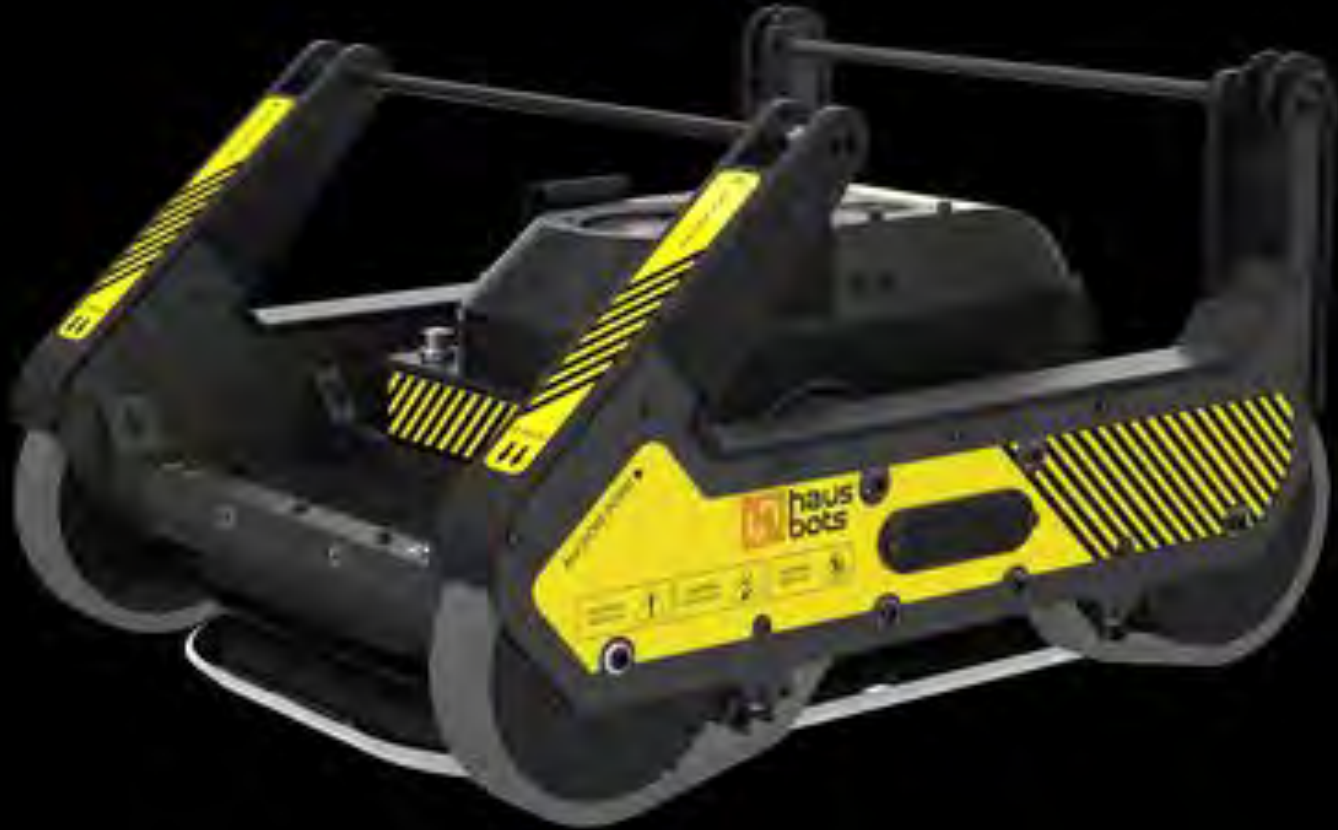
## HB2

- Remote visual
- UT (A-scan/ B-scan)
- Light payloads on small diameter assets

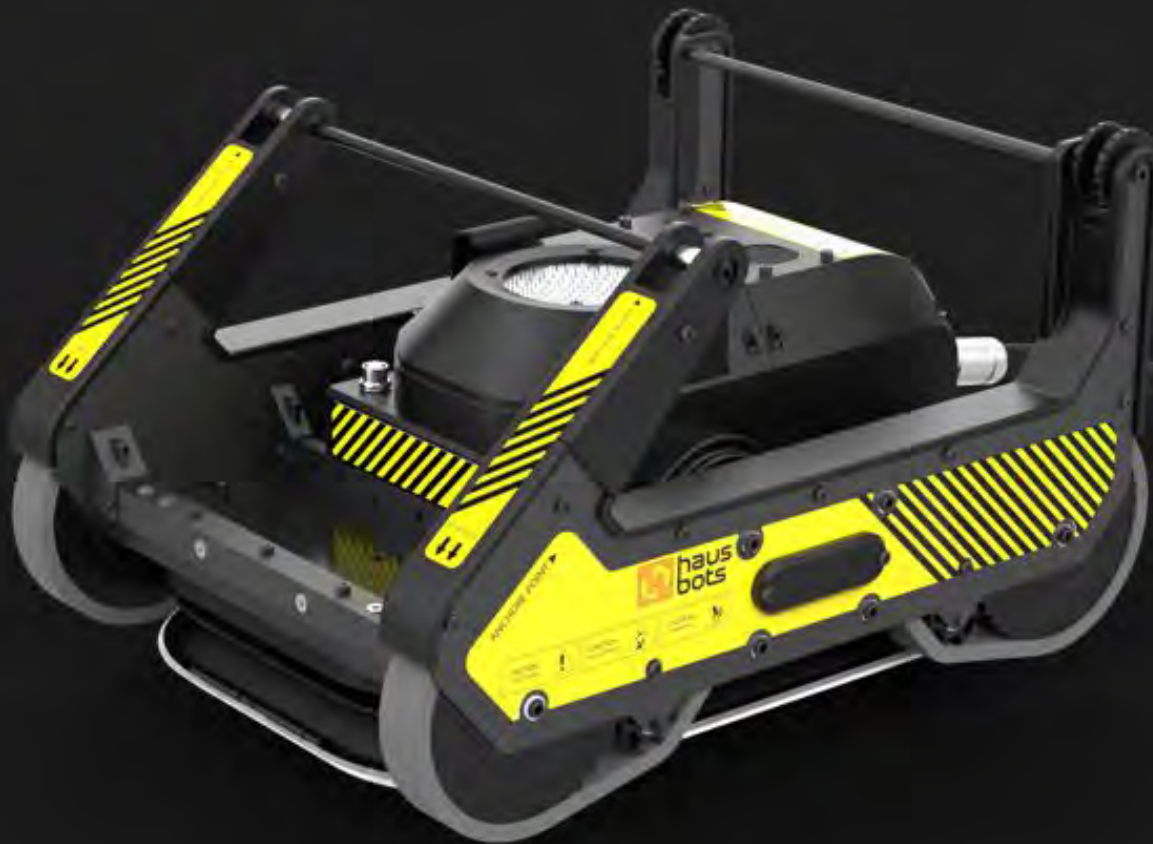
## HB3

- Corrosion mapping
- Scanning
- Large area coverage

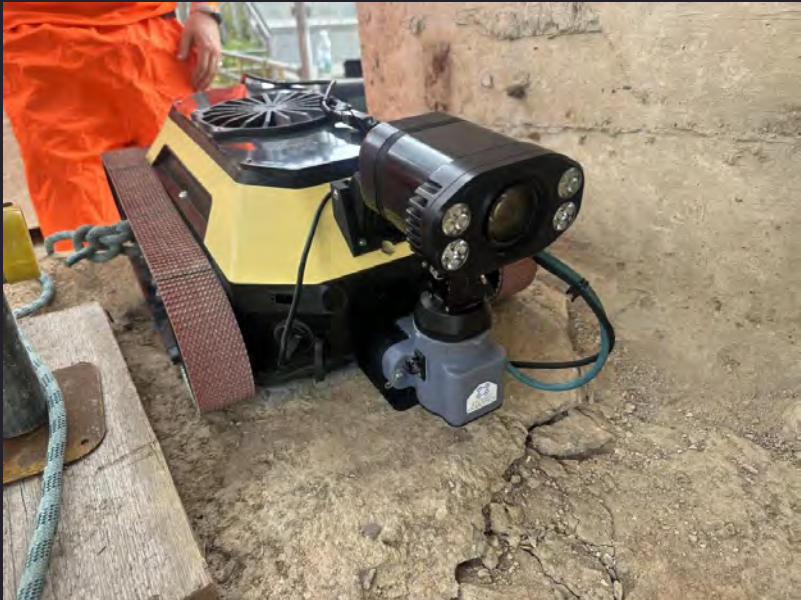
## Camera Specifications

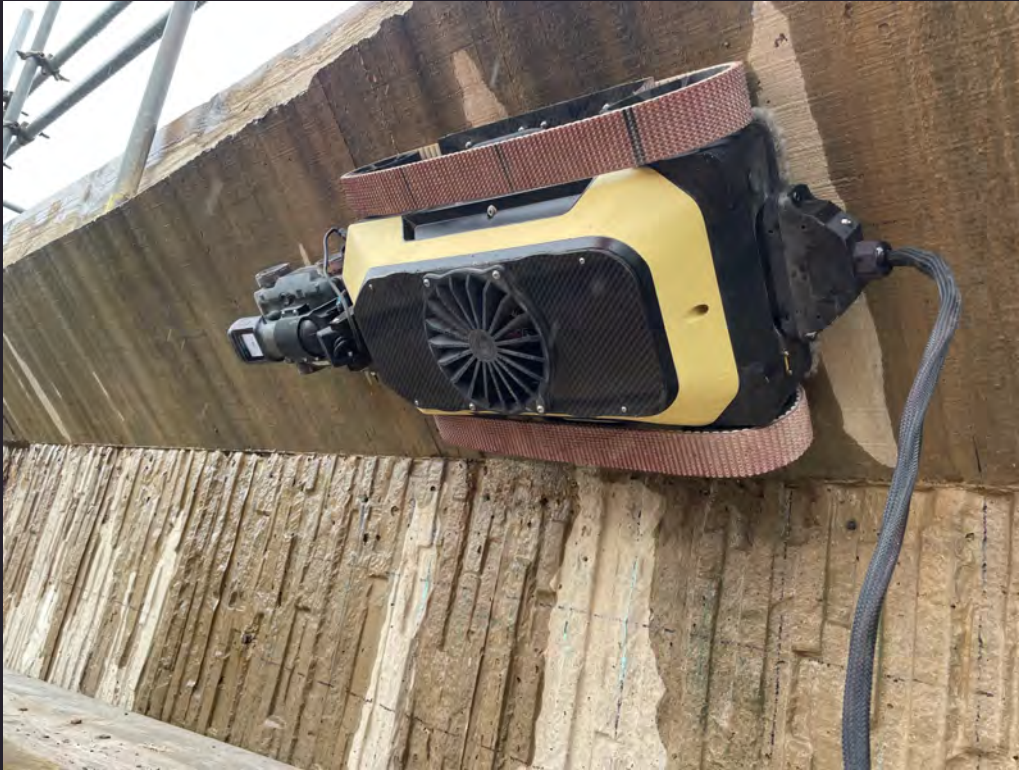
## GPR Specifications

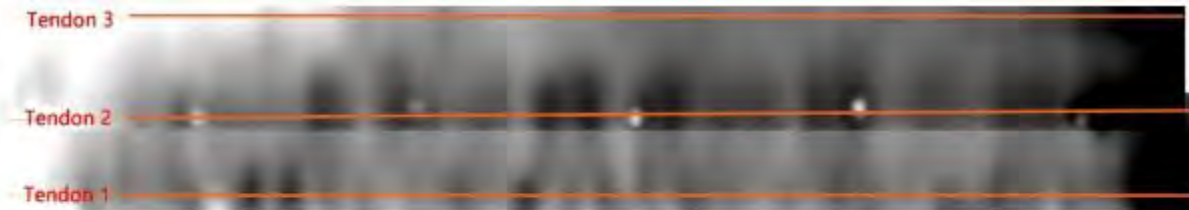
figure 6-3: The magnetic picture from figure 6-1 with marking of the position of tendons 1 to 3

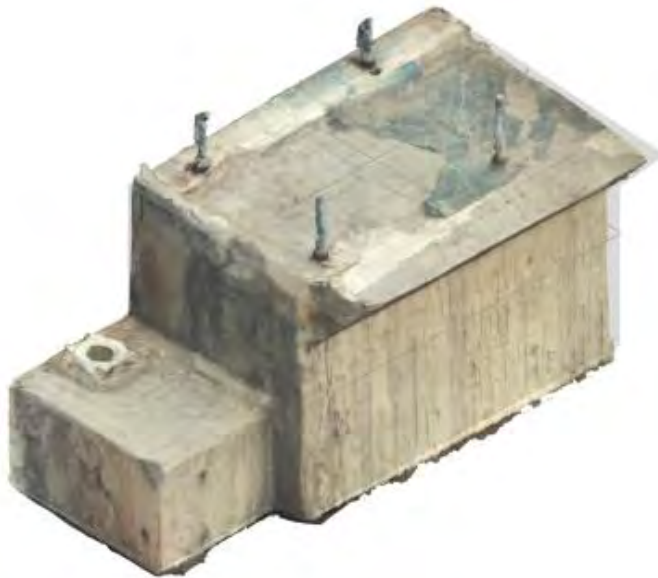
November 22nd

# Hydrodemolition LiDAR Scans

Polycam

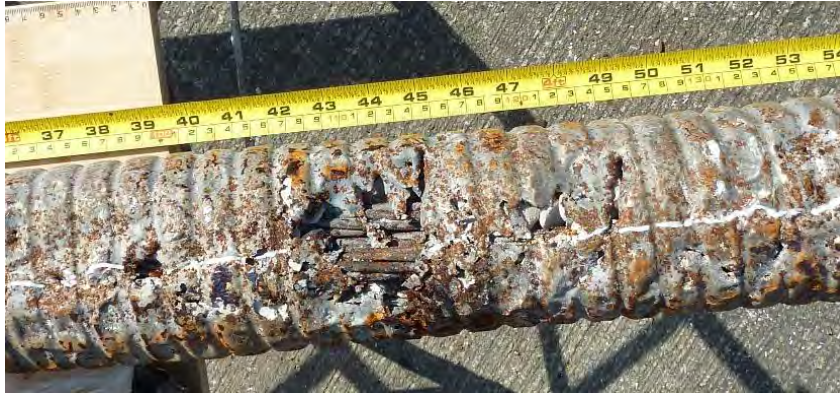
Ducts

# Intrusive Inspection Results

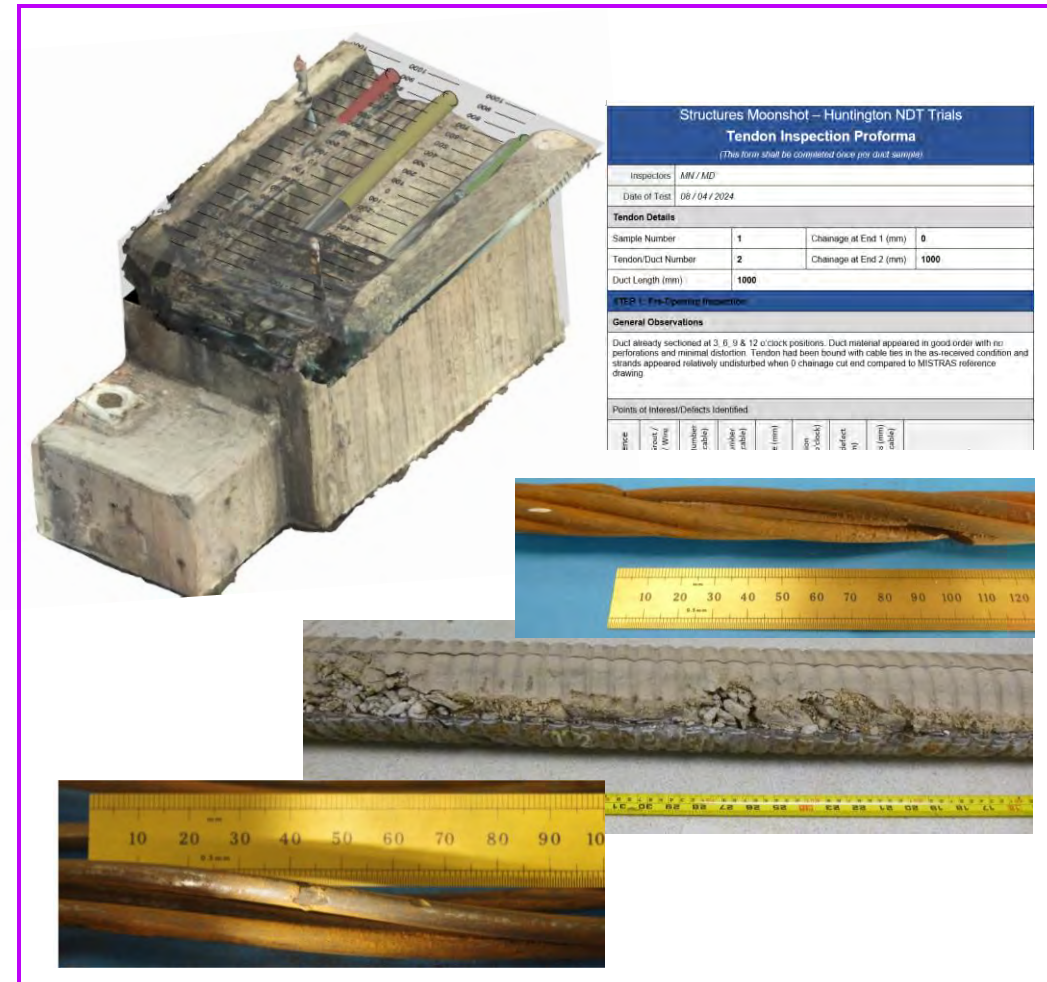
Non-Destructive  
Testing Results

Actual defects recorded  
during hydrodemolition and  
intrusive inspection

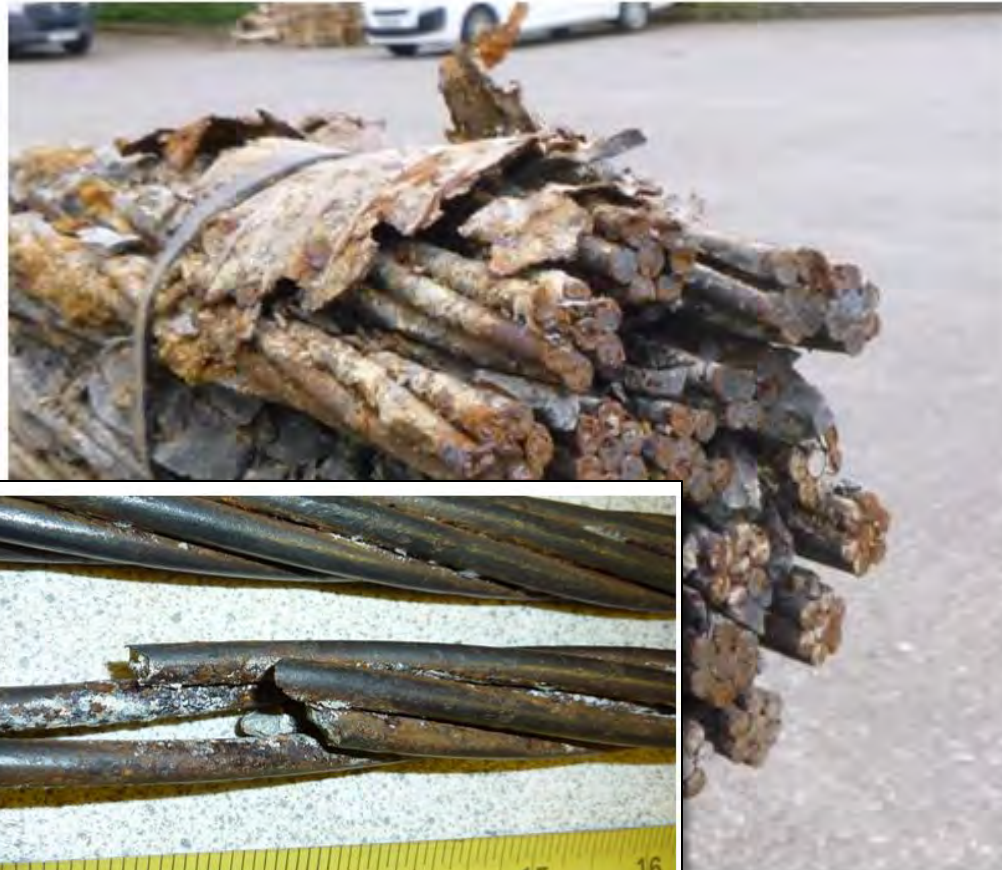
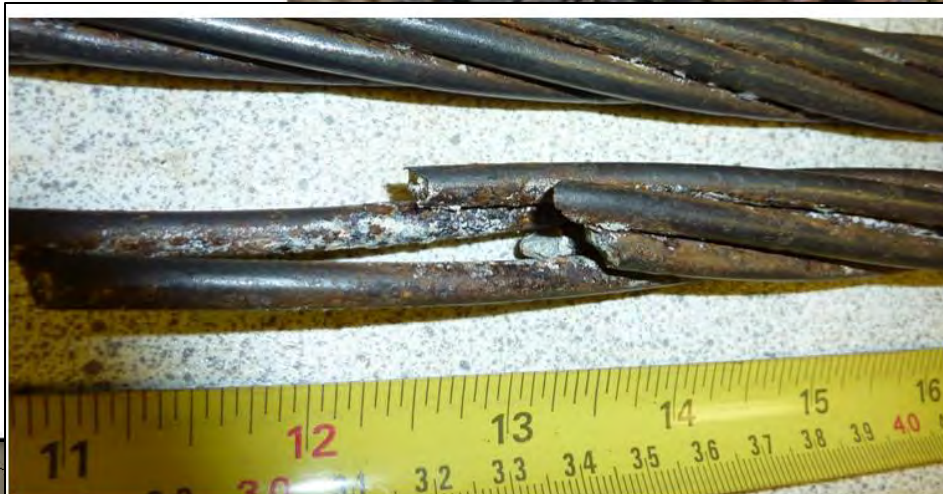
Fractured Wires on Tendon #1

| All strands subject to full unwinding operation. Defective regions itemised as follow: | | | | |
|---|---|---|---|---|
| 1 | 1 | 270 - 400 | N/A | 0 – 270mm wires missing due to tensile fracture of all wires in strand. Fractures appeared brittle and not attributable to section loss – no additional broken wires in evidence. |

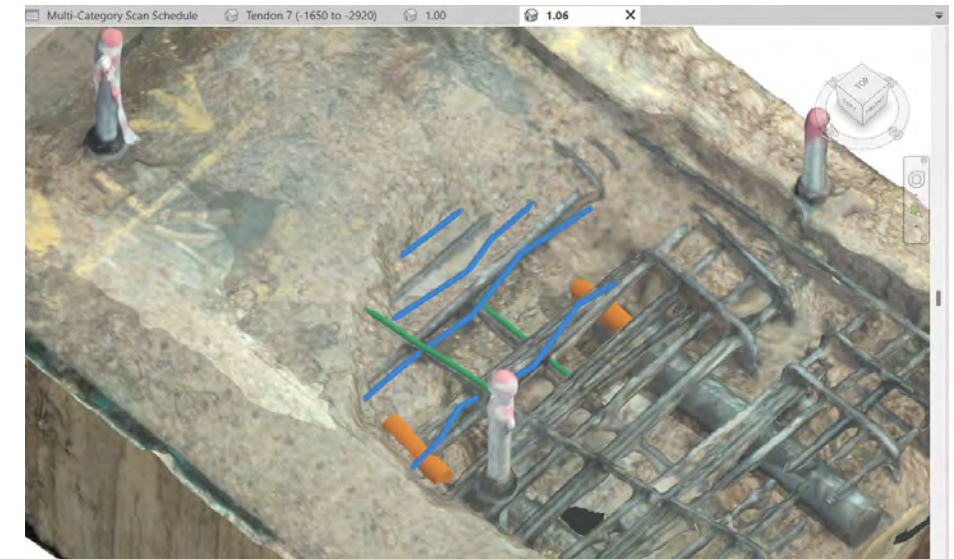
Ground Penetrating Radar (GPR):  
**GSSI Flex NX**

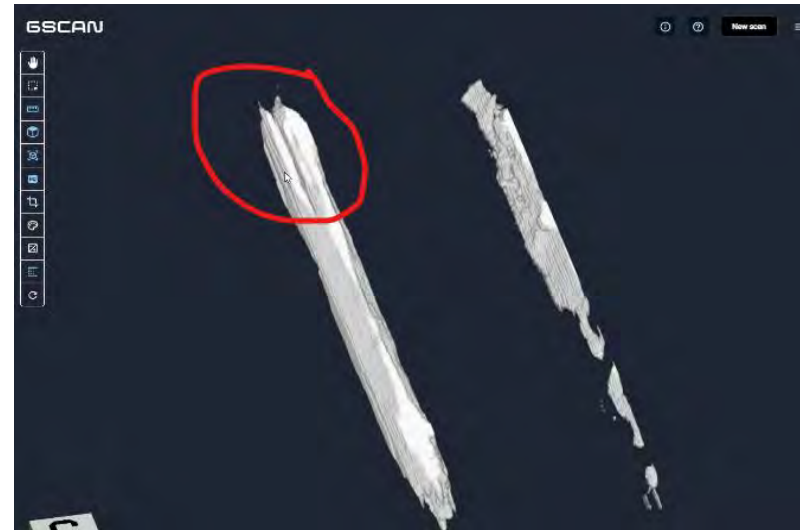
Locate any **absence of duct grouting**

Muon Tomography:  
**GScan Hodoscopes Generation 1**

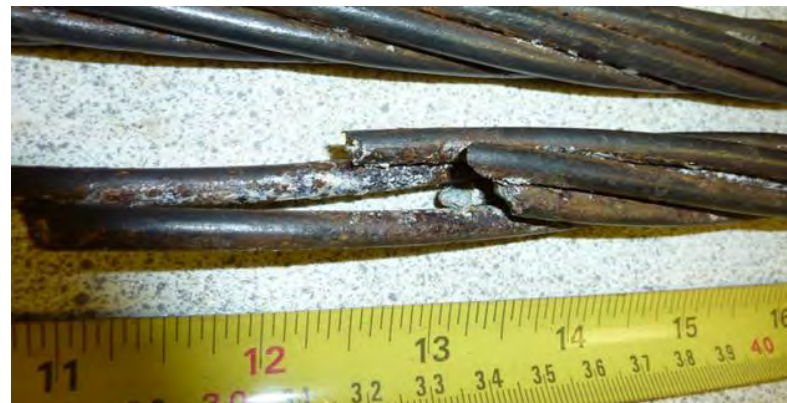
Table 3: Test 2 results.

## Ultrasonic Measurements (Steel Tendon): Mistras Proprietary

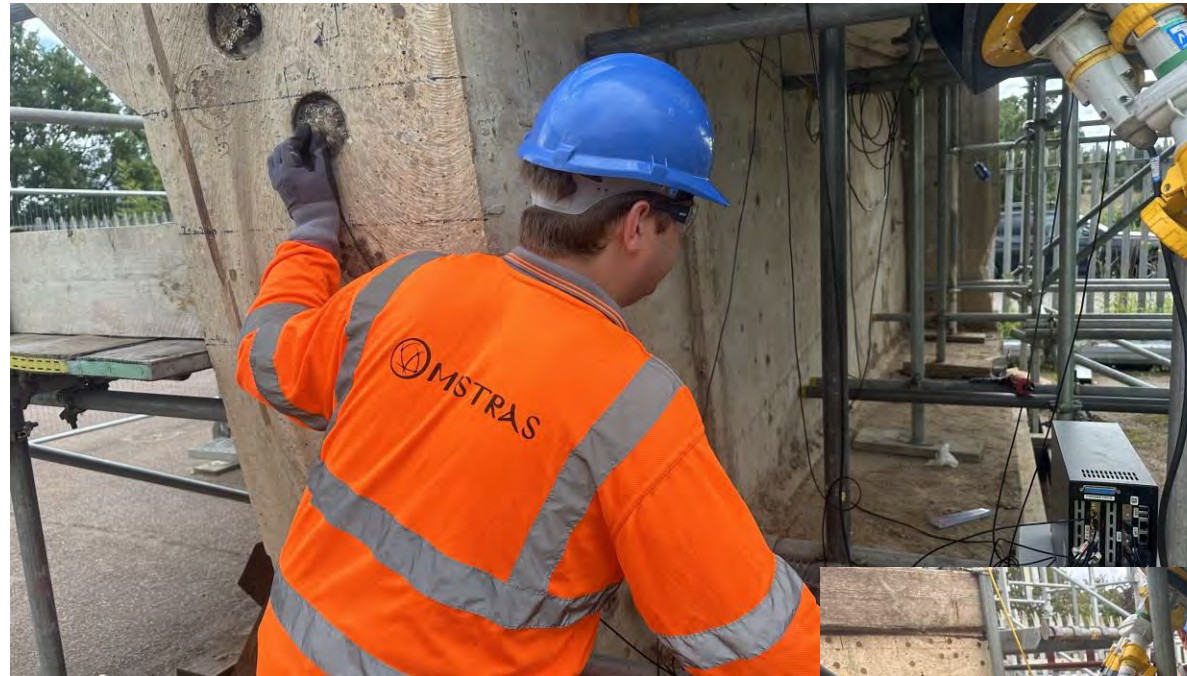
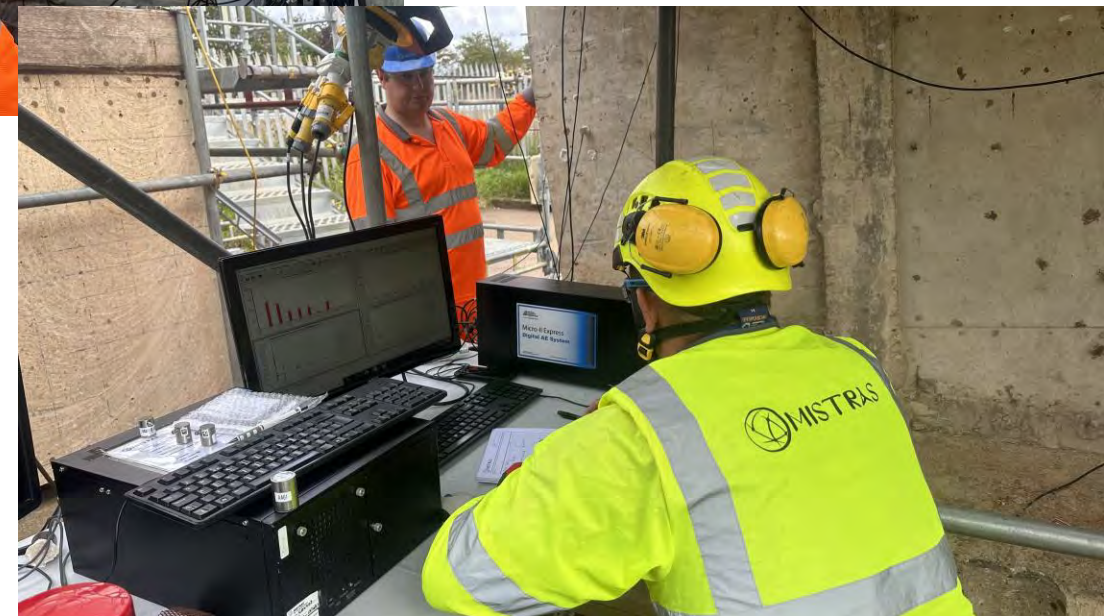
Acoustic Emission:  
**EXPRESS-8 (Mistras Proprietary)**

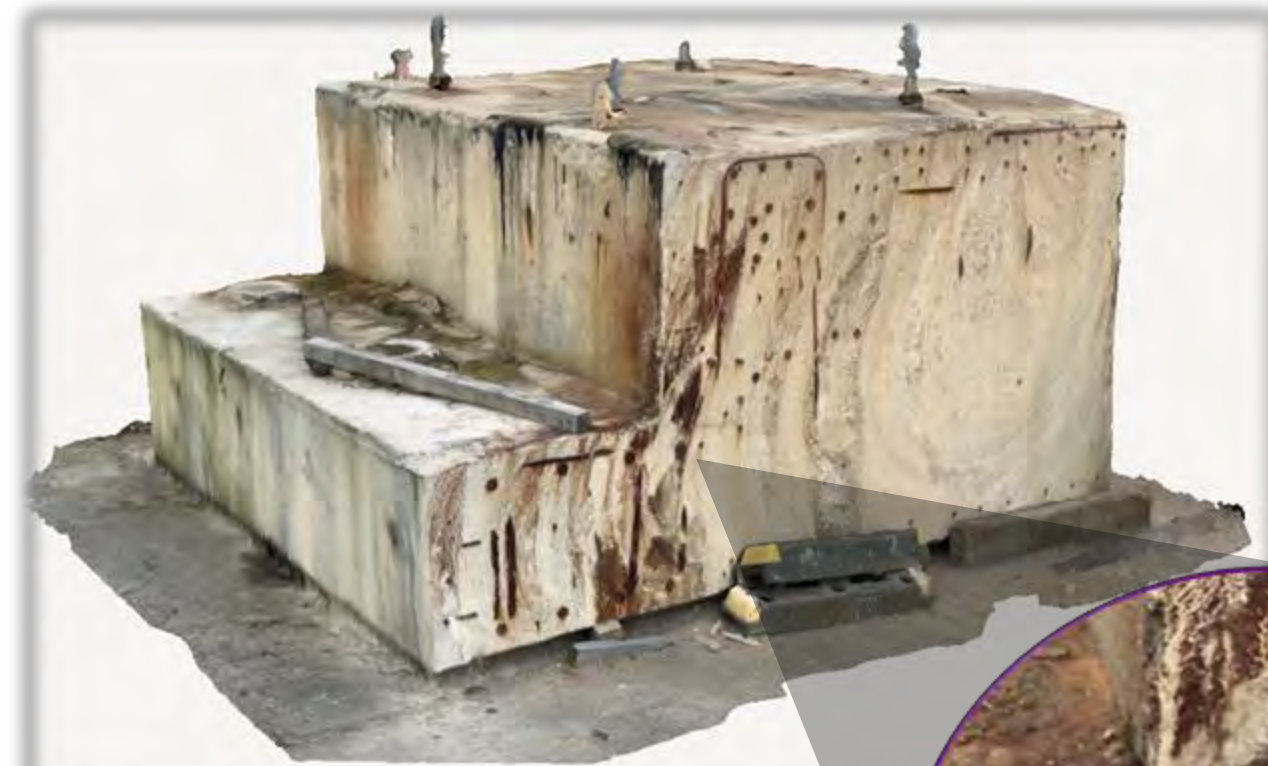
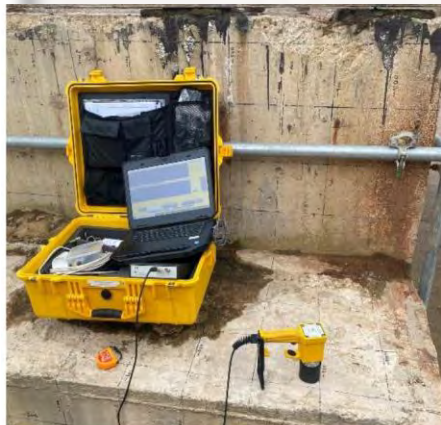
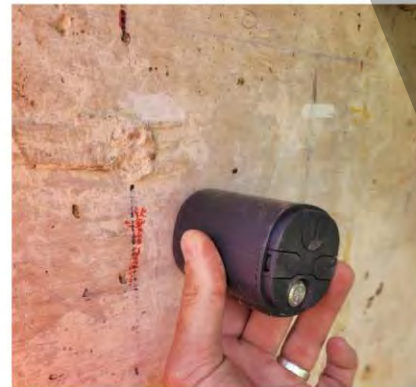
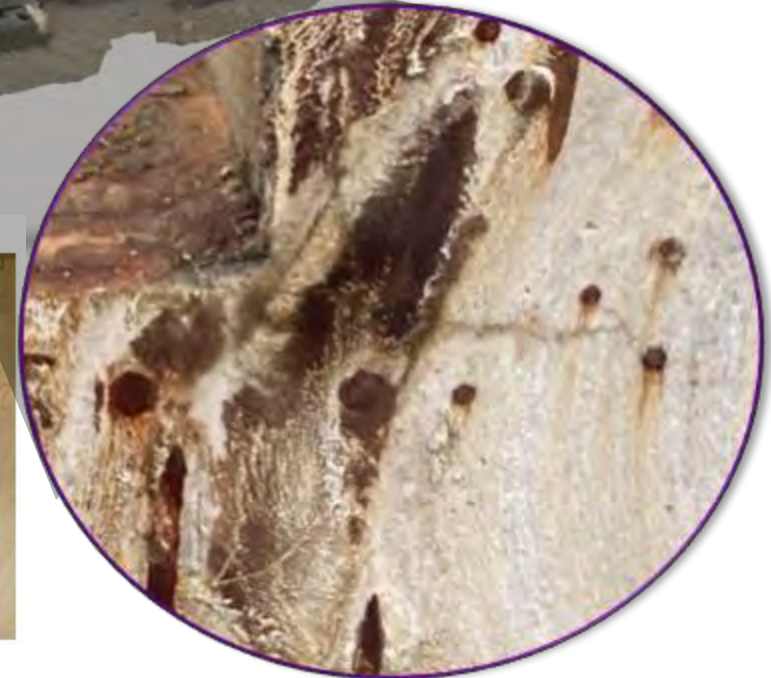
Impact Echo  
**Proseq PI8000**

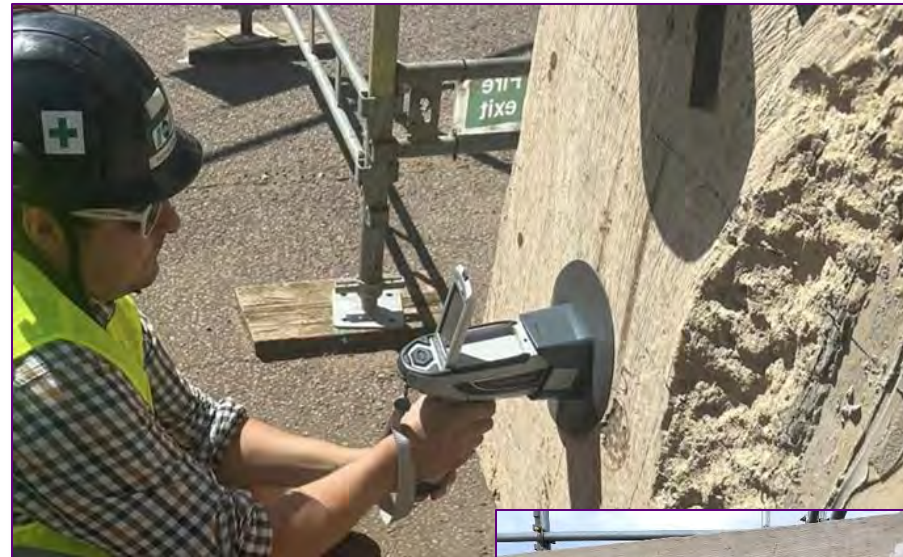
Portable X-Ray  
Fluorescence  
(exposed tendons only)  
**ThermoFisher Niton XL3t**

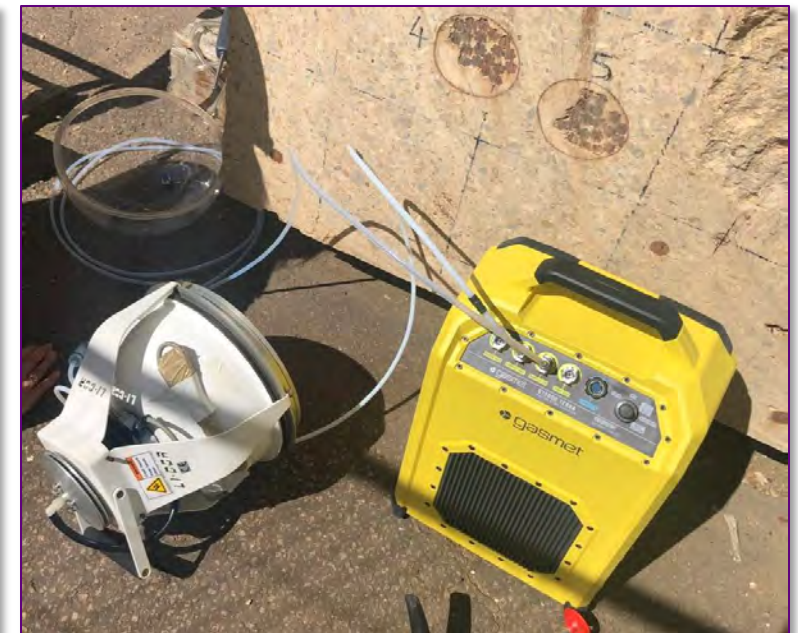
FTIR Gas Monitoring (exposed tendons only)  
**Gasmet GT5000**

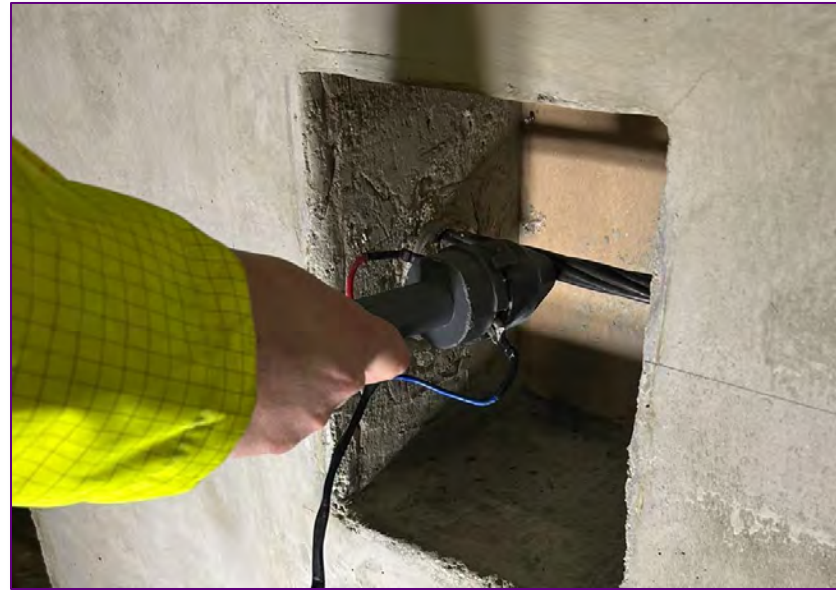
Guided Wave  
(indicative)  
**Omnia Vigor System**

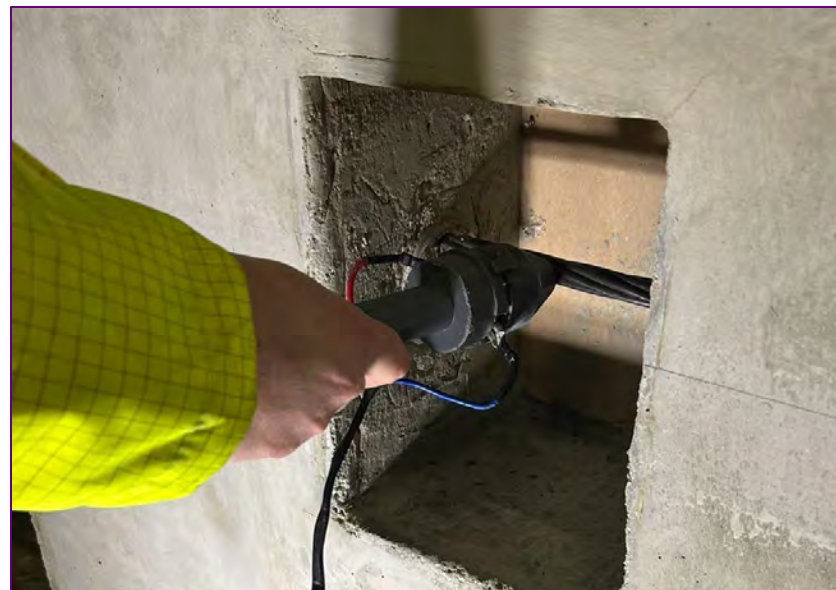
Guided Wave  
(indicative)  
**Omnia Vigor System**

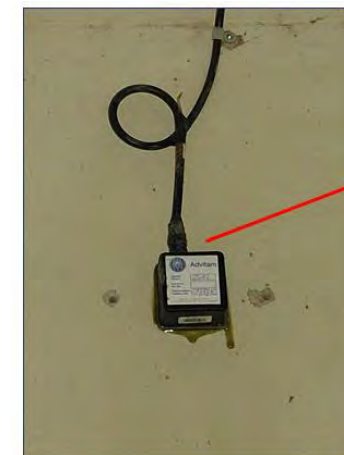
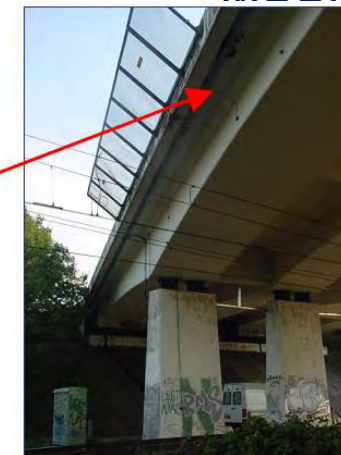
Acoustic Emission Monitoring  
e.g. **Mistras Sensor Highway III**

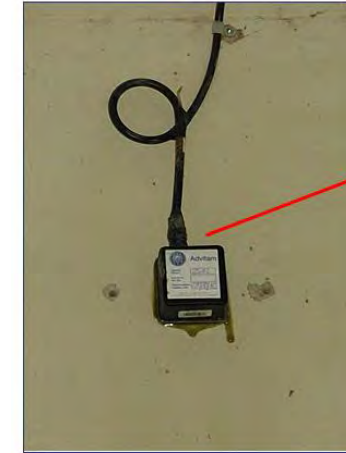
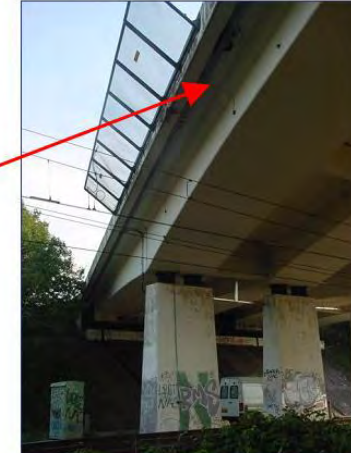
Acoustic Emission Monitoring  
e.g. **Mistras Sensor Highway III**
