## STRUCTURES MOONSHOT

# Delivering the Moonshot Ambition

# Huntingdon Viaduct – History

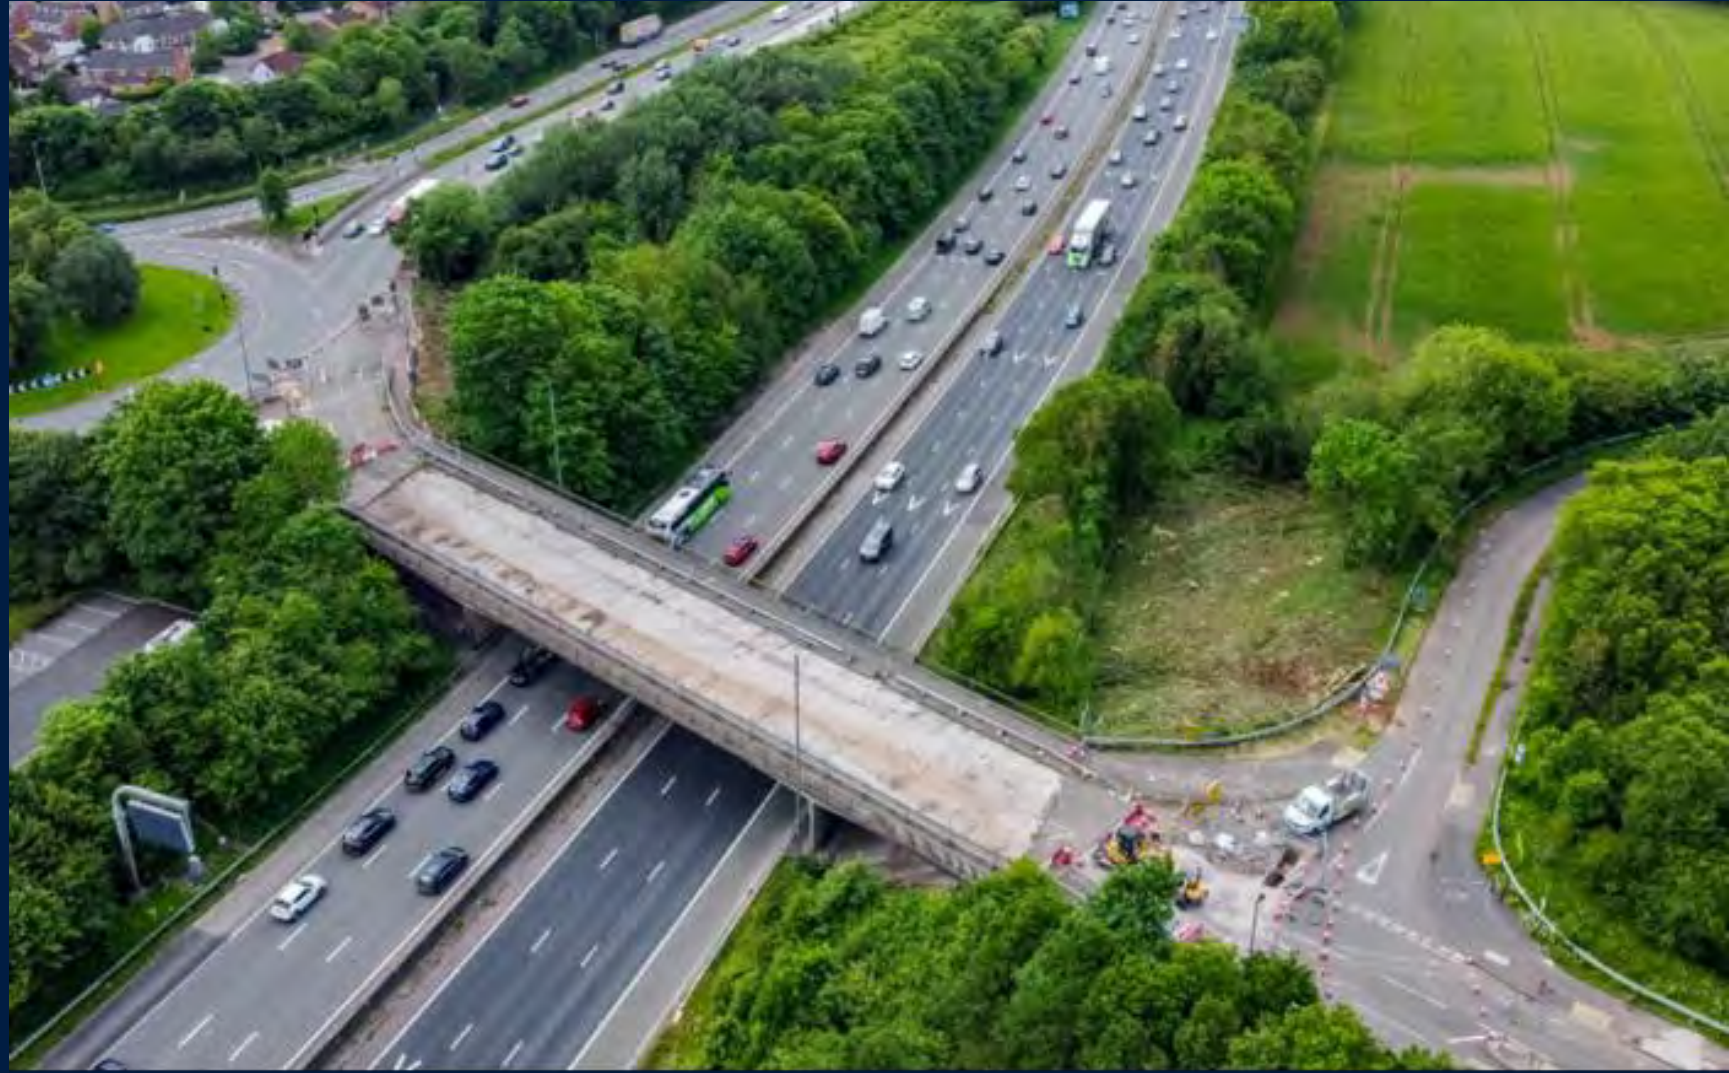
# The Structure

- Located 6 Miles Northeast of Bristol
- Constructed in 1966
- Carried the A432 over the M4
- Post Tensioned Concrete Structure
- 180 Total Tendons

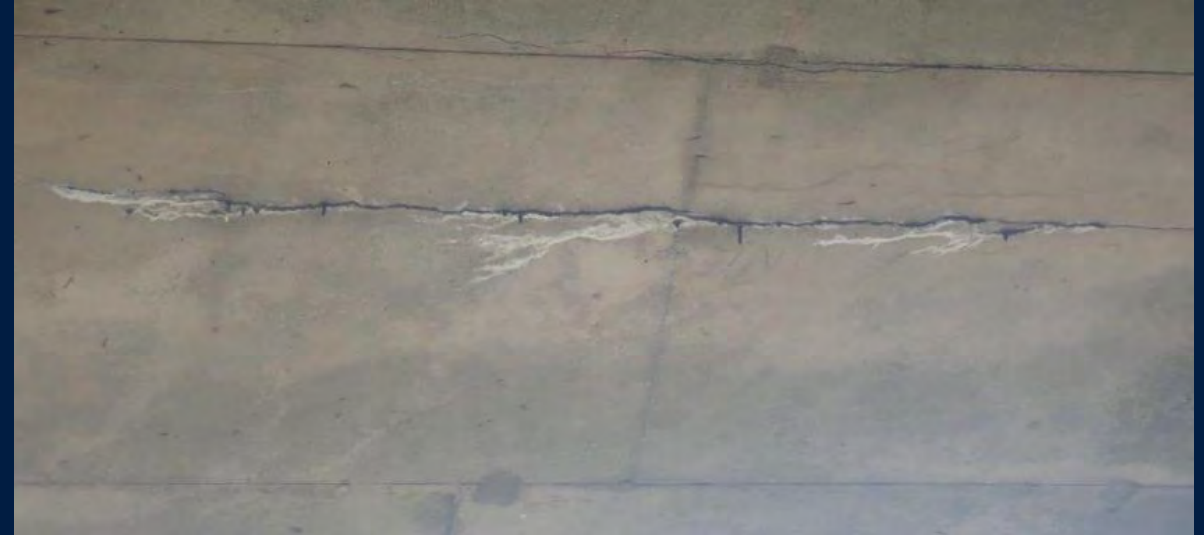
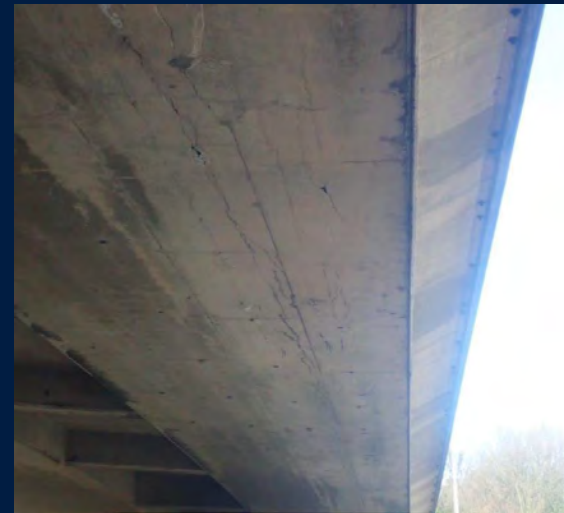
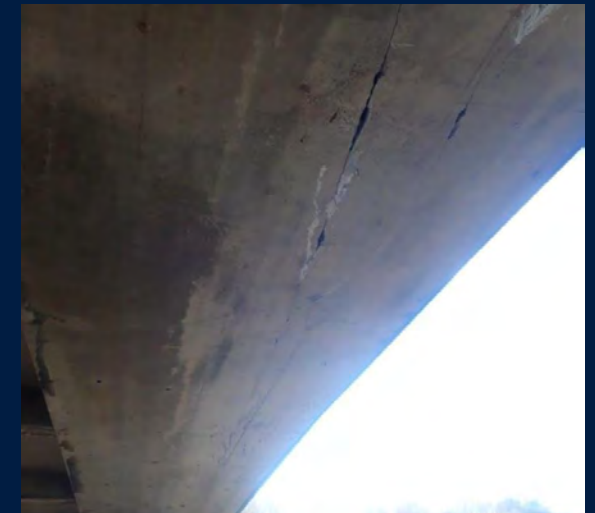
# Condition

- Severe Longitudinal Cracking.
- Differential Clearance Indicating Non-Monolithic Deck.
- PTSI Identified Excessive Voiding in Pre-Tensioned Ducts.
- Various Corrosion Products.
- Significant Water Egress from Exposed Pre-Tensioned Ducts.
- Structure Assessed as Category 0 at SLS and Closed to Public.
- Catalyst for Condition not Fully Understood.
- Demolished in March 2025.

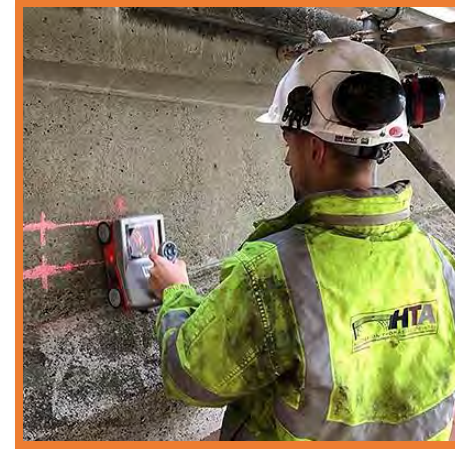
# NEW HTA PTSI METHODS – GPR

Ground Penetrating Radar provides an accurate determination of the location of post tensioning ducts and provides an estimation of the depth of cover for subsequent breaking out.

This method allows post tension ducts to be found quickly and prevents damage to the ducts or tendons from blind drilling.

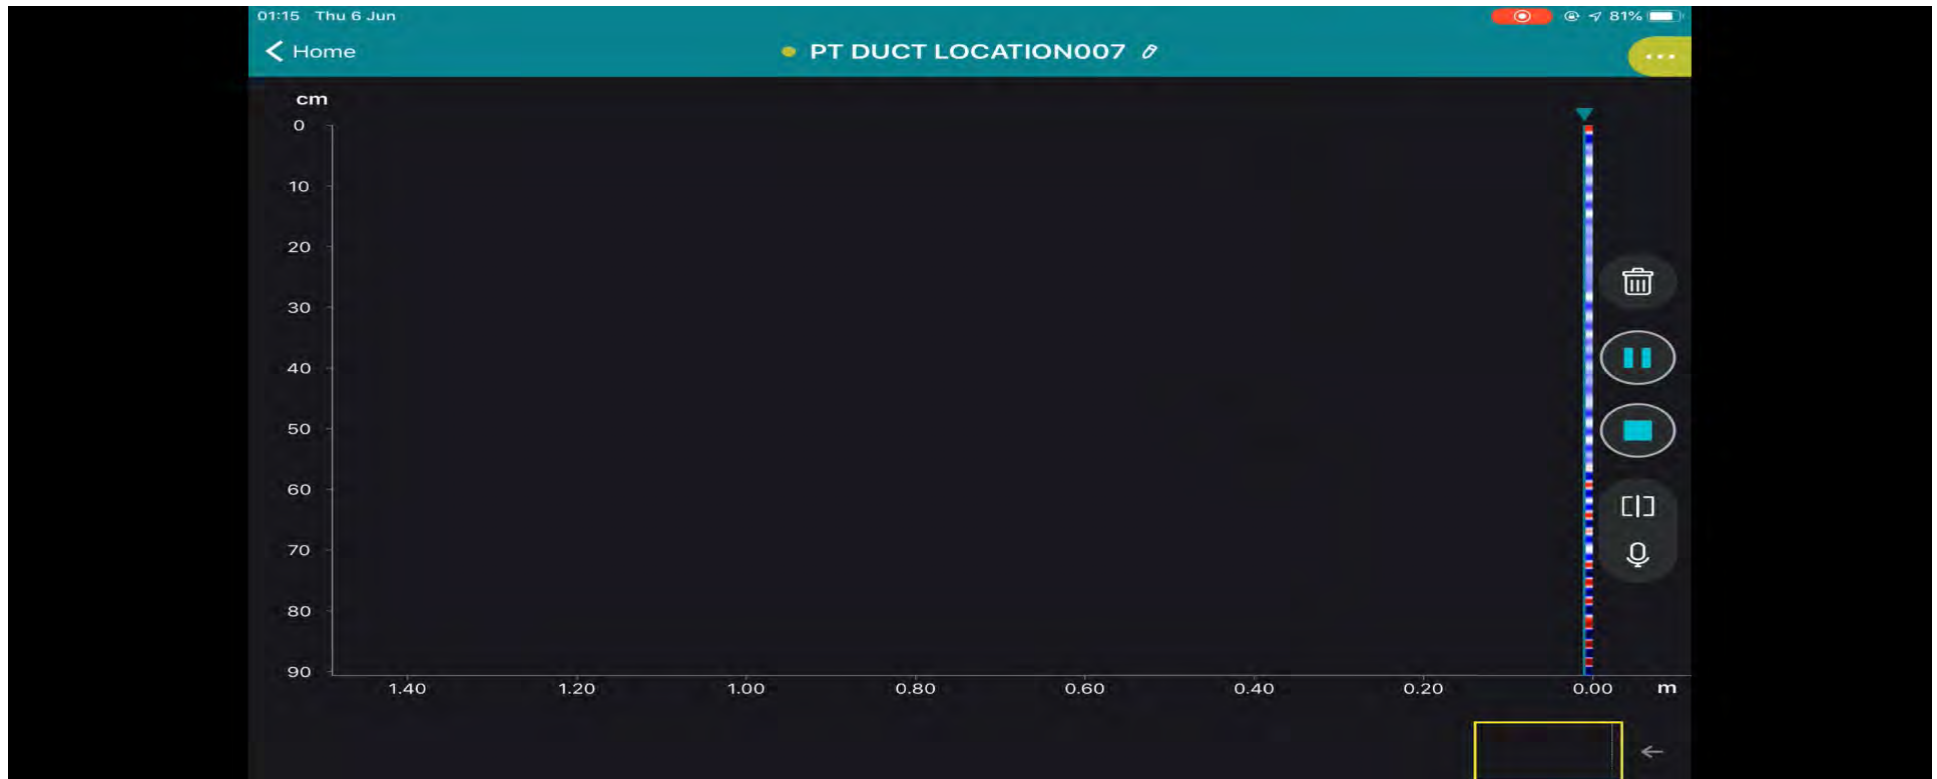
Here's an example of our GPR survey that we carried out on Brent Cross flyover back in 2017. The GPR was used to locate the tendon ducts & reinforcement.

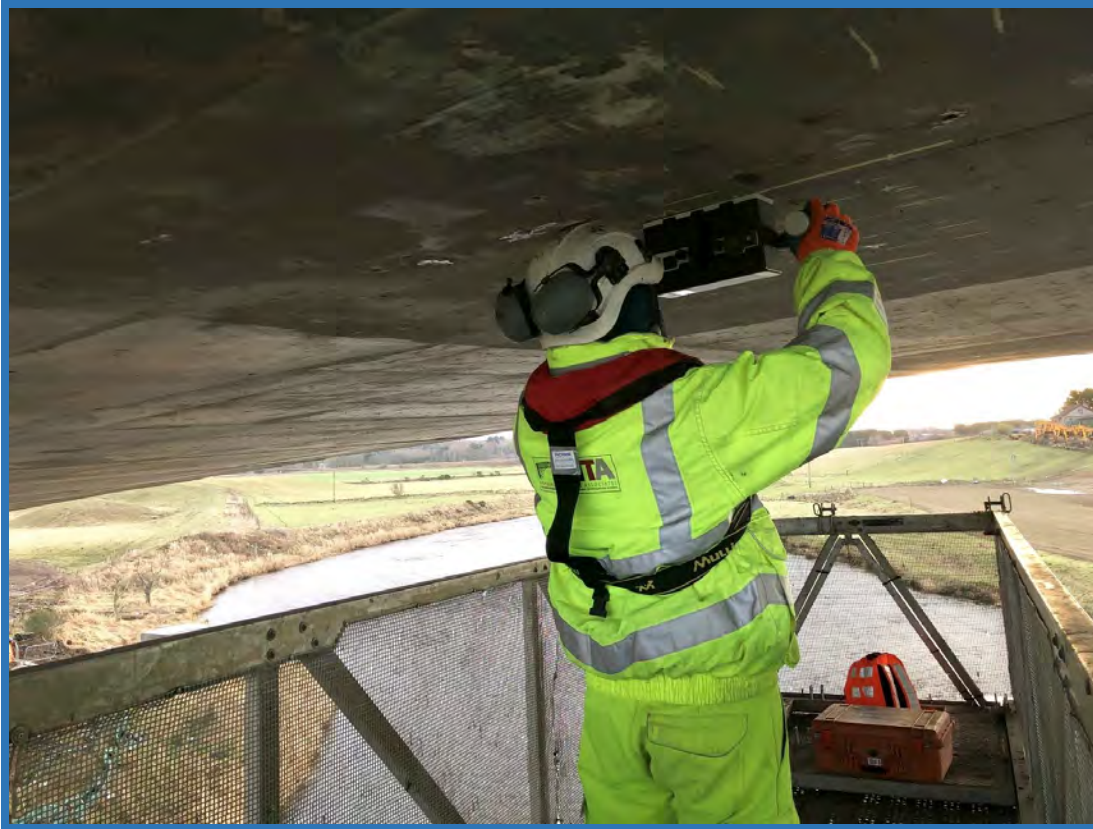
# NEW HTA PTSI METHODS – TOMOGRAPHY

Pundit Pulse Array Live 'Tomography' is used to detect voids and defects – removing the large amount of guesswork used in the traditional approach.

This prevents any breaking out of areas that do not require it and focuses on areas that show potential problems.

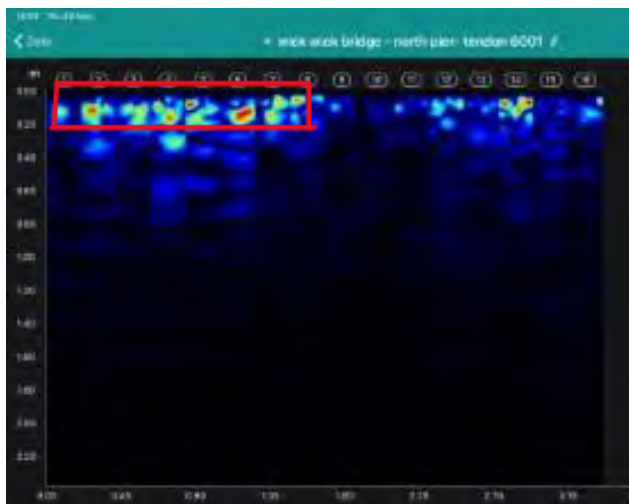
# PUNDIT ULTRASONIC PULSE ECHO RESULTS – BADMINTON BRIDGE

Due to the condition of the structure after the preparation of the bridge being demolished. We were unable to collect clear & accurate data from the pundit tomography. Where the concrete surface had been perforated after the removal of tarmac & waterproofing we was left with a delaminated & spalled surface. As you can see from the highlighted areas on the scans above you can see that there's no clear run of tendon ducts. This is where you can't apply even pressure through the transducers which distributes the ultrasonic waves through the concrete slab.

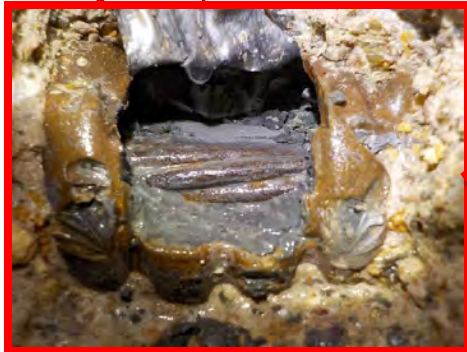
**Spot A:**  
Duct with known void

This is a perfect example of two tendon ducts within the same structure. As you can see that location A has indicated voided areas on the Pundit and that location B has shown fully grouted ducts. We then carried out two inspections on both areas to calibrate our findings to the Pundit tomography. As you'll see that the tomography was accurate and we was able to pin point the correct areas without causing unwanted destructive works

**The Object at Spot A**

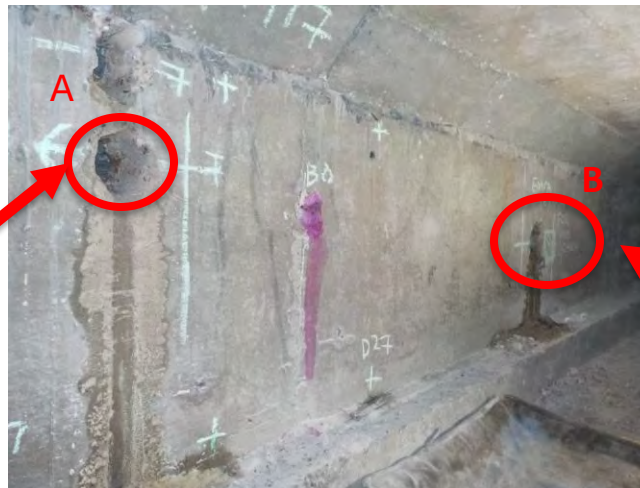
**Spot B:**  
Duct known to be fully grouted

**The Object at Spot B**

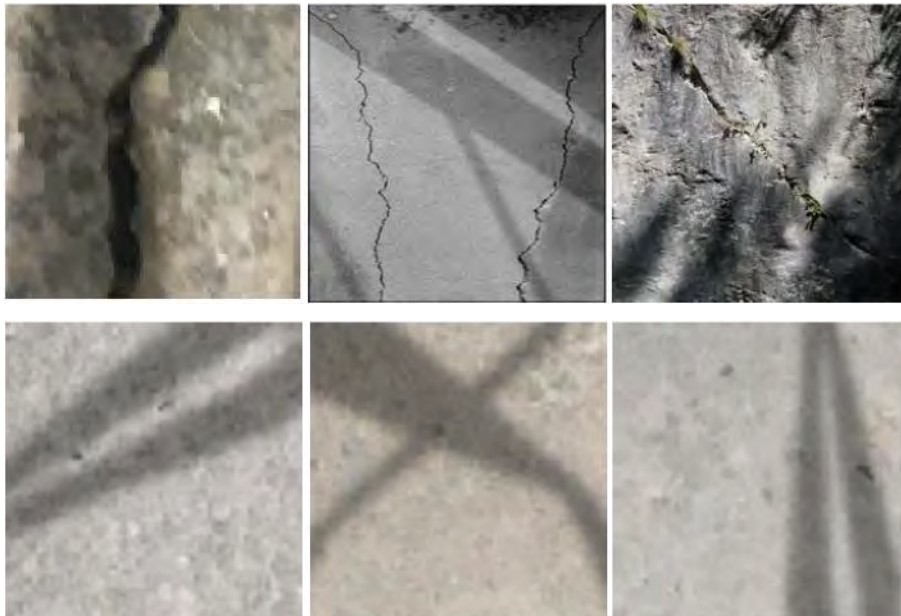
- AI-powered algorithms can inspect captured inspection images.
- However, these methods are challenged by shadows and inconsistent lighting:

Hidden cracks

False cracks

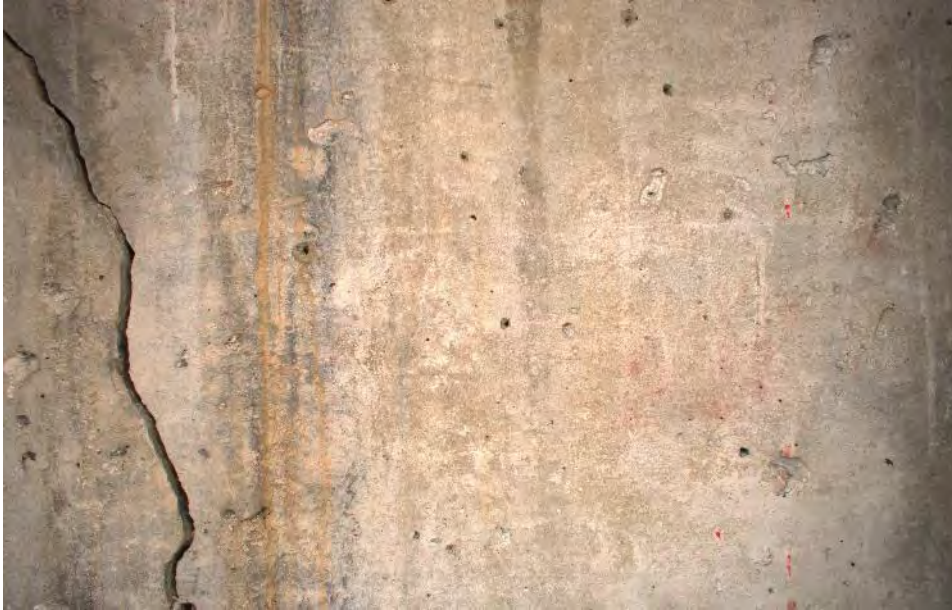
Diffused lighting

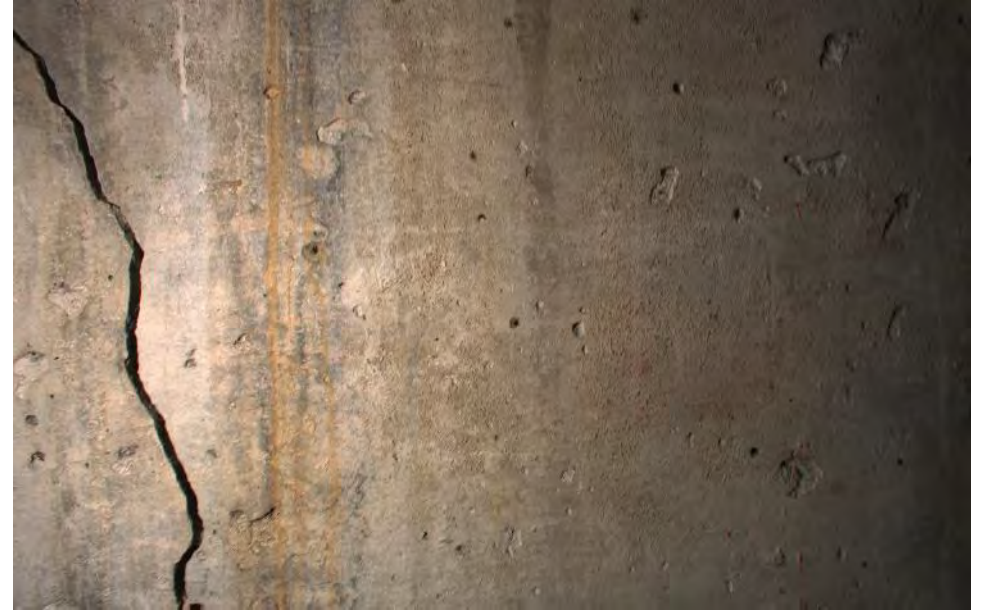
Directional lighting

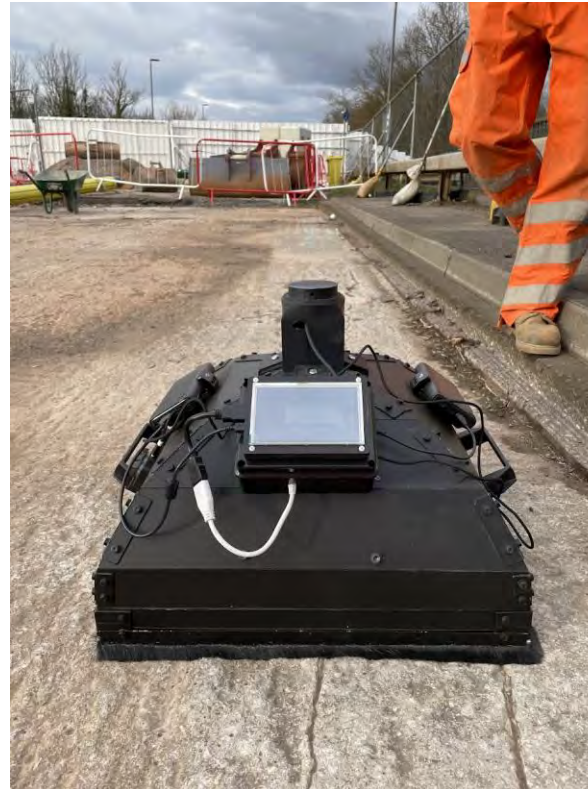
# ALICS Hardware

**ALICS: Adaptive Lighting for the Inspection of Concrete Structures**

- Lighting-enhanced concrete inspection device.
- Deployed at Wick Wick Viaduct.
- Produced crack map of 76 m<sup>2</sup> in under 5 hours.
- All major defects identified.
- Thank you to:

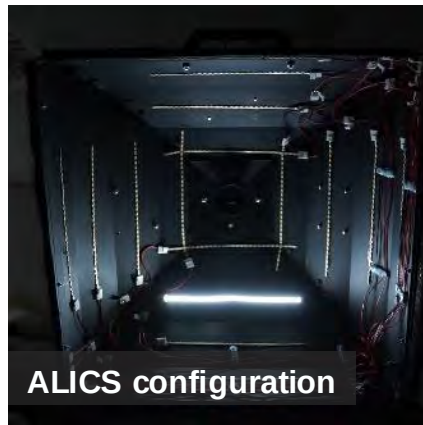
Below Lighting

ALICS configuration

Full-resolution view

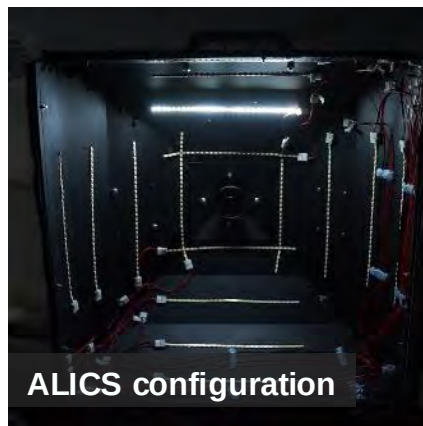
Above Lighting

ALICS configuration

Full-resolution view

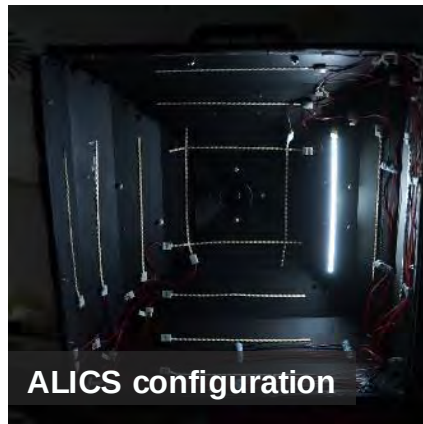
Left Lighting

ALICS configuration

Full-resolution view

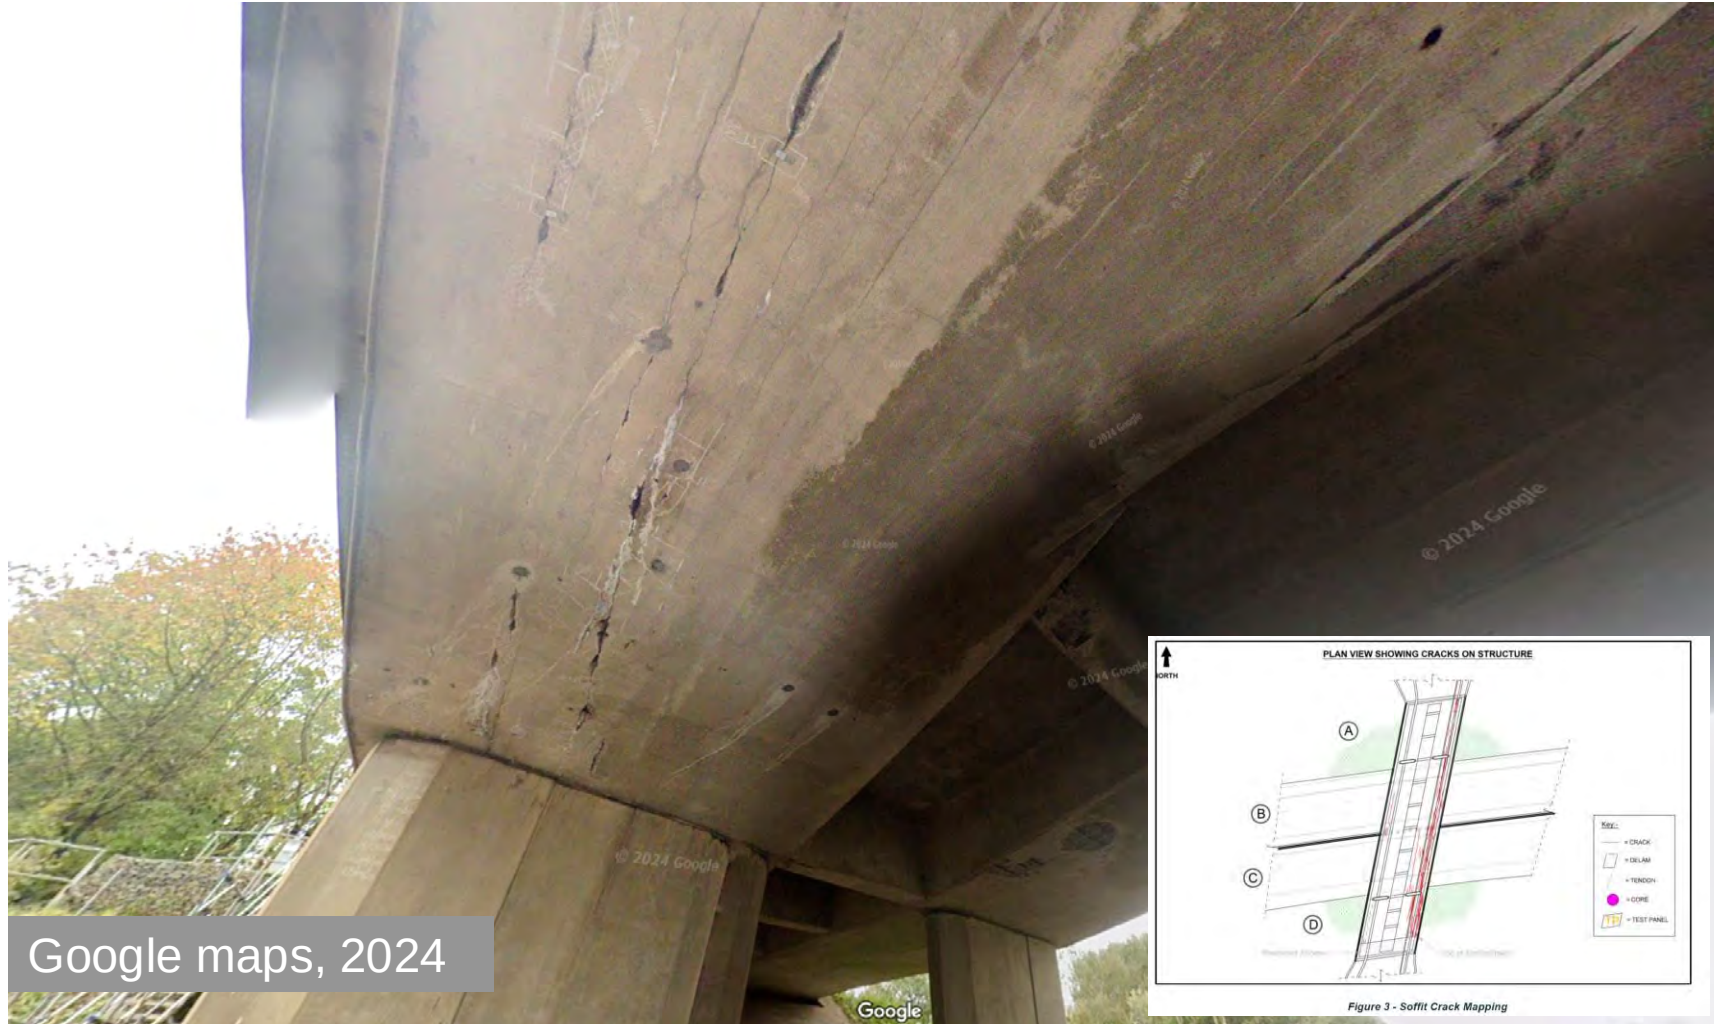
## Bridge Soffit

# Inspection Task

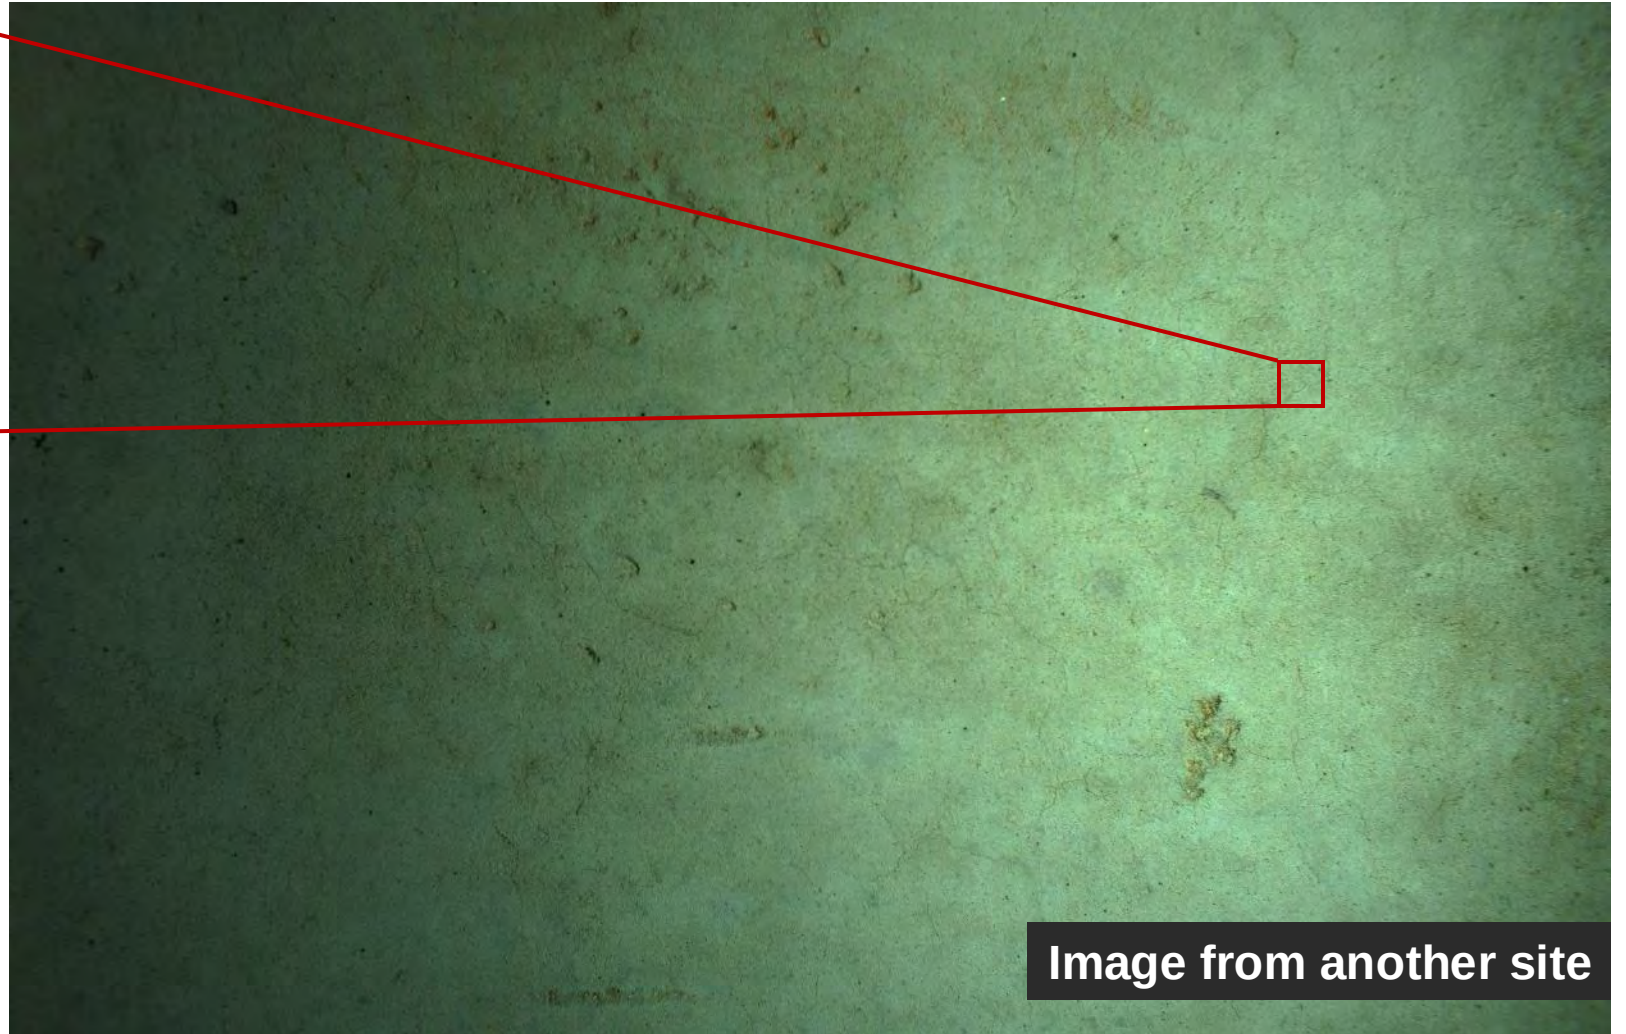
## Previous work

Image from another site

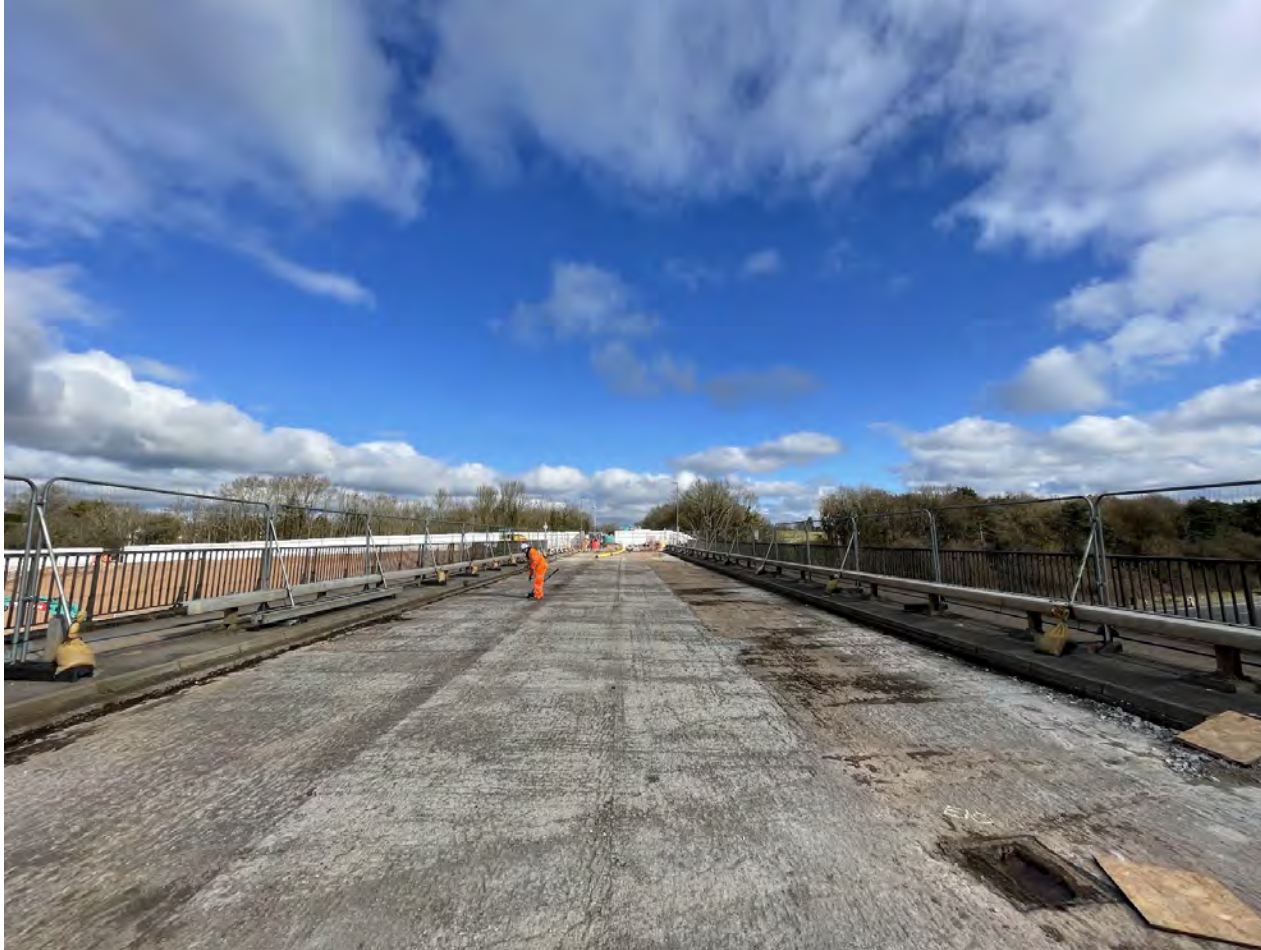
## Bridge Deck – Day of Inspection

# Inspection Task

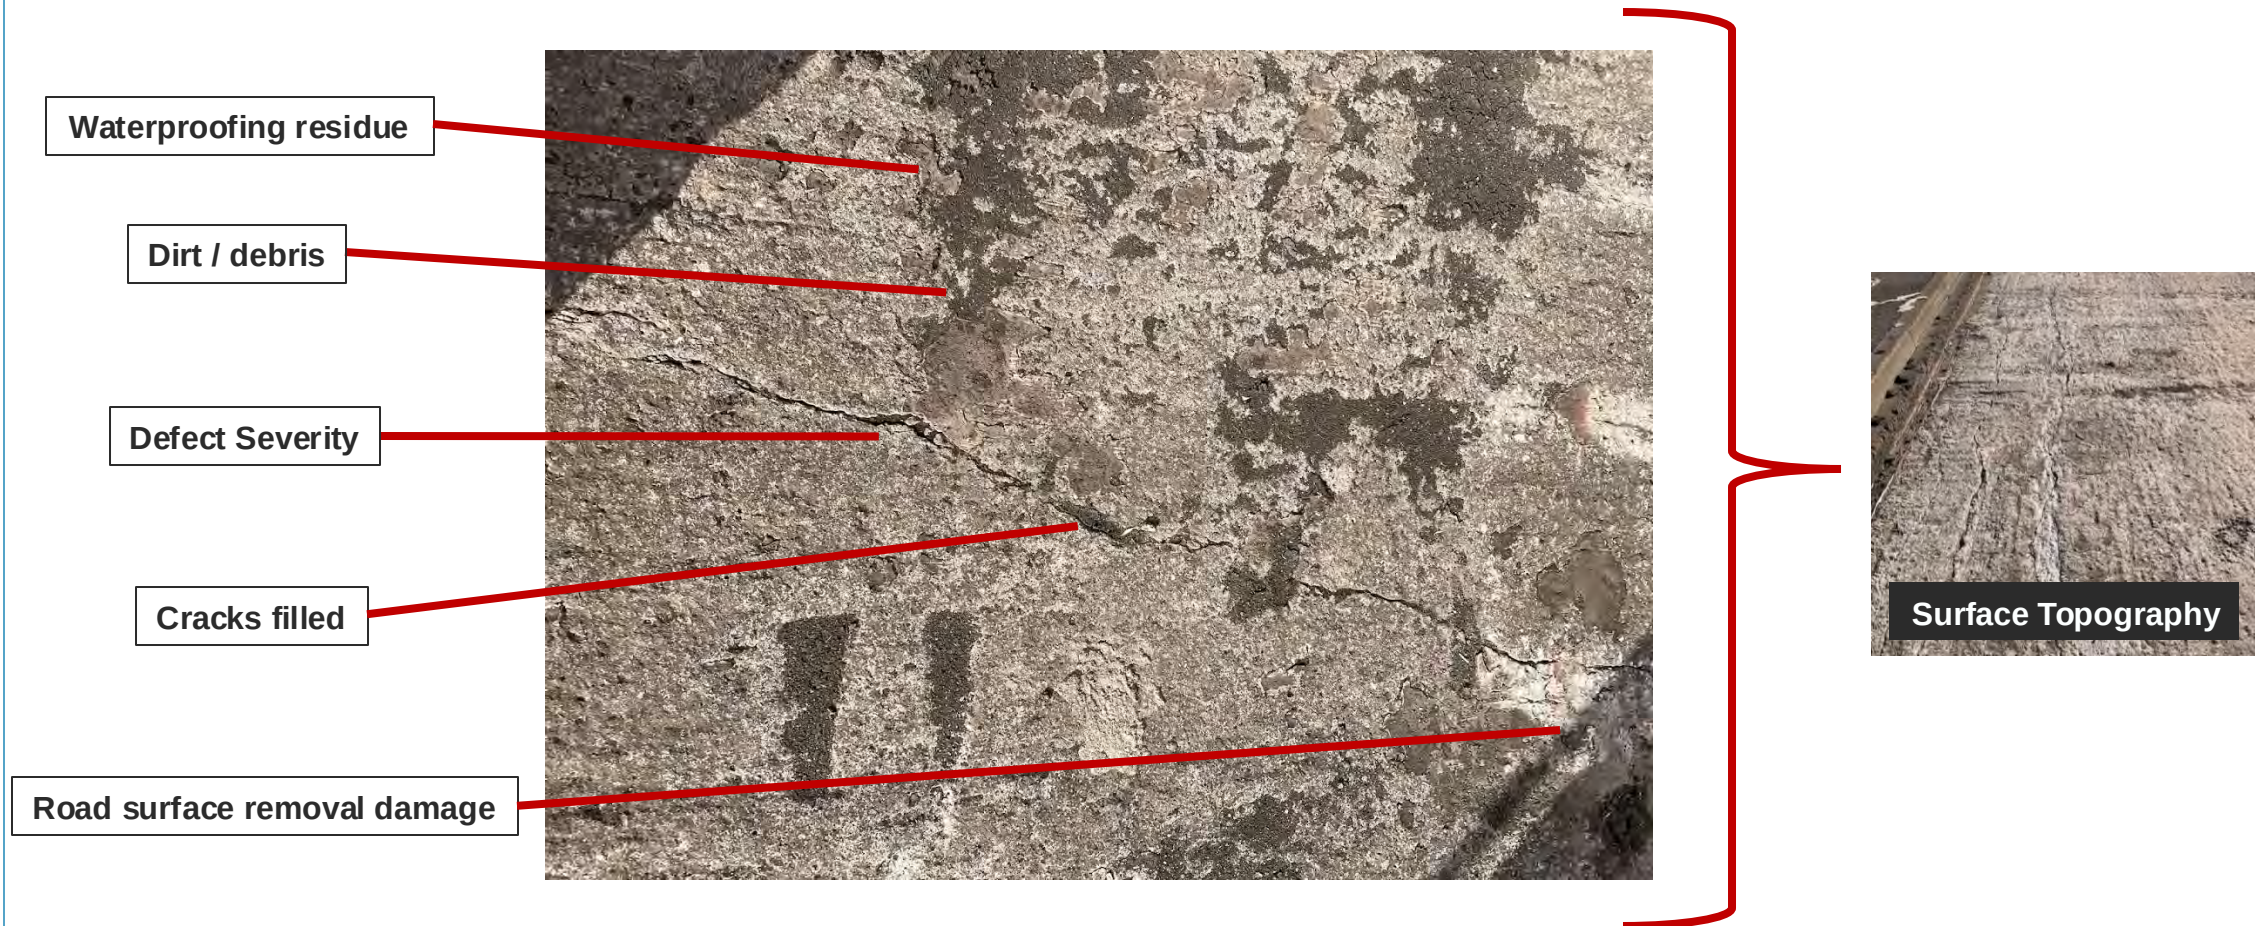
## Bridge Deck – Day of Inspection

### Challenges:

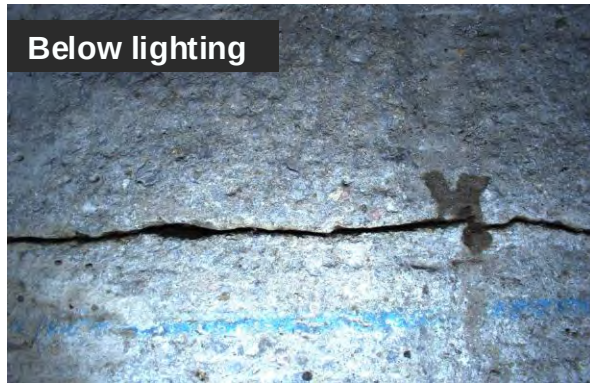
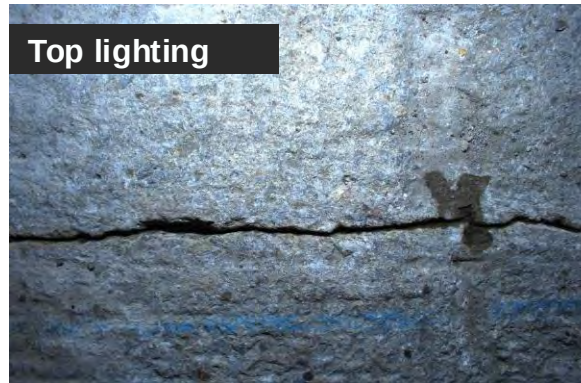
## Crack map data:

- 7,600 full-resolution images captured in under 5 hours
- ALICS FOV: 450 mm x 270 mm

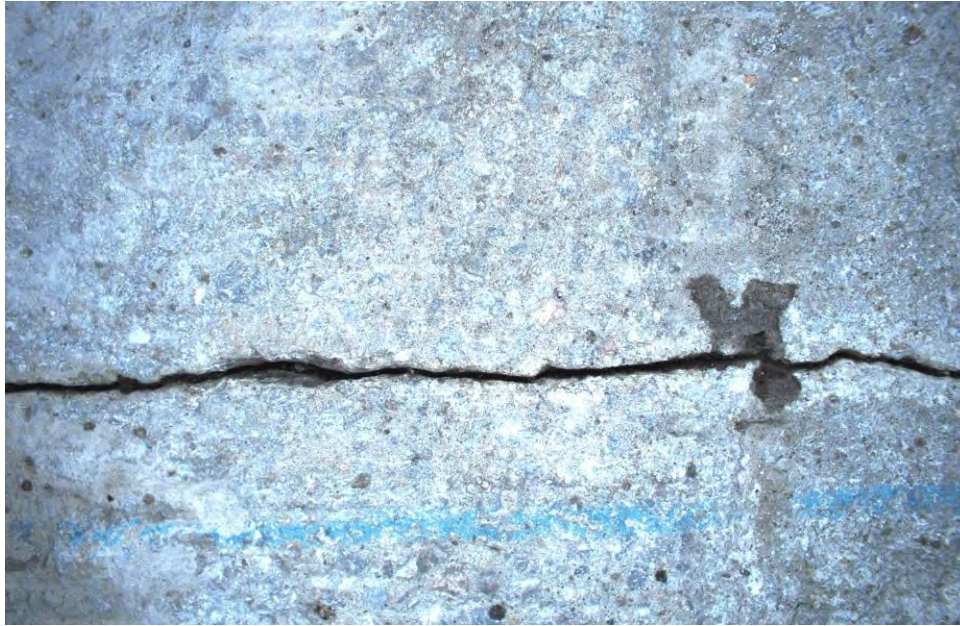
## Crack map data

# Inspection Method

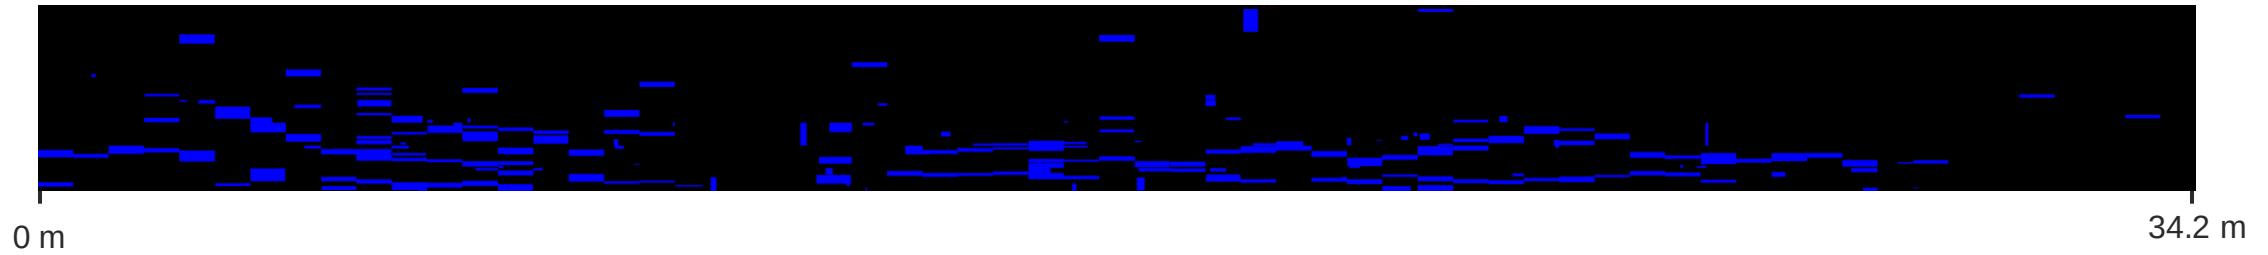
## Full results: cracked regions

# Results

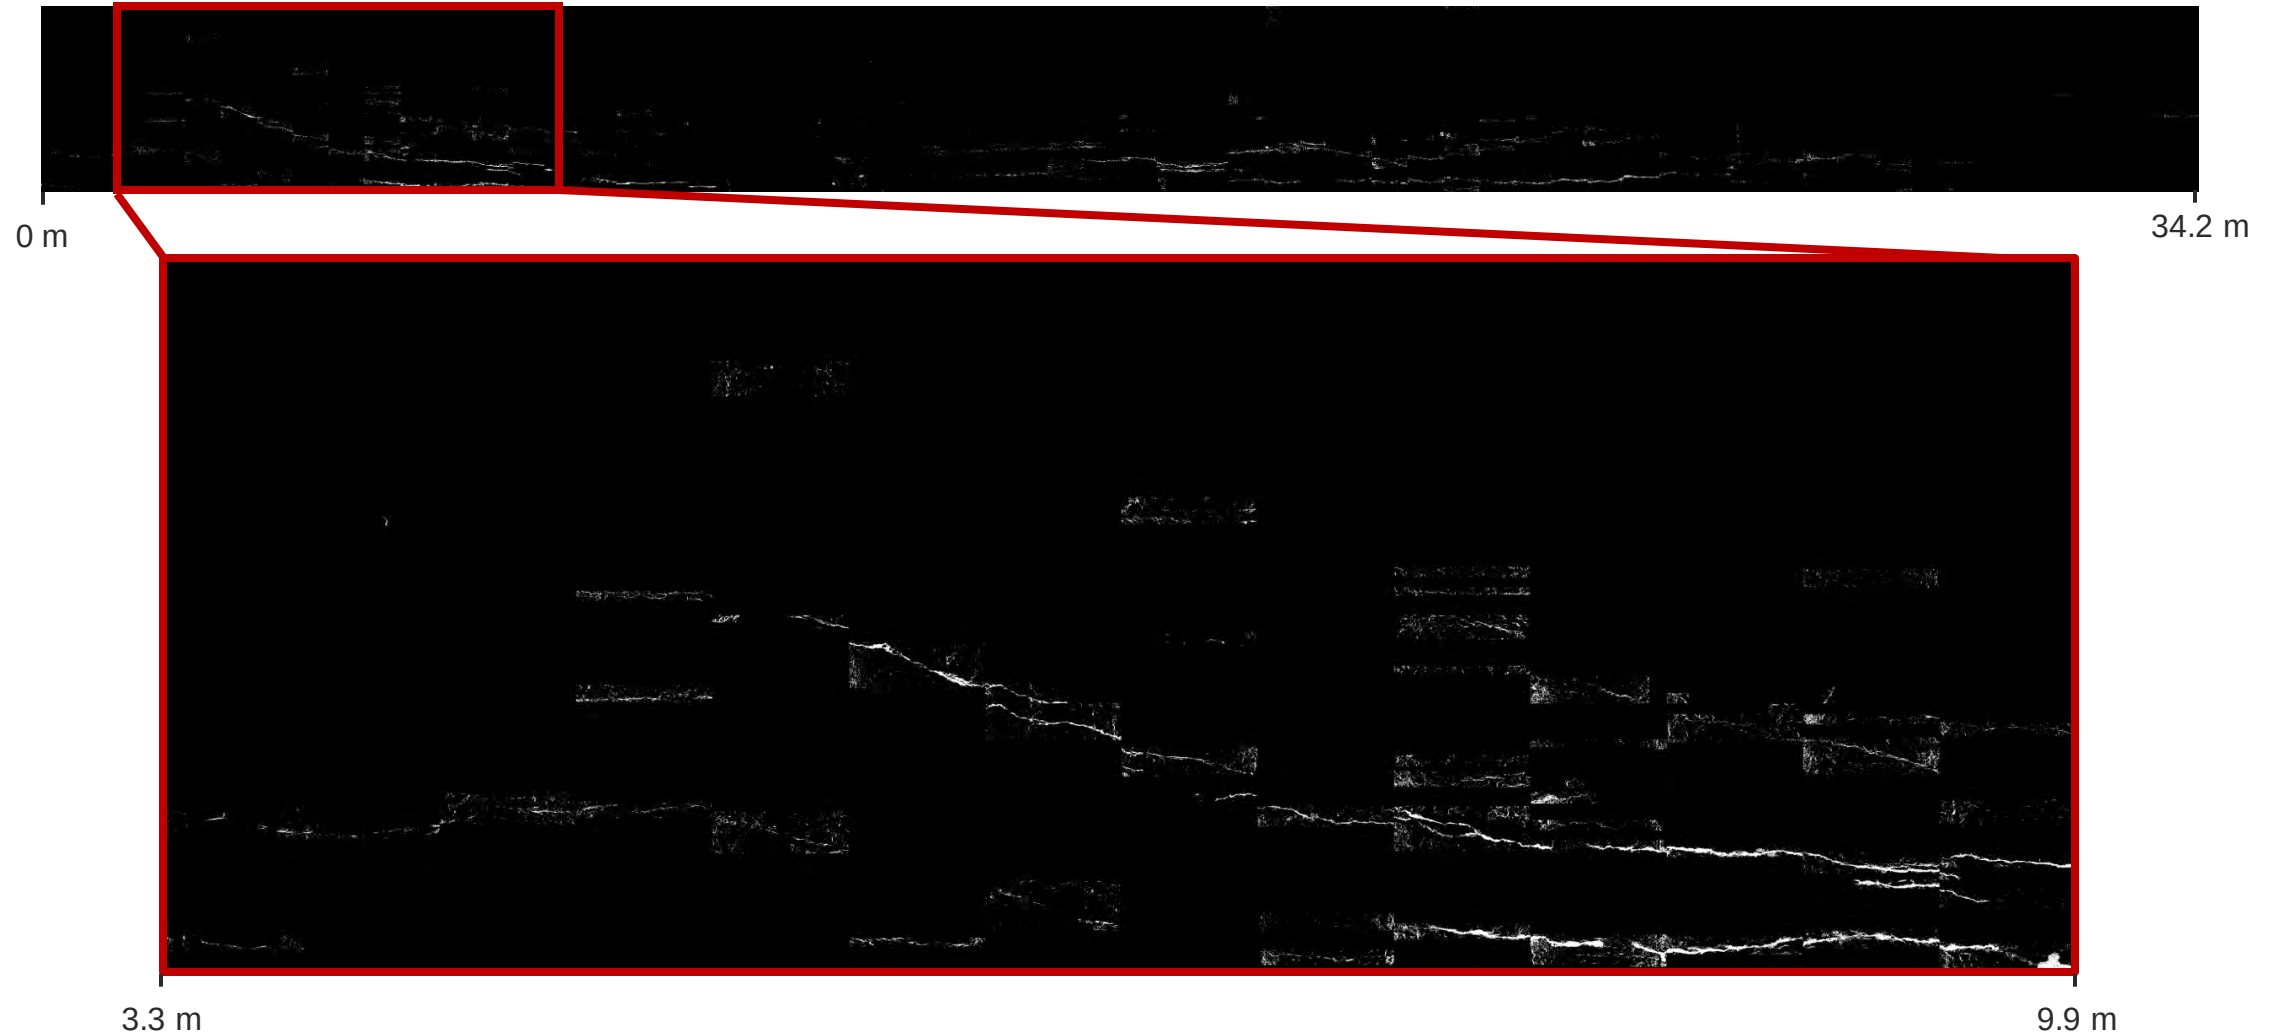
**Chainage: 3.3 m – 9.9 m**

# Results

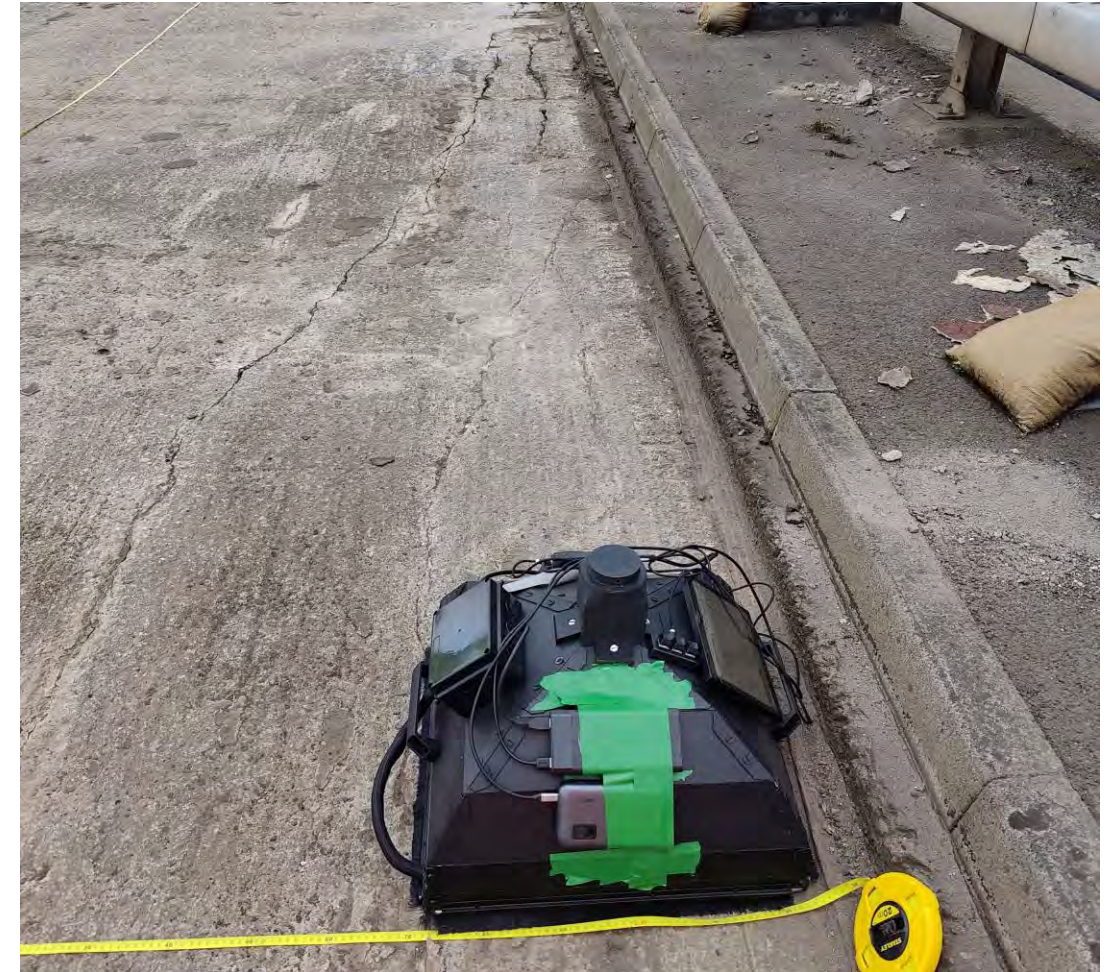
Chainage 3.3 m – 9.9 m

**ALICS Inspection**
