## STRUCTURES MOONSHOT

# Delivering the Moonshot Ambition

# Huntingdon Viaduct – History

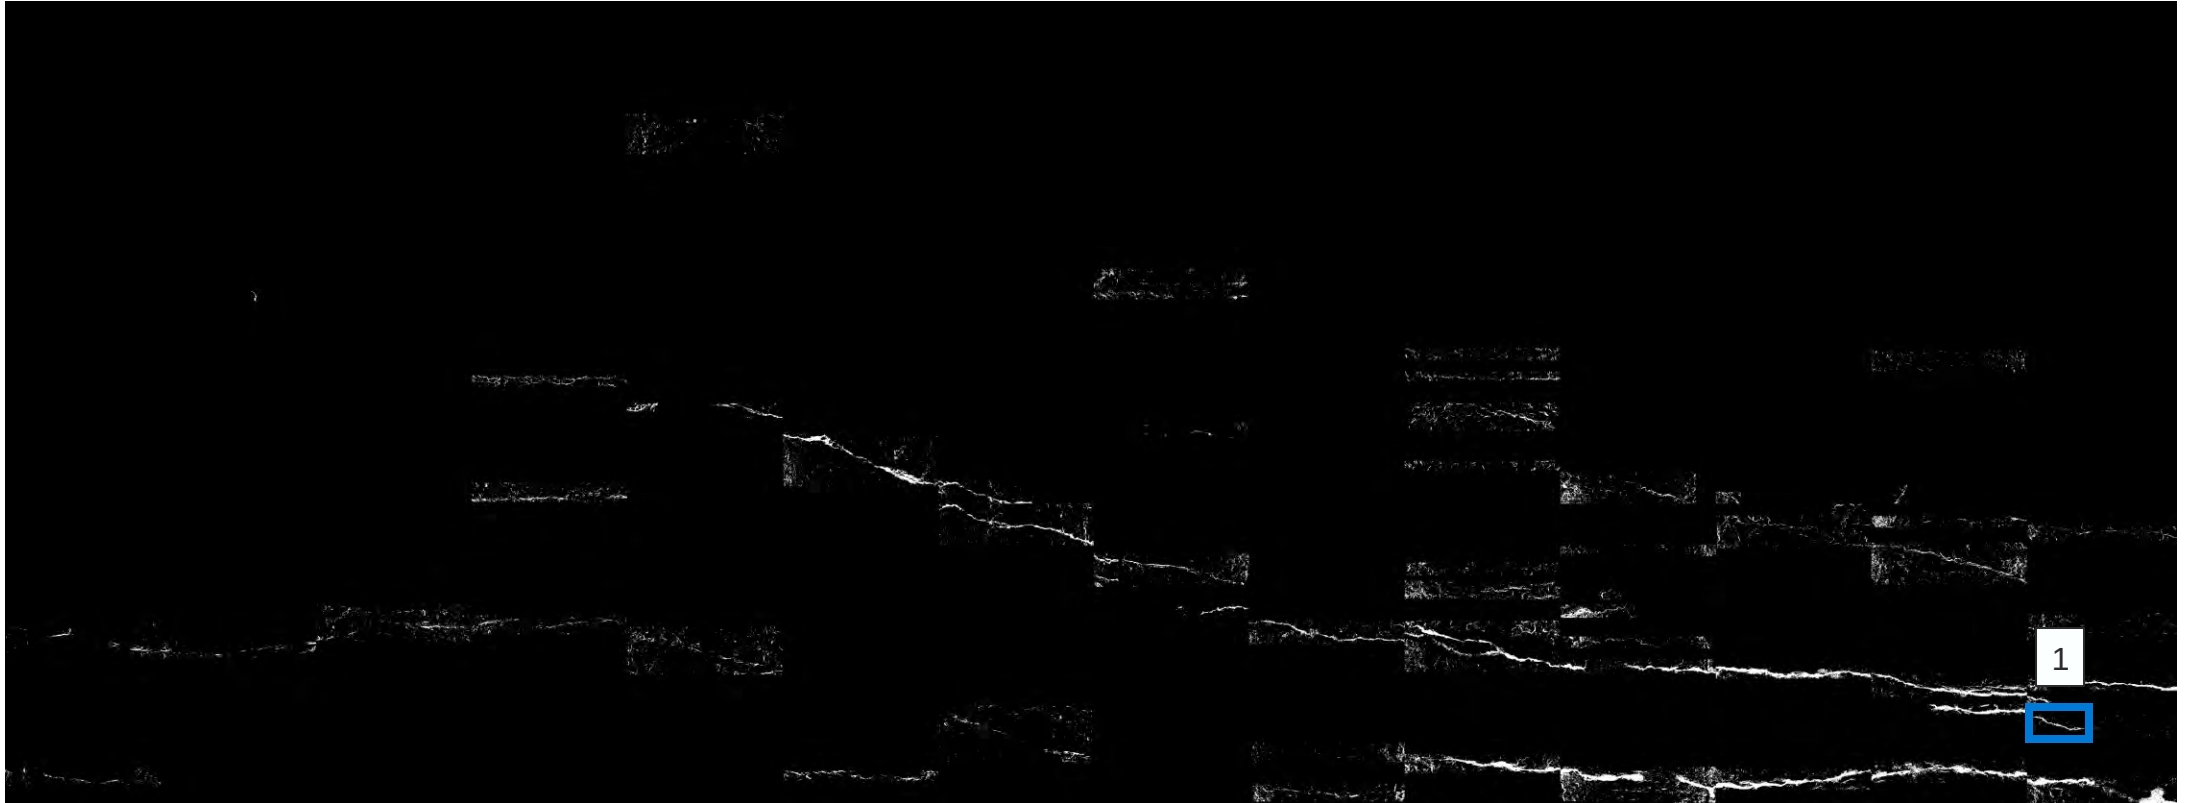
## Width measurement

# Results

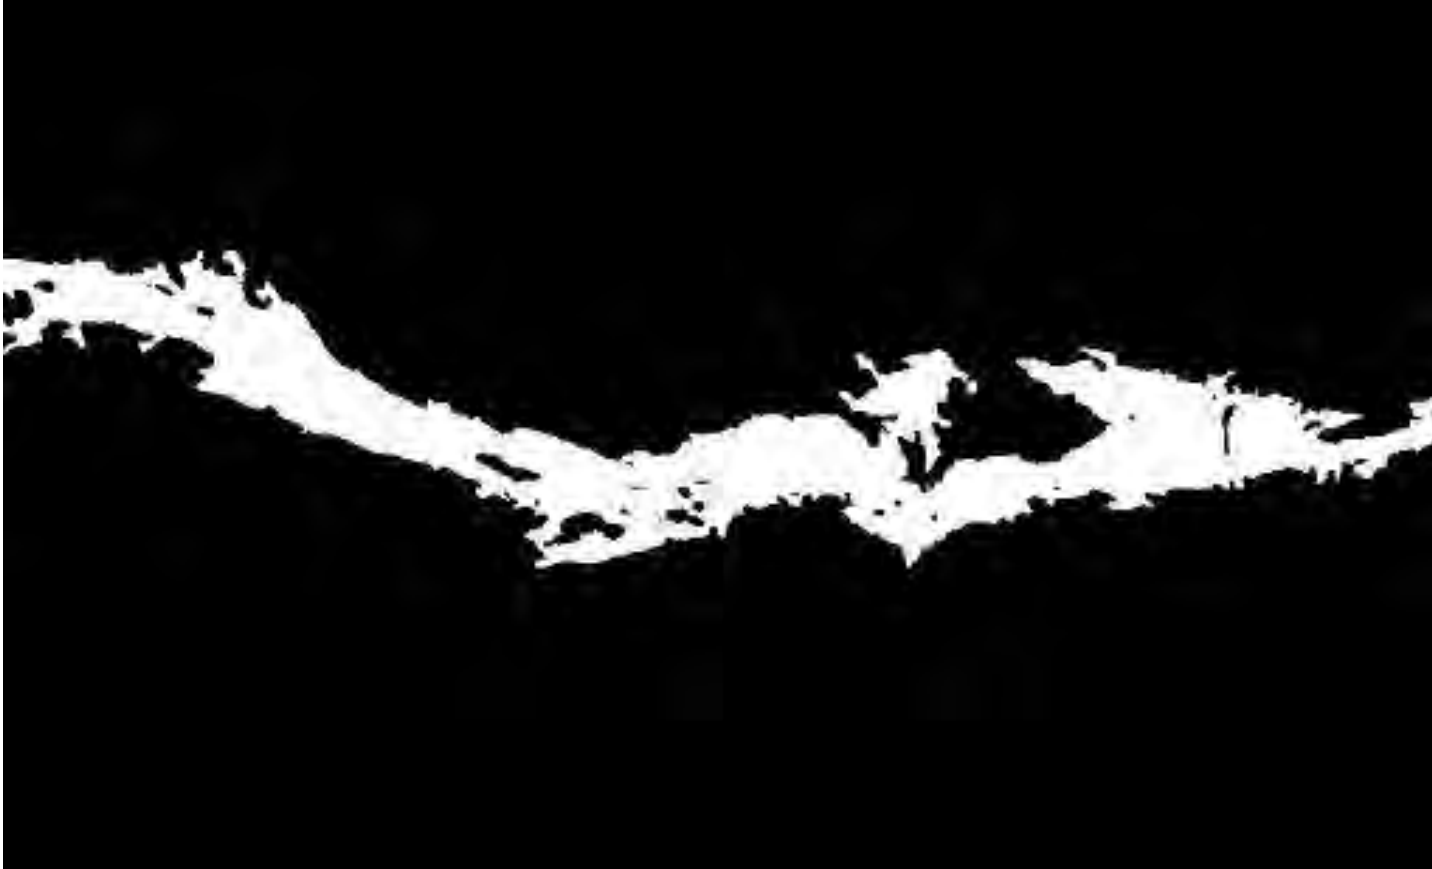
## Width measurement - Area 1

# Results

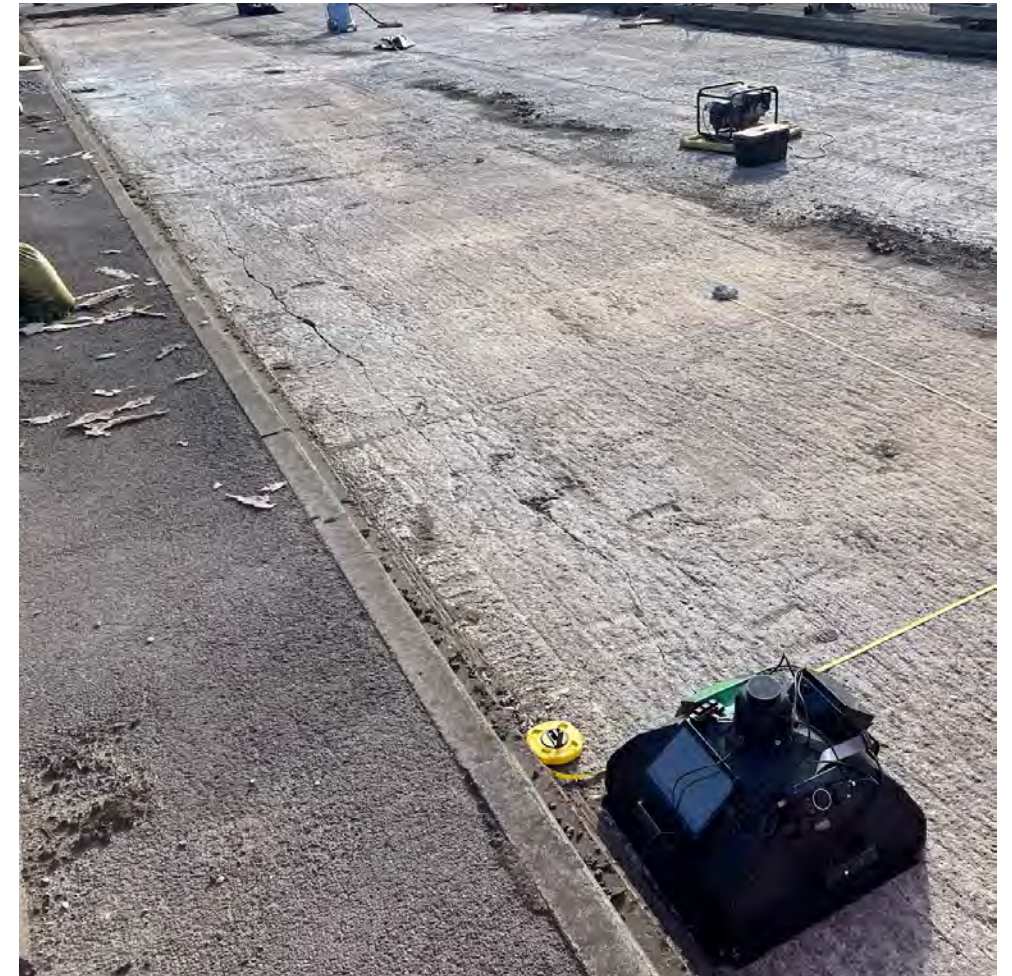
Chainage 19.8 m – 31.5 m

**ALICS Inspection**

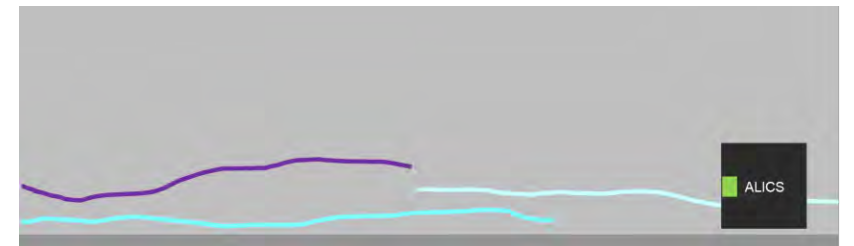
Chainage: 19.8 m – 31.5 m

# Results

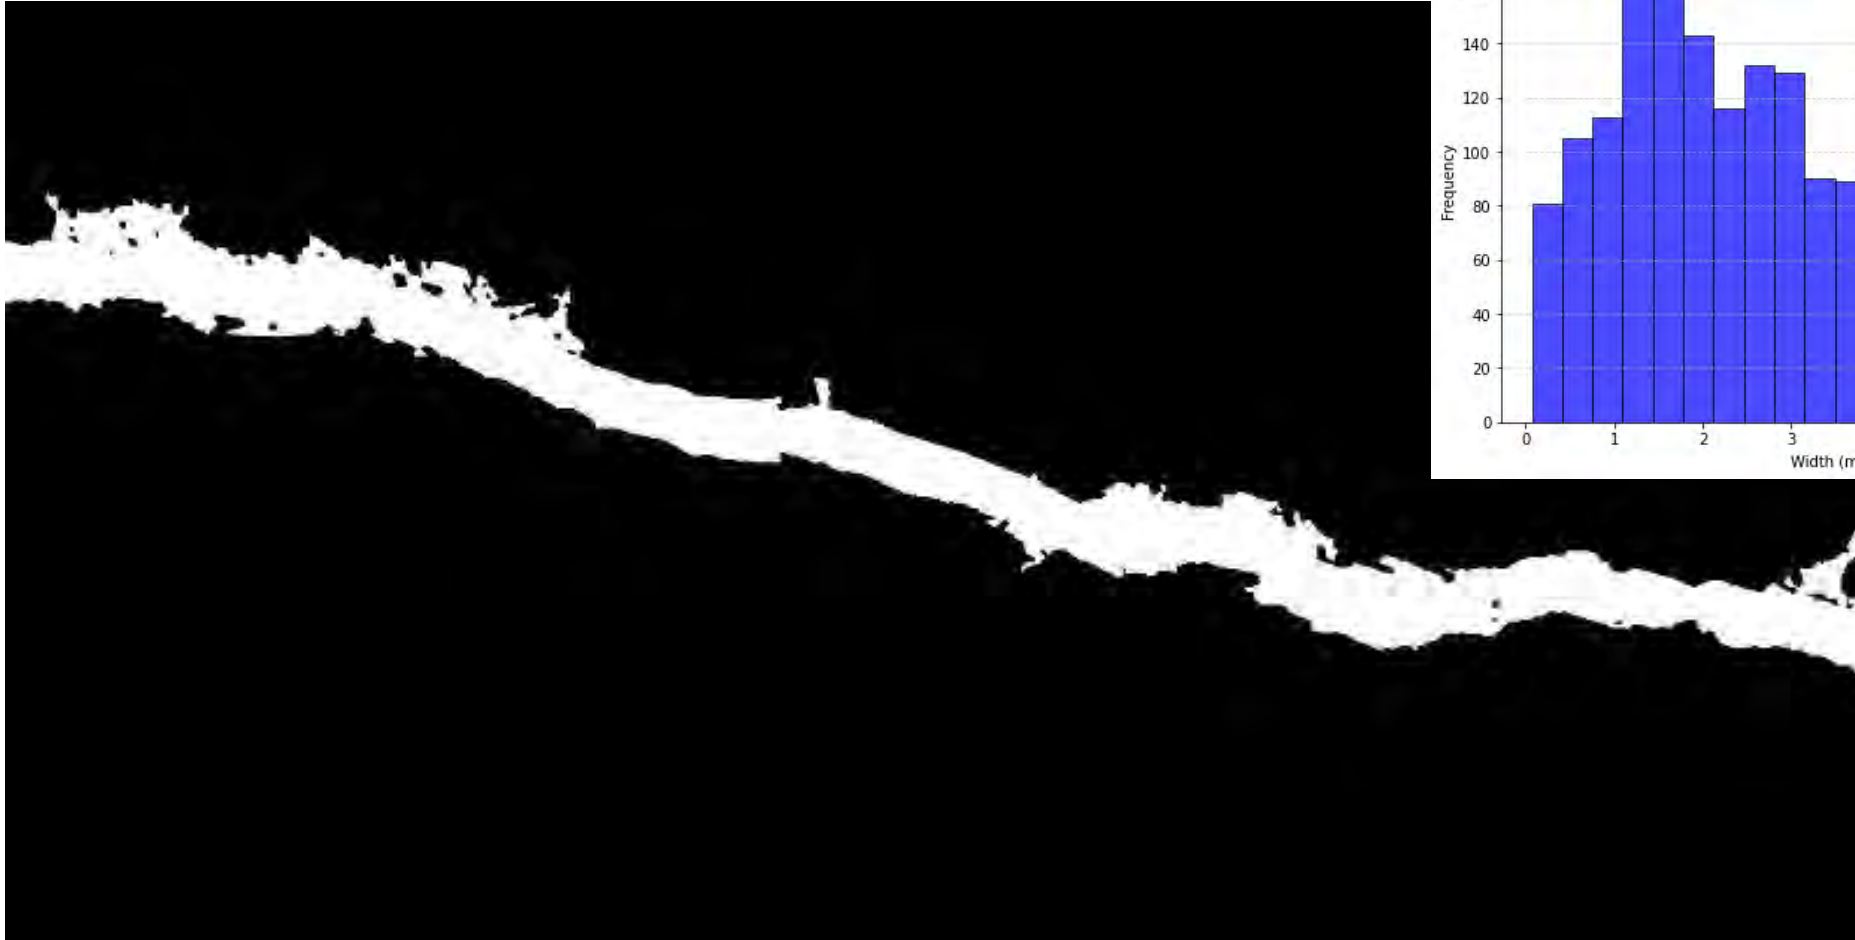
## Width measurement – Area 2

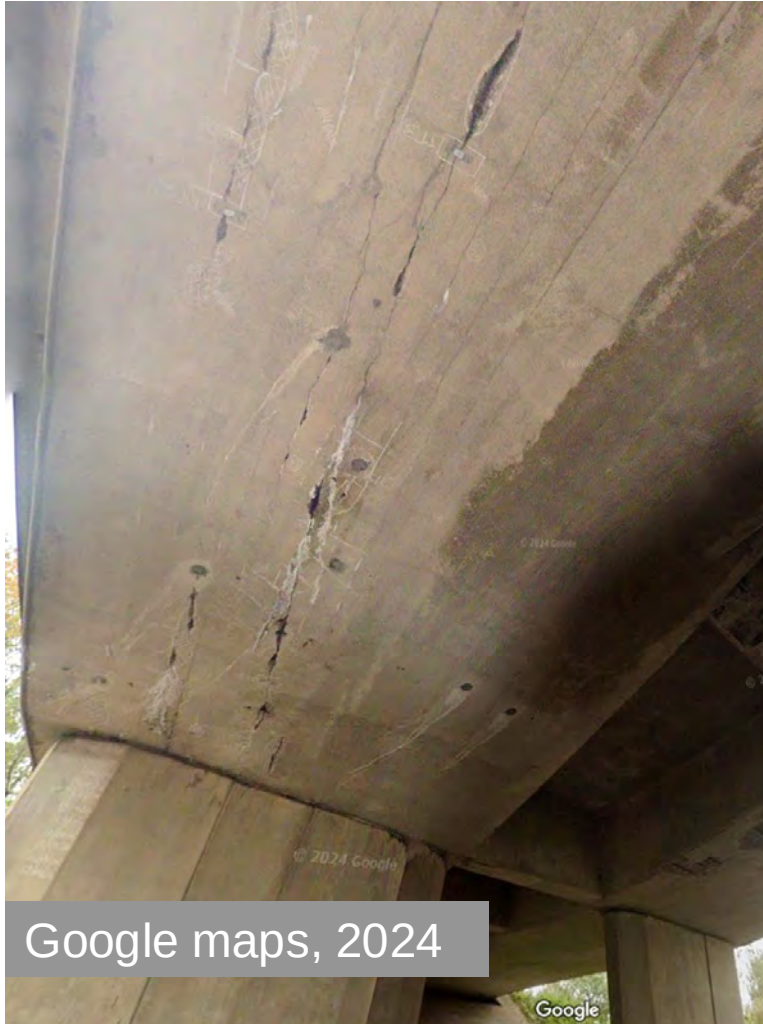
**Soffit**

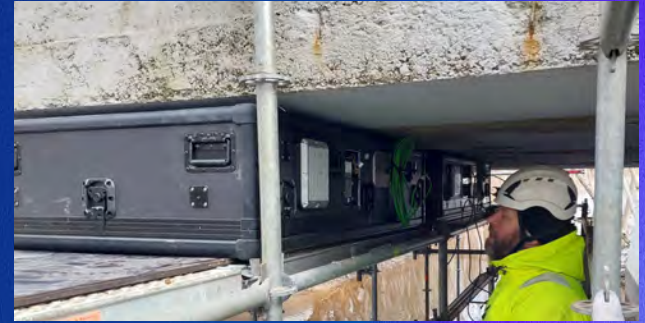
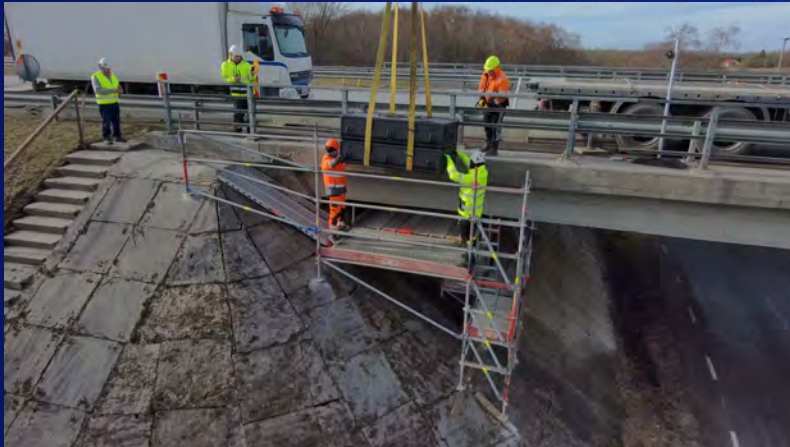
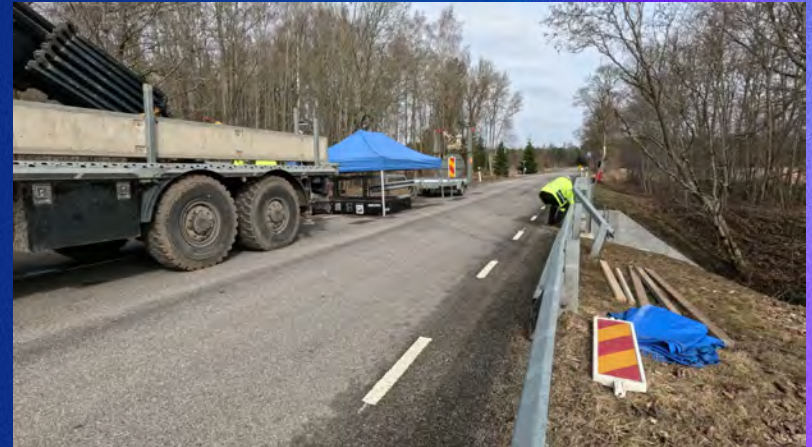
- Common cargo vehicle for transport
- Two man lift on top of the bridge
- Lifting equipment for under bridge installation

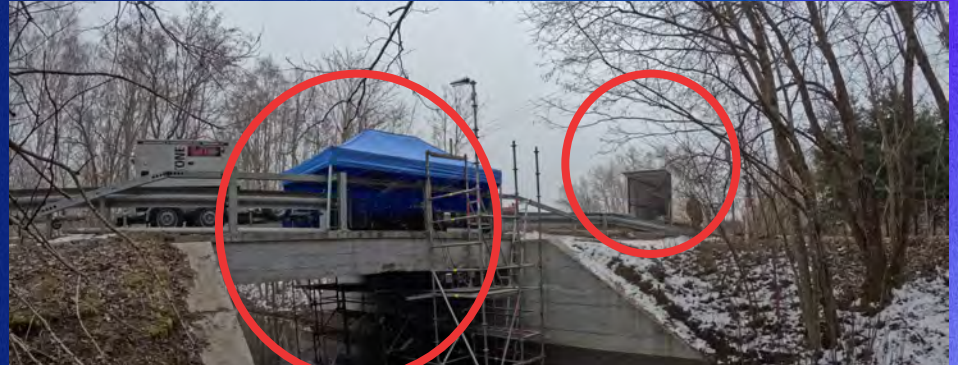
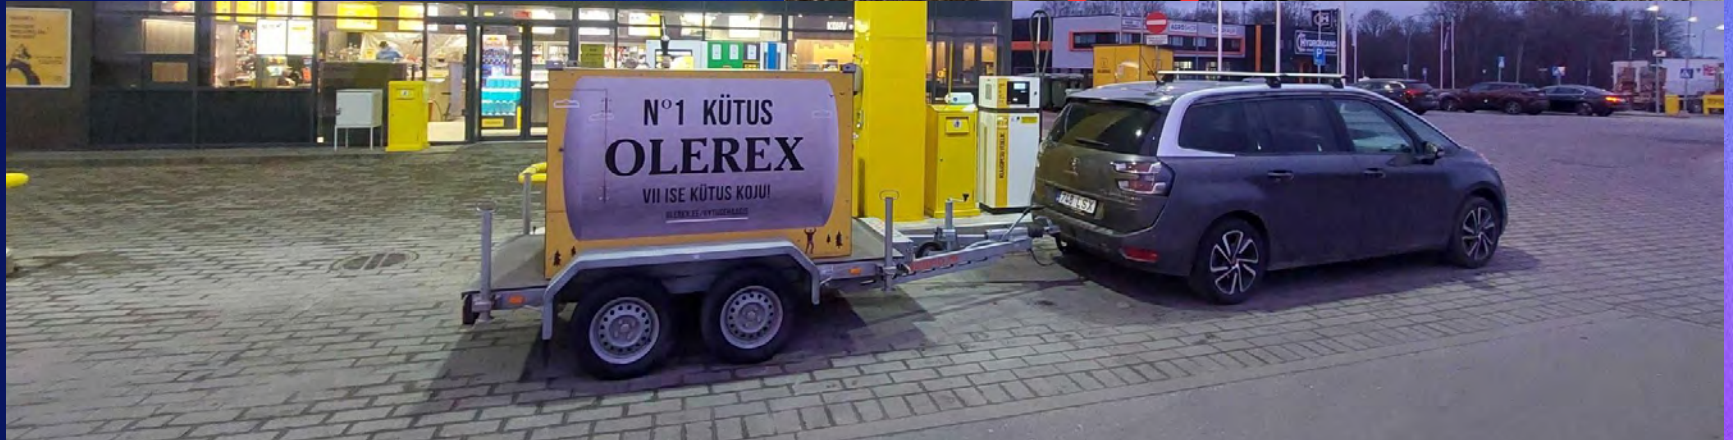
- Diesel generator
- 4G/5G cellular

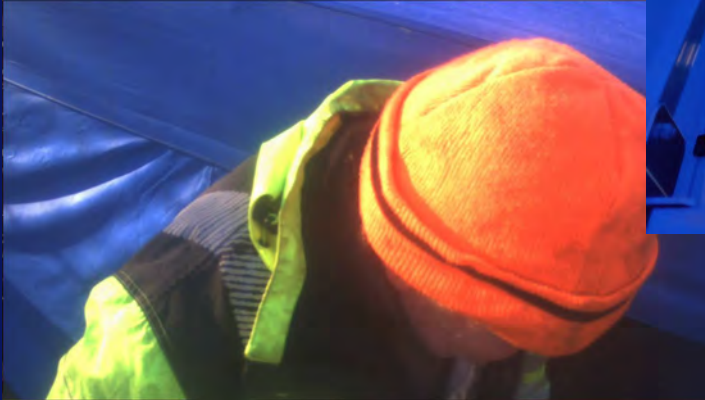
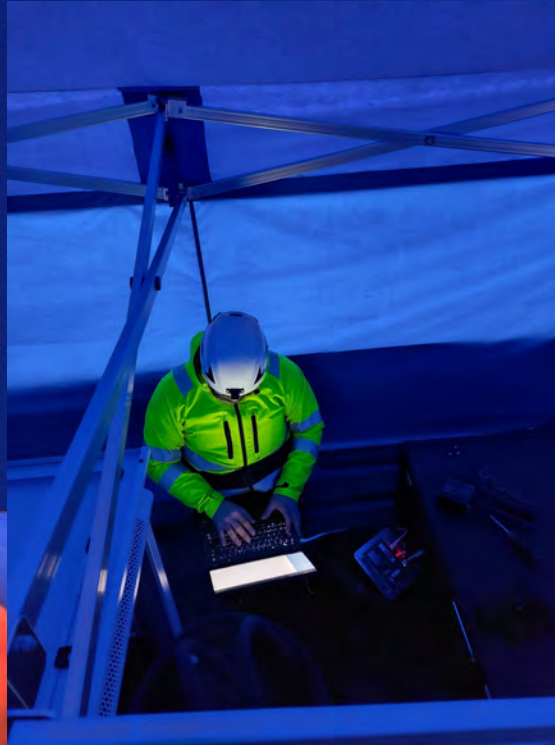
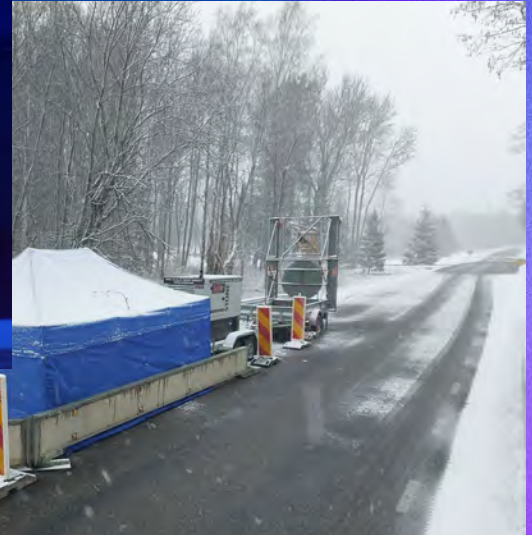
Why we have the tent?

- Safety
  - Traffic
  - Visitors
  - Weather

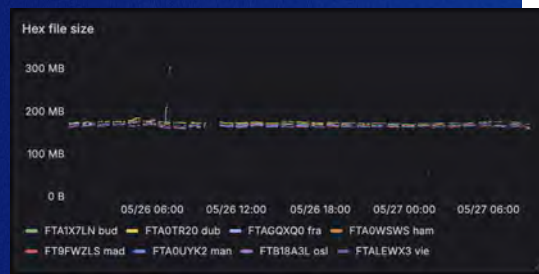
- Position data
- Active monitoring
- 5 minute chunks for data transfer

- 88% first bridge
- 75% second bridge
  - External factors

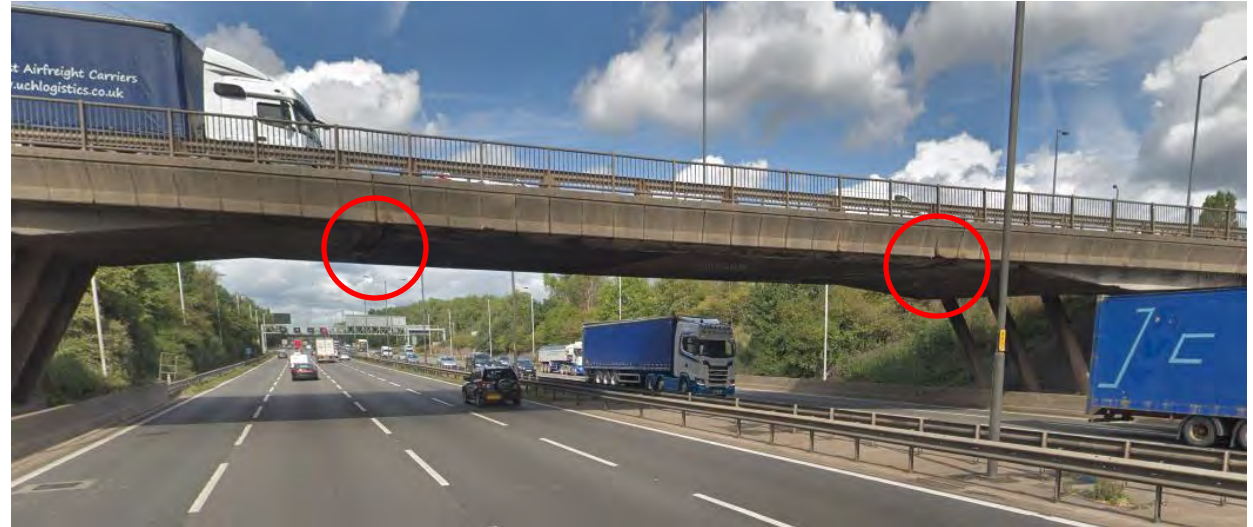
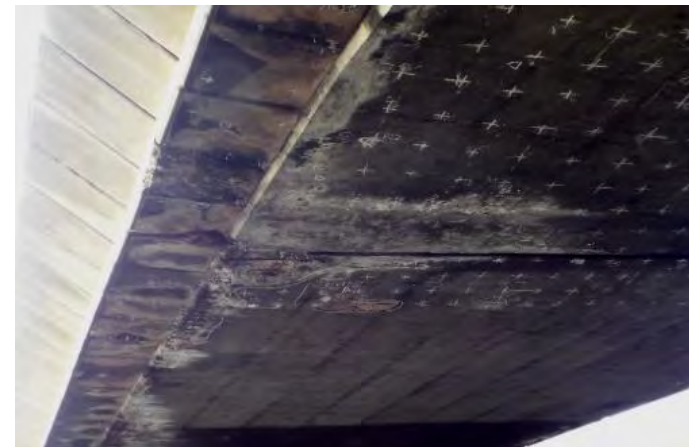
Figure B.2 Typical deck hinge details

# Deployment at Priority Risk Structures (3 – Hinge-deck Structures)
