Lower Thames Crossing

6.3 Environmental Statement Appendices Appendix 8.16 – Draft EPS mitigation licence application – bats (Clean version)

Planning Inspectorate Scheme Ref: TR010032
Application Document Ref: TR010032/APP/6.3

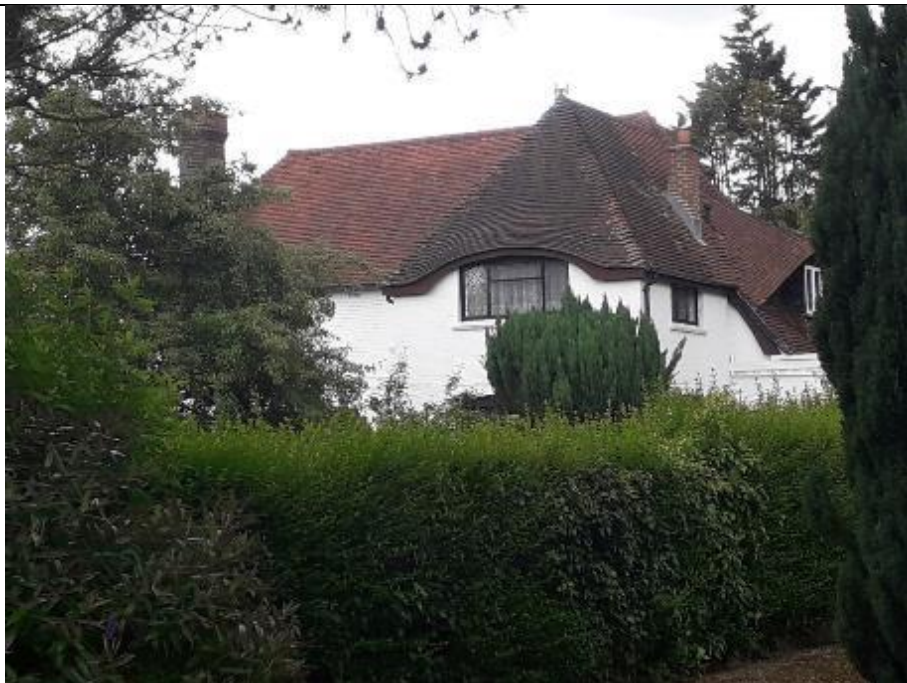
S14 Marling Manor: Pile of (after DNA analysis) brown long-eared bats droppings. No bats were seen within the building. Bats have since been seen emerging

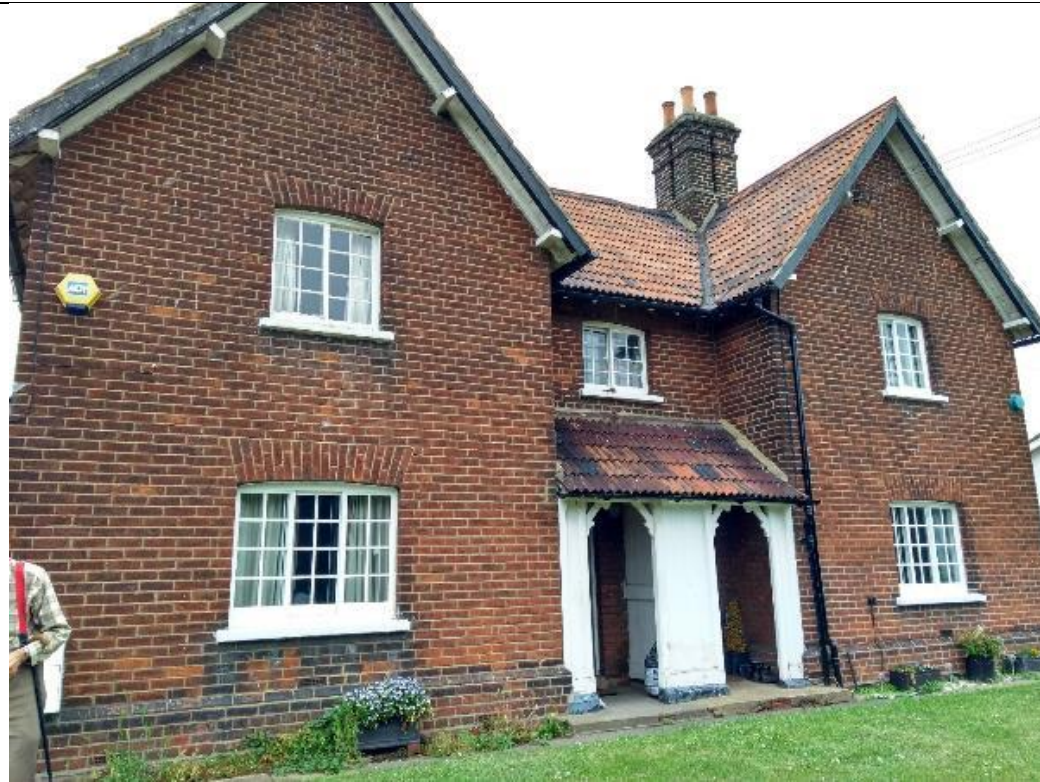
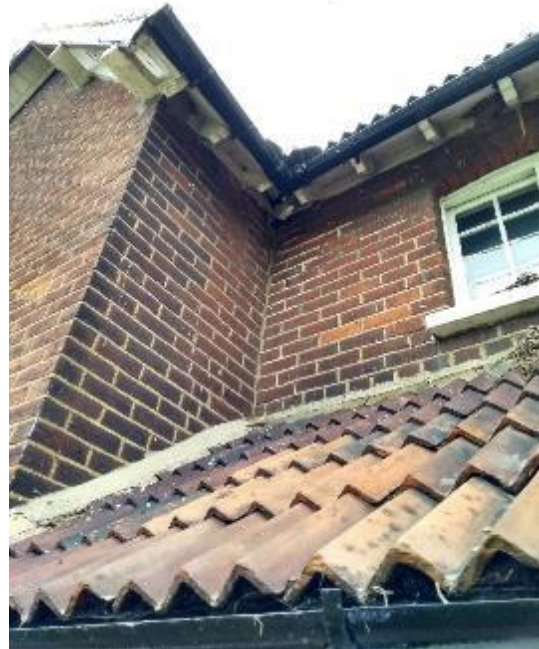
S29 1 + 2 Bridge Cottages: Emergence was identified under the gable end, fascia boards on the southwestern gable.

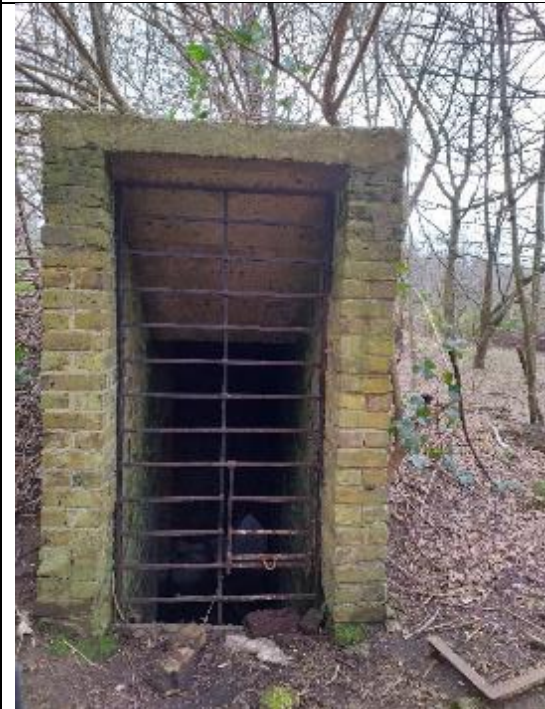
S328 Shorne Woods Air Raid Shelter Bunker 2: Internal inspection identified one hibernating Daubenton's bat. The local bat group have confirmed it as a hibernation roost for brown long-eared and Natterer's as well.

Data loggers were installed in S328 as part of the hibernation surveys to ensure similar conditions are recreated in the artificial roost.
